# **HOW NOT TO LEARN FROM MISTAKES: RECURRENT AND FORTHCOMING DEFECTS IN INSTALLATION OF CERAMIC TILES**

**Peter Hartog**

Principal - Building Diagnostics Asia Pacific

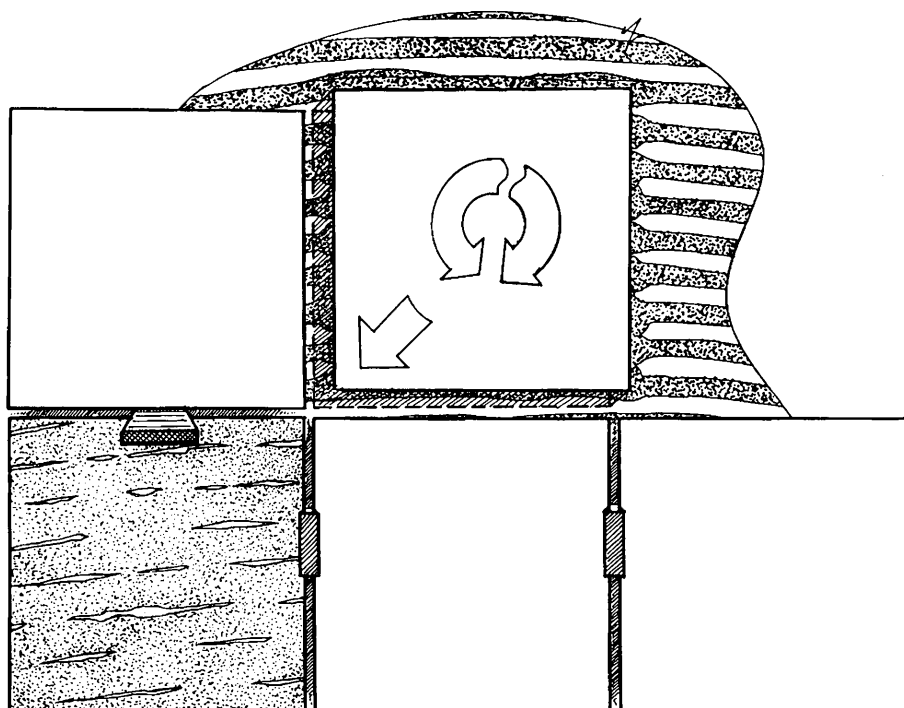
**Diagram 1**

*The preferred twist and slide technique of wall tiling. The tile is pressed into ribs of thin-set adhesive above and slightly to one side of its ultimate location. The tile is given a slight twist, both clockwise and counterclockwise, and then made to slide into position. This action causes ribs of adhesive to flatten and merge. Dried skins on ribs tend to be torn or dragged, thereby allowing contact between wet paste and the porous tile surface. Contact coverage is likely to be more or less uniform across the tile.*

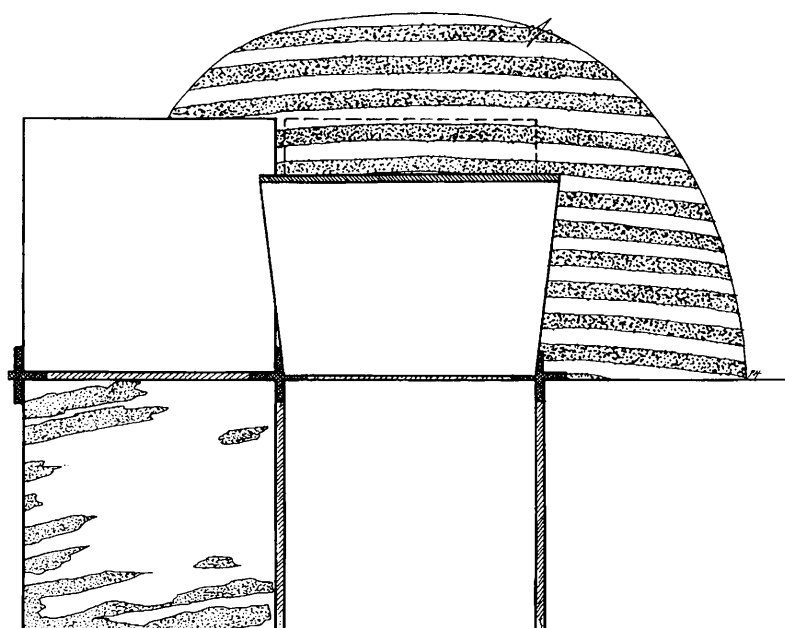
**Diagram 2**

*The fixing technique, here termed hinge and thump, adopted to overcome the problem of dislodging spacer crosses already in place along the top of the preceding course of tiles. The bottom edge of each tile is lowered onto the horizontal arms of two spacers. The tile may immediately compress and cut into the lowest two or three ribs of adhesive. The tile is then hinged towards the wall and beaten. This action flattens ribs of adhesive without forcing them to merge. There is an increased risk that ribs with slightly dessicated skins are pressed against the tile without wetting and bonding to it. BDAP's studies of delaminated tiles fixed by this method have shown that ribs of adhesive remaining on the substrate, in the area corresponding to the central two-thirds of the tile, tend to be flat, smooth-surfaced and bear neat impressions of embossments on the tile. However, they leave no residues of adhesive, other than milky stains, on the tile.*

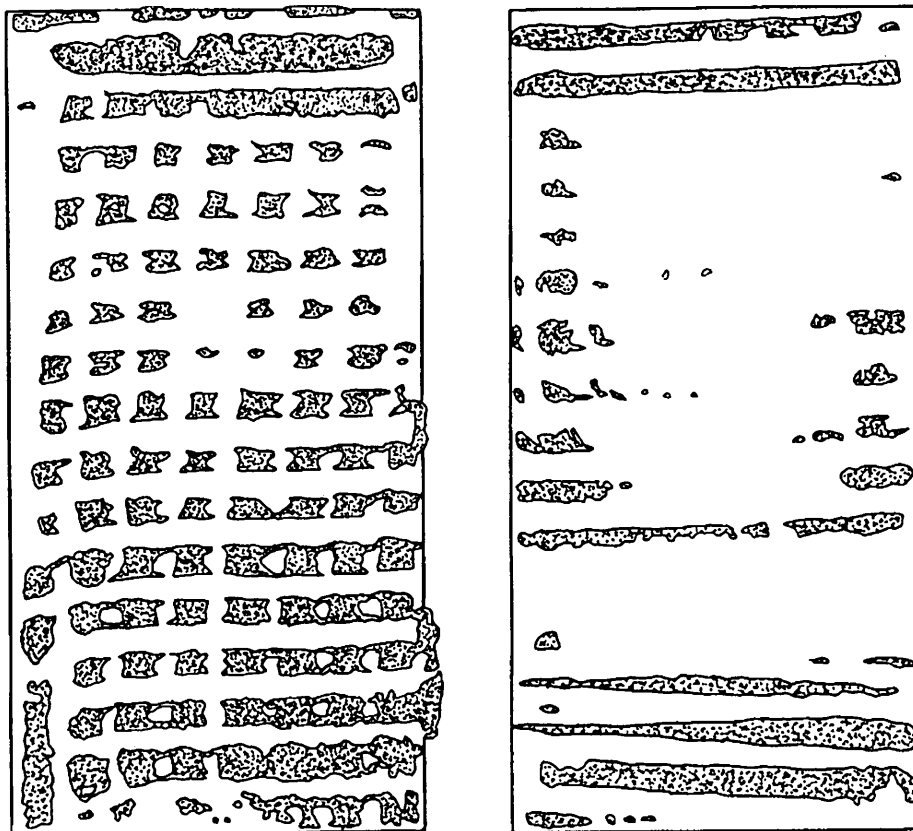
**Diagram 3.**

Patterns of coverage of thin-set adhesive on delaminated 100 x 200 mm wall tiles. The shaded areas represent adhesive which bonded to the tiles during fixing and remained attached after the tiling failed. These patterns are characteristic of ribs of adhesive retrowelled after expiry of the product's effective working time.

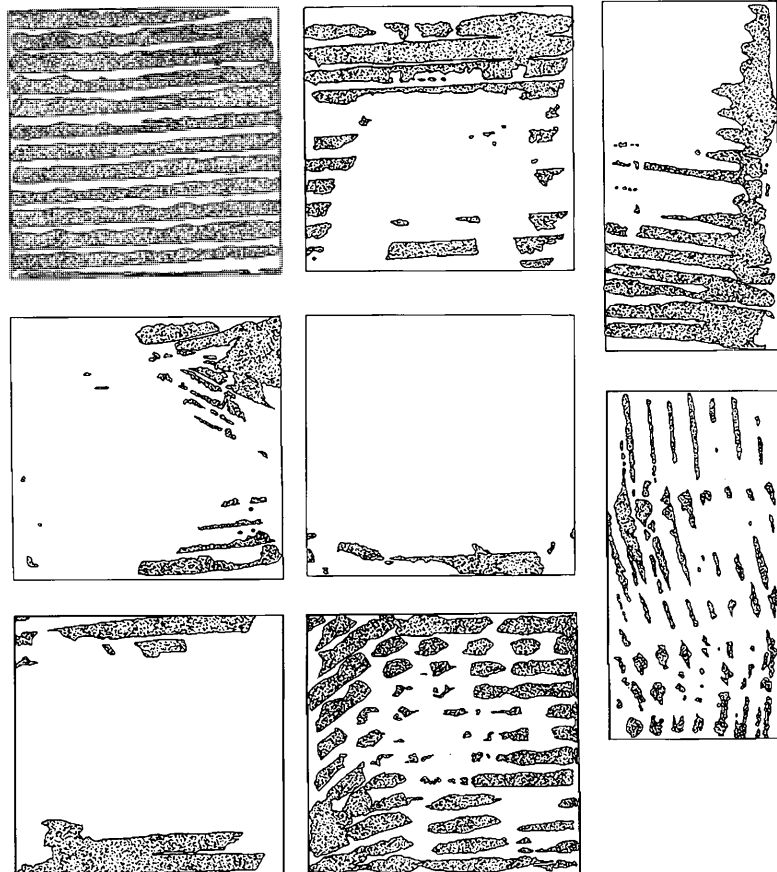
**Diagram 4.**

Adhesive coverage patterns associated with the hinge and thump fixing method encouraged by prior embedment of cruciform plastic joint spacers along the tops of preceding course of tiles. The shaded areas represent thin set adhesive which bonded to 150 x 150 mm and 100 x 200 mm wall tiles during fixing and remained attached after the tiling failed. Adhesive elsewhere on the rendered substrate either did not come into contact with the tile or did not wet and bond to the porous surface.

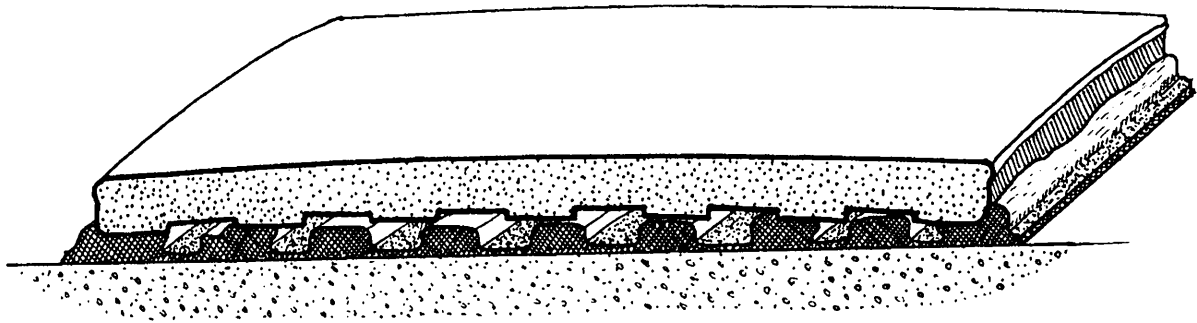
**Diagram 5.**

Thin-set adhesives are generally defined in Australian and North American as being not more than 3 mm thick. Manufacturer's instructions commonly recommend use of trowels with square notches at least 6 x 6 x 6 mm to spread these adhesives. In theory, this produces ribs of adhesive 3 mm thick which, if fully compacted, give a uniform adhesive layer about 1.5 mm. 75% contact coverage would correspond to a 2 mm thick layer. Smooth substrates, worn trowels and incorrect application techniques occasionally combine to produce ribs of adhesive too shallow to be flattened during fixing of wall tiles with a slight but permissible concavity on the unglazed face. BDAP has recorded instances in which the average thicknesses of intact smooth-faced ribs of hardened adhesive paste is as low as 0.83 mm.

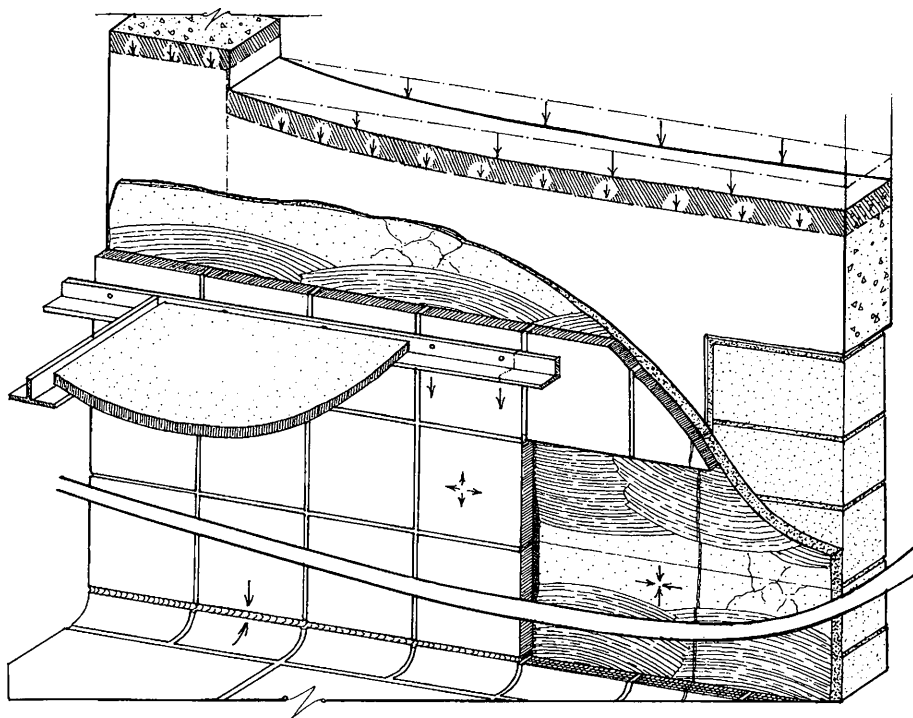
**Diagram 6.**

Factors which commonly contribute to adhesion failure of conventional wall tiles:

- Progressive elastic shortening, creep and shrinkage of reinforced concrete columns and shear walls.
- Deflection of reinforced concrete elements such as wall beams and Vierendeel trusses.
- Omission or inadequacy of control joints around the perimeters of nonloadbearing infill panels in concrete walls such as elevator shafts.
- Inadvertent transfer of gravity loads from suspended ceilings into the top course of tiles and from wall-mounted fixtures to wall tiles elsewhere.
- Shrinkage and cracking of cement substrates.
- Irreversible moisture-related expansion of ceramic tiles.
- Horizontal bands of weakness in the adhesive layer due to trowelling of thin-set adhesives to feathered edges parallel to string lines used to set out the tiling.
- Omission or obstruction of horizontal expansion joints at floor and skirting level.

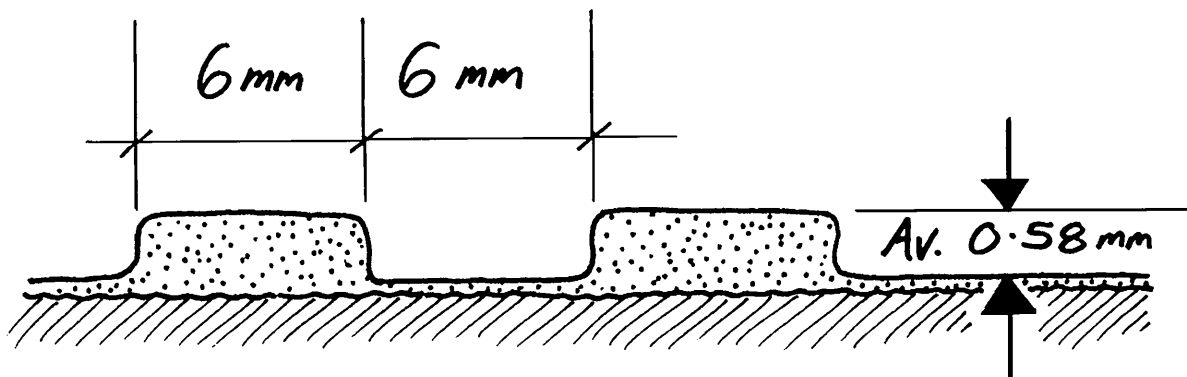
Diagram 7.

A set of micrometer measurements of ribs of trowelled thin-set tile adhesive from the rendered substrate of wall tiling which failed in adhesion on the walls of a hospital in eastern Australia. The figures record in millimetres the distance from the smooth top surfaces of uncompressed ribs, ie. those which were undisturbed during fixing, to the thin film of adhesive paste scraped onto the render
