# **DURABILITY OF CERAMIC FACADE CLADDING - PROCEDURES FOR DIAGNOSING ON-SITE PATHOLOGIES**

**Campante, Edmilson Fritas\*, Sabbatini, Fernando Henrique\*\***

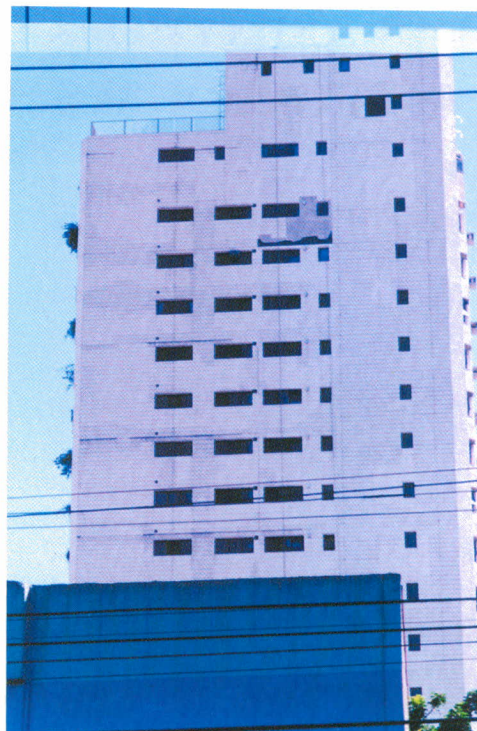
*Building "A"*

The building in question is a residential block of 15 floors and a duplex penthouse. It was built using reinforced concrete filled in with ceramic blocks and covered with white glazed extruded ceramic with teeth on the back, fixed on conventional adhesive cement mortar using a fine layer over cured mortar. The building took 36 months to build and the first indications of pathology began one year after completion (1990) and went on until 1999, periodically during the autumn, which leads us to believe that we are facing a case of faults caused by thermal amplitude which are typical at this time of year in this region of Brazil.

The detachment happened on the north and south faces, being more apparent on the southern side which has the largest faces and which has no discontinuities either from openings or working joints (none at all on this building). The problem was worse at higher levels of the south face and lower levels of the north face. The main cause of detachment happened between the tiles and the fixing mortar, and signs were also found of bad filling of the back of the tile, which leads us to believe that the fixing was badly carried out and the fixing mortar was not well chosen.

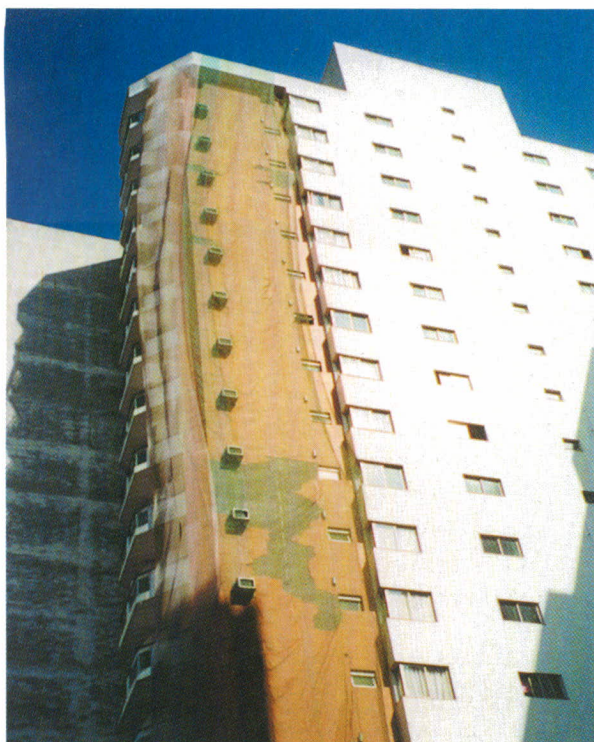
*Building "B"*

This building, with kitchenette style apartments, is located in a densely populated region, has 20 floors and was built using reinforced concrete filled in with ceramic blocks and covered with high absorption (30% in test results) unglazed extruded ceramic "Cotto". Although it took 53 months to complete the building there were no work stoppages. However, the schedule was extremely irregular, and the first news of detachment came two years after completion (1997). Fixing was carried out using conventional cement mortar, applied on a plaster base, which was left exposed to the weather for 5 months, by the sub-contractor.

The detachments occurred after showers on a very hot day, specifically on the north and west faces which receive the most sunlight. Possible causes range from inadequate material (high absorption ceramic and inflexible mortar), to project ina-

dequacies (lack of working joints) and even deficiencies in the production process (no filling of the back of the tile) and the labour skills (sub-contracted for price reasons).

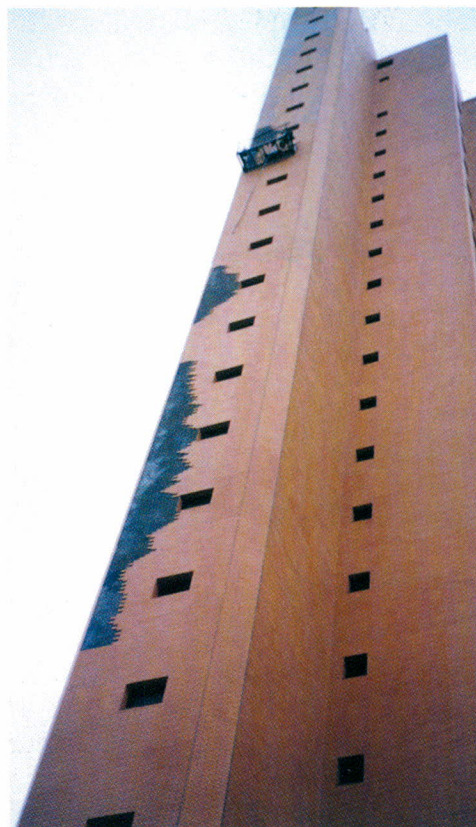
*Building "C"*

A residential building with 21 floors located in a densely populated region, was built using reinforced concrete, filled in with ceramic blocks and covered with unglazed extruded ceramic "Cotto". The construction took 24 months with no work stoppages, the first appearance of detachment coming one year after completion. (1998), most notably on the west face at mid-level. Tile fixing was carried out using cement mortar on cured mortar by subcontractors.

In this case we saw that the building had a very flexible structure, with small pillars and thin floor slabs (8cm) which, when associated with the type of mortar used (low flexibility) could be one of the causes of detachment., which happened after a "summer shower". The lack of working joints on these faces could also help to explain what happened. Apart from this, we also noticed bad filling of the back of the tiles, associated with insufficient spreading of the mortar lines, which could be due to tile fixing on dried mortar.

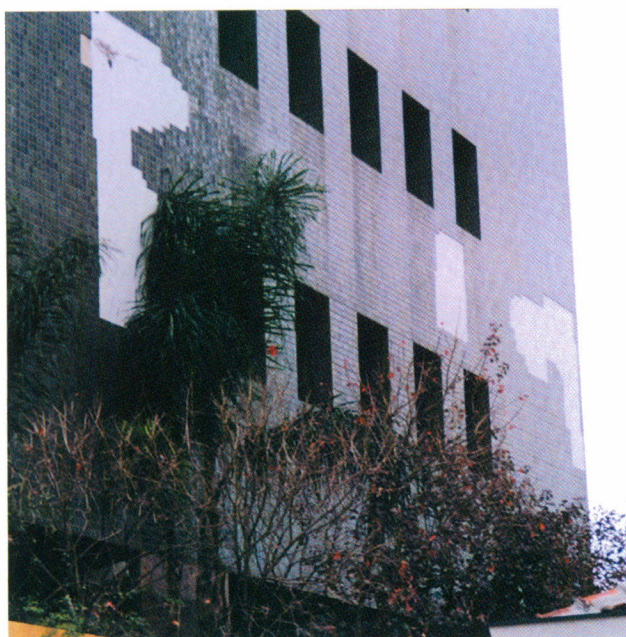
*Building "D"*

The fourth case is a residential building 15 floors high built of reinforced concrete filled in with ceramic blocks and covered with porcelain stoneware, fixed using traditional techniques with conventional cement mortar and the construction company's own labour. This building took 30 months to complete and the first occurrence of detachment came 3 years later (1997). The worst sides of the building were the north and west faces at the mid and upper levels. In this case the detachments happened in autumn, a period of hot days and cold nights.

Once again we have a combination of factors to explain the pathology, i.e. the use of inadequate material, fixing mortar unable to stand any deformities

caused by temperature change, bad production process (no double bonding - applying mortar to the wall base and to the back of the tile). Apart from this, the lack of working joints could also have contributed to the problem.
