## PROCEDURES FOR REPAIR OF PATHOLOGIES IN CERAMIC FACADE CLADDINGS

*Through a discussion of the factors involved in the occurrence of detachments in ceramic facade claddings, this work seeks to establish parameters for restoring this building subsystem. Through this investigation, subsidies are sought for applying a methodology developed for the repair of this type of pathological manifestation.*

*The work presents and analyses a case study in a residential building located in the city of São Paulo - Brazil. In this case study it is attempted to apply parameters based on actions of a preventive and corrective character, in defining an approach for repairing facades affected by detachments.*

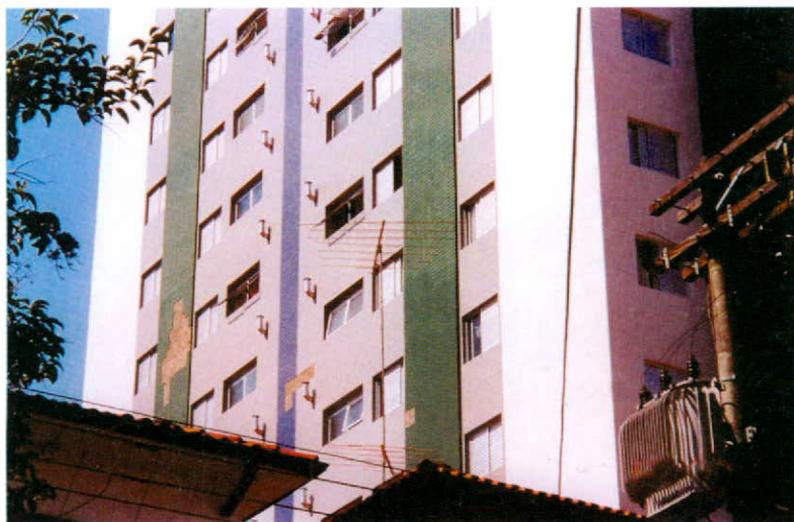
It can be observed that the problem happened in the east facade of the building, as shown in Figure 3 and quantified in Figure 4.

Figure 3: Detachment event in the east facade of the building.

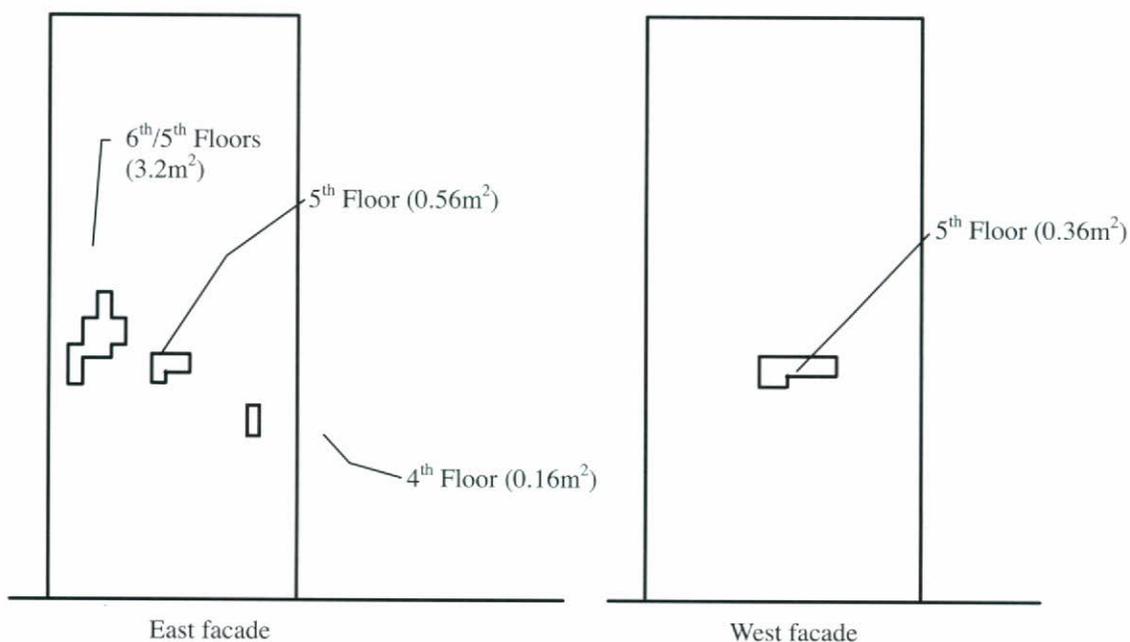
Figure 4: Views of the positions at which the detachments occurred and their respective areas.

The conclusion reached was that nearly 65% of the east facade was affected, and 55% of the west facade exhibited local 'swellings'. In view of the risk for the users, it was decided to completely renew the subsystem.

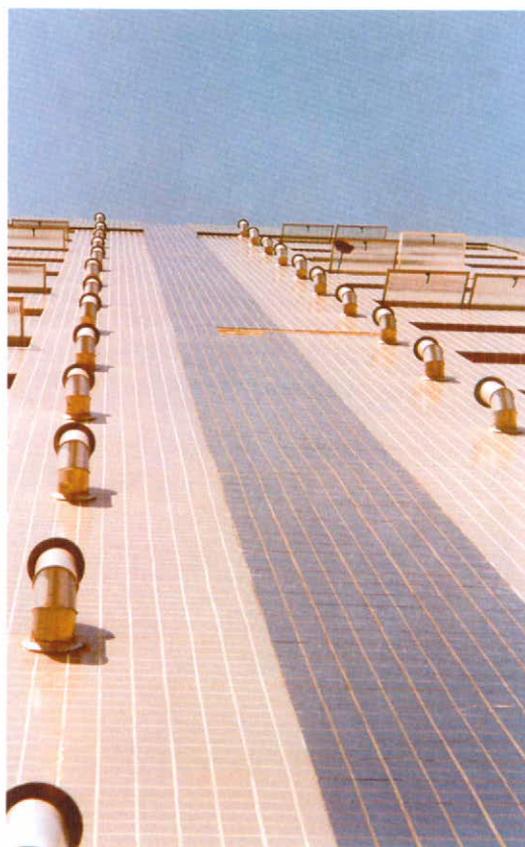
The *in situ* inspection also highlighted the notable exposure to sunlight that affected the facade in two periods of the day, as shown in Figure 5.

Figure 5: Evidence of east facade exposure to sunlight.

- Lack of care in cleaning the fixing surface;
- Installation on surfaces subject to severe climatic conditions, such as: high exposure to sunshine on the facades, high frequency of strong winds, high temperatures and rainfall in the period in which the facade was built (October, November, according to the building engineer), without appropriate protection;

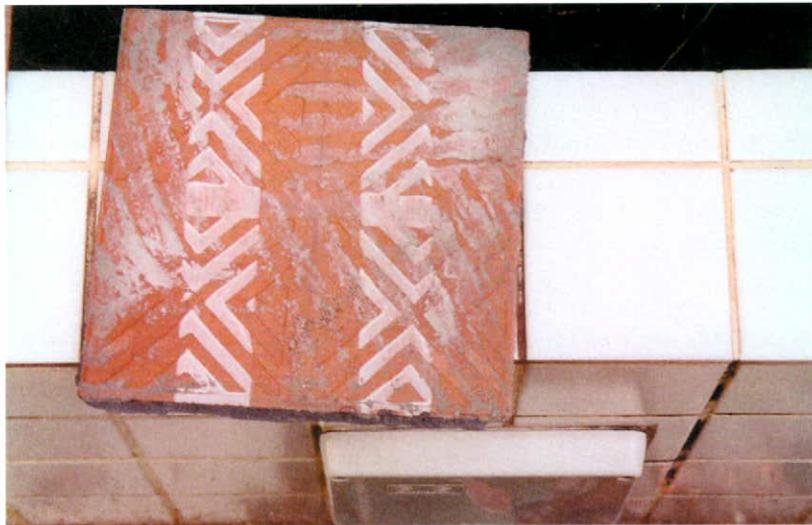
Another fact demonstrated in the inspections was the lack of coverage on the back of the ceramic tiles that came off the facades, as shown in Figure 6.

*Figure 6: Evidence of the lack of coverage on the back of the ceramic tiles.*

As access was unavailable to all the relevant information, based on the evidence established during the interviews and the *in situ* visit, it was sought to determine the **Nature** and **Origin** of the problem, following the approach developed by CAMPANTE (2001). Thus, starting at contact with the problem of ceramic tile detachment of the east facade, the 1st observation Level, the Immediate Cause, was reached, i.e., it was caused by lack of bonding between ceramic tiles and fixing mortar evidenced by absence of coverage on the back of the tiles.

- Installation after fixing mortar open time had expired;
- Installation without carrying out the floating and buttering adhesive procedure;
- Inadequate pressing down onto the bands of mortar and thumping of the tiles evidenced by the lack of tile rear profile impressed in the surface of the fixing mortar;

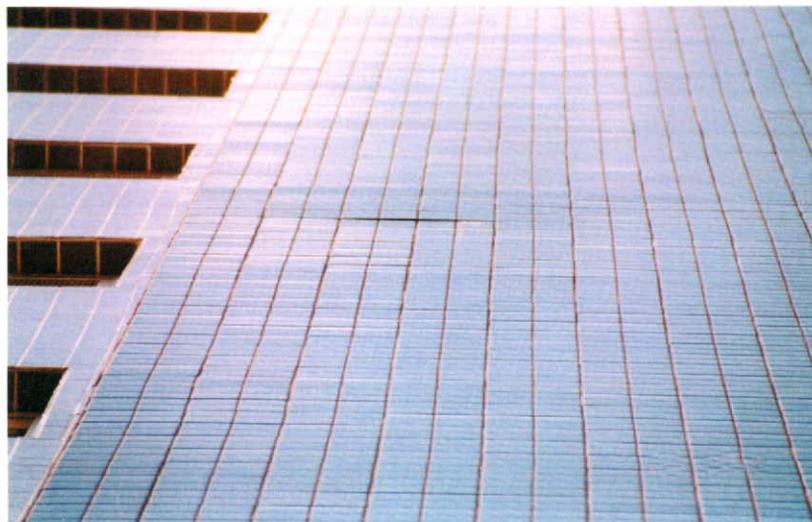
Areas were also observed in which tiling swellings warned of the eminent risk of tiles popping, entailing great risks for the users and demanding urgent solution, as Figure 7 shows.

*Figure 7: Appearance of swellings in areas of the west facade of the building.*

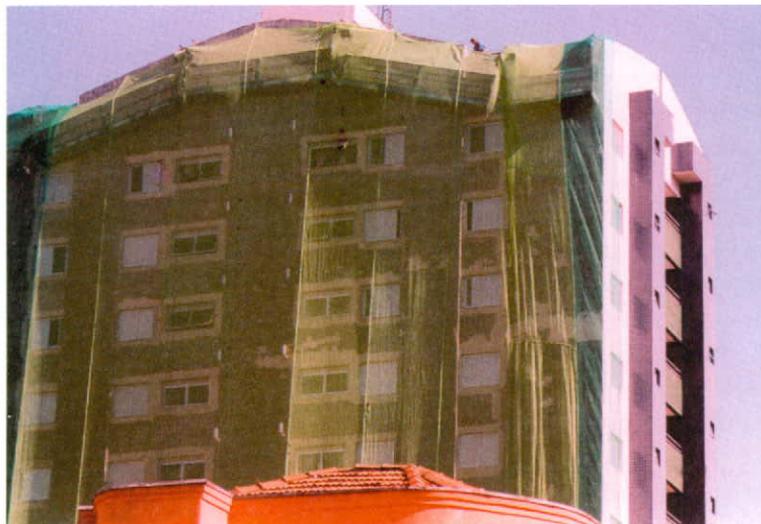
*Figure 8: View of the east facade during repair.*

During the removal of the ceramic tiles, evidence was encountered of other problems hidden till then, such as, render apparently affected with regard to its mechanical strength and physical integrity in different points of the facade.

Thus, in March 2001 renovation of the east facade was started. A piecemaker recommended by the tile manufacturer was hired (a company that seeks to be accredited by the tile manufacturer for installing its products) to carry out the repairs. The initially considered (and budgeted) procedure for the piecemaker was to be the complete removal of the ceramic tiles and the installation of new ceramic tiles, on the previous fixing mortar, with the opening of movement joints in the render, as shown in Figure 8.

Based on these tests it was concluded that there were only some small areas (about 10% of the total area) of affected render; these were mapped and identified for repair. In most of the surface the fixing mortar still retained its surface strength, which allowed it to be used as a base for the new layer, just recommending sanding of its rough edges and regulating its surface with mortar of the AC II type.

In the regions in which the fixing mortar was removed, but the render was unaffected, it was necessary to apply a priming layer between the old render and the regulatory AC II mortar layer, using a cement slurry mixed with water and PVA Rodopas<sup>®</sup> 503 D resin in a proportion of 1:6, with application after 1 hour with a foam roller.

After regulation of the whole surface, ceramic tile installation can start using mortar of the AC III type (due to its larger open time) using the floating and buttering technique (owing to the impossibility installing movement joints, as shown below) and using the procedures set out in standard NBR 13755 (ABNT, 1996).
