## **TILING FAILURES – A CHRONIC PROBLEM RE-VISITED**

**Wong Chung Wan**

Division Director  
Construction Technology Division  
Setsco Services Pte Ltd  
18 Teban Gardens Crescent, Singapore 608925  
email: wcyan@setsco.com

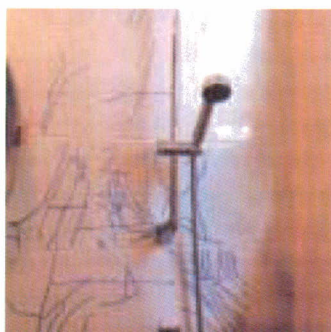
*Picture on left shows massive random fine cracks on the surface of the glazed tiles. These cracks were due mainly to shrinkage in the bedding/plaster. Picture on right shows regular pattern cracks on the glazed tiles, partly contributed by movement in the brick wall, especially along the brick mortar joints.*

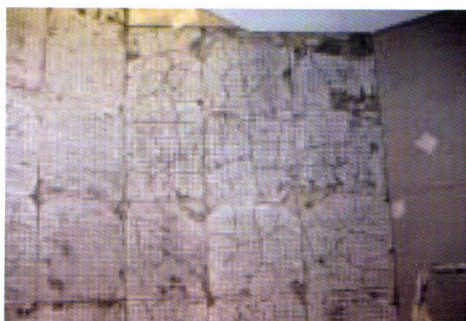
Here lies one of the biggest controversies: what is defined as a thin bed system? According to BS 5385: Part 1: 1990, installation of thin bed adhesive in excess of 3mm, can lead to excessive stresses possibly resulting in cracking of the tiles and/or adhesion failure. Similar recommendations have been given in AS 3958.1: 1998. In the TCA Handbook for Ceramic Tile Installation, the term 'thin-set' is used to describe the method of installing tile with a bonding material usually  $3/32''$  to  $1/8''$  in thickness (2.3 to 3.1 mm). A thick bed system has been defined as bedding exceeding 3 mm. To the local practitioners, a thin bed system is those with thickness typically between 3 – 6mm. For larger tiles, which are becoming more popular, thickness of thin bed up to 8mm has also been used. Bedding between 6-15mm is considered as medium bed and those exceeding 15mm as thick bed system. Some technical brochure of adhesive locally defined a thin bed system as those exceeding 3 mm with no clear indication of the maximum limit. It is also argued, obviously by the contractor, that is it not feasible to lay tiles with 3mm *thin* adhesive since it is not possible to ensure that degree of flatness of the rendered wall. According to Goldberg<sup>[5]</sup>, thin bedding method is defined as an application of a layer of adhesive, ranging from a minimum of 3mm to a maximum of approximately 20 mm thick for facades. So, this begs the question as to how does one knows if the thin bed has been applied too thick and has contributed to the cracking of the tiles. Substantial amount of investigation works carried out by the author on cracked glazed wall tiles showed presence of shrinkage cracks in the bedding. These cracks are typically rectilinear and some linear and perpendicular to the bed thickness. Many of these cracks had been carried through to the tile. Most of these bedding that had cracked were very thick and without fillers.

*In picture, hollow sounding or debonded tiles were removed and the bedding adhesive was found to contain massive shrinkage cracks. The bedding was neat cement without any fillers with thickness up to 6-8 mm.*

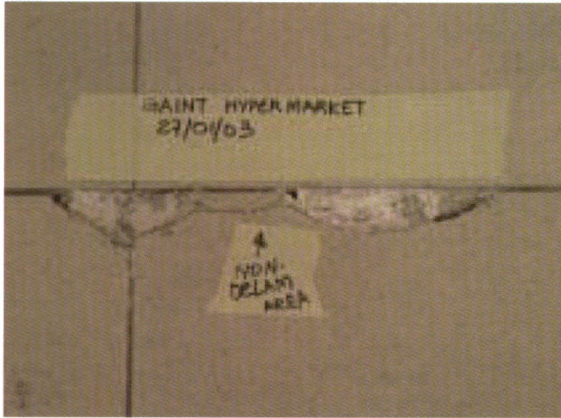
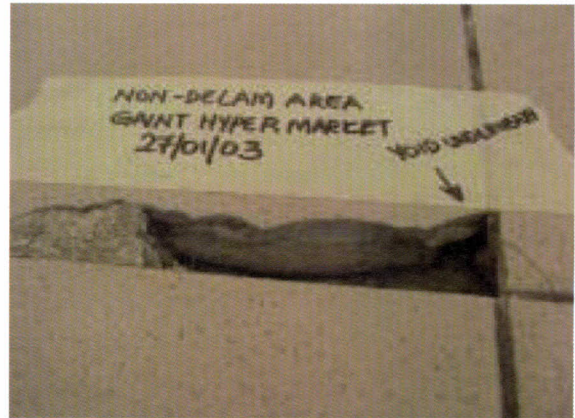
Top pictures show cracking and impact damage of floor tiles along or near the edge. These tiles were laid in heavily trafficked area. Down picture shows presence of voids below the tiles. The voids were generally found to be less than 10% of each tile surface area.

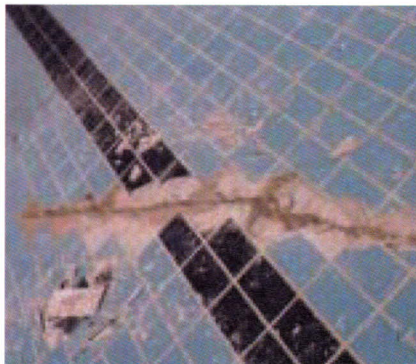
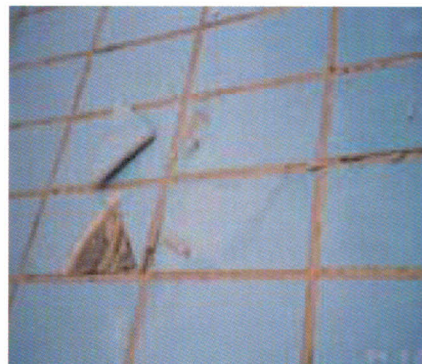
Top pictures show cracking of the tiles in a swimming pool. Down picture shows lifting up of the tiles especially around the inlet of water supply. These cases were found to be due to leaking water supply pipes.

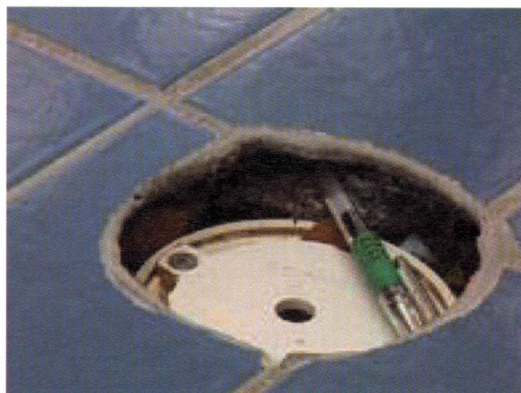
In some cases of ceramic tiled swimming pool failure, the cause was not so much of the tiling works and materials themselves, but rather, from faulty buried mechanical services. The water supply pipes to the swimming pool would need to overcome the pressure of the water height and thus the water from the pipe is supplied under high pressure. There had been cases where the pipes embedded within the screed at the base of the pool leaked and the leaking water under the immense pressure was uplifting the screed up resulting in cracking of the tiles, especially along the pour joint in the screed. The problem with such symptom is that the initial diagnosis was thought to be movement of the joint. Similarly, phenomenon has also been experienced in water supply pipe from the wall.

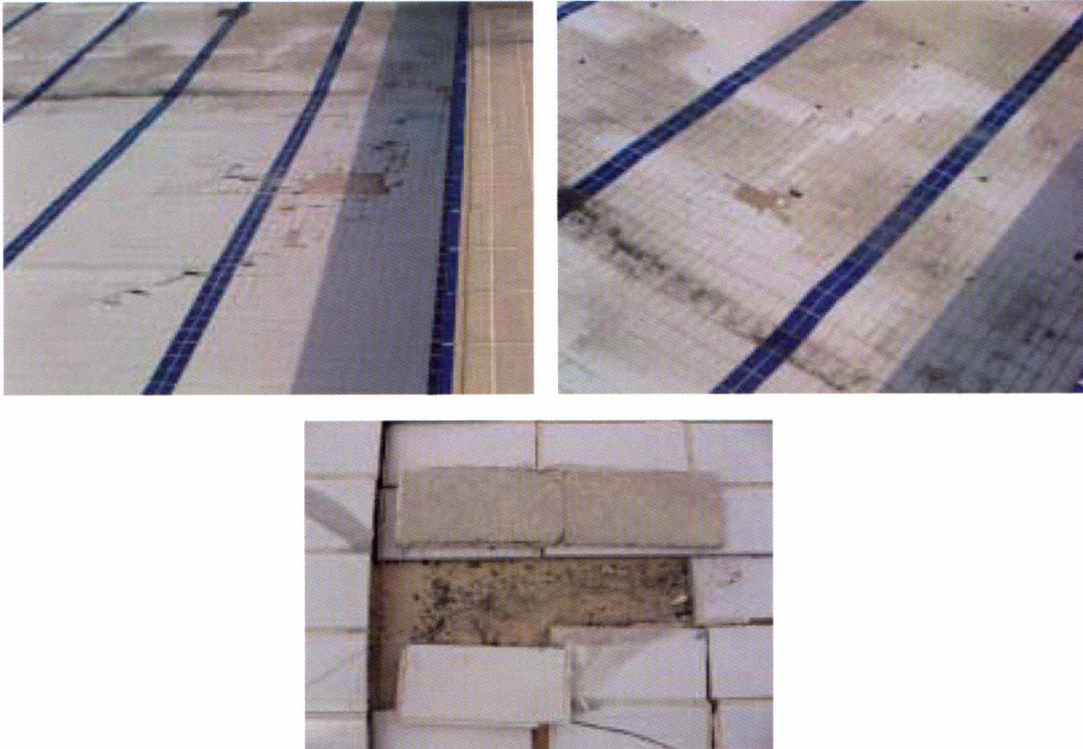
for repair, cleaning or testing, the failure proliferated. This is due to the removal of the counter weight of the water and expansion of the tiles due to moisture and thermal once the tiles are now exposed to direct solar heat. Such failure is commonly due to badly prepared plaster/screed background. The failure mode is typically either adhesion failure between the bedding and screed or cohesive shearing of the top layer of the screed. In some cases, the tile with the bedding were lifted up and detached from the underlying waterproofing membrane. This suggests an unsuitable waterproofing membrane and poor screed quality as among the possible roots.

*Top pictures show buckling and debonding failure of tiles in a swimming pool. The failure proliferated upon draining of the pool water for repair. Down picture shows a close up view of the mode of failure. Most of the tiles failed by cohesion fracture along the surface of the screed, indicating a poor screed quality*

These pools clearly were not constructed with movement/expansion joints and its omission is one of the leading causes of failure in ceramic tiled pools. The exclusion is mainly because of difficulties with waterproofing and sealant installation and maintenance. There appear to be a lack of guide in the design and installation of ceramic tiled swimming pool locally. Currently, the Technical Committee for the Architectural Works of the Singapore Productivity Board, in which the author is a member, is looking at the drafting of such a guide or code.
