DATA COLLECTION OF FIVE YEARS OF EXTERIOR FACADE PATHOLOGIES IN BRAZIL

Mansur, A. A. P; Nascimento, O. L.; Mansur, H. S.

Department of Metallurgical Engineering and Materials - Federal University of
Minas Gerais, Belo Horizonte. Brazil
hmansur@demet.ufmg.br

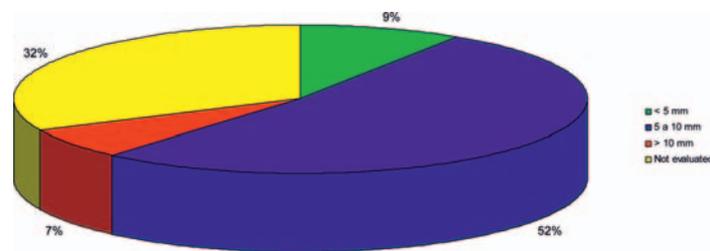
Figure 8. Statistics of grout joints width.

In less than 10% of the buildings, the width of joints between tiles was narrower than the minimum recommended width of 5 mm (Figure 8) and in all the cases they were filled with based Portland cement materials. Horizontal movement joint was observed in only 3 out of 44 evaluated facades while vertical movement joints and movement joints at existing concrete structural joints and at changes of planes or between dissimilar materials were not found (Figure 9). It is interesting to note that six buildings were built after the publication of the standard that outlines movement joints requirements (NBR 13755/96) and only one adopted this type of joint.

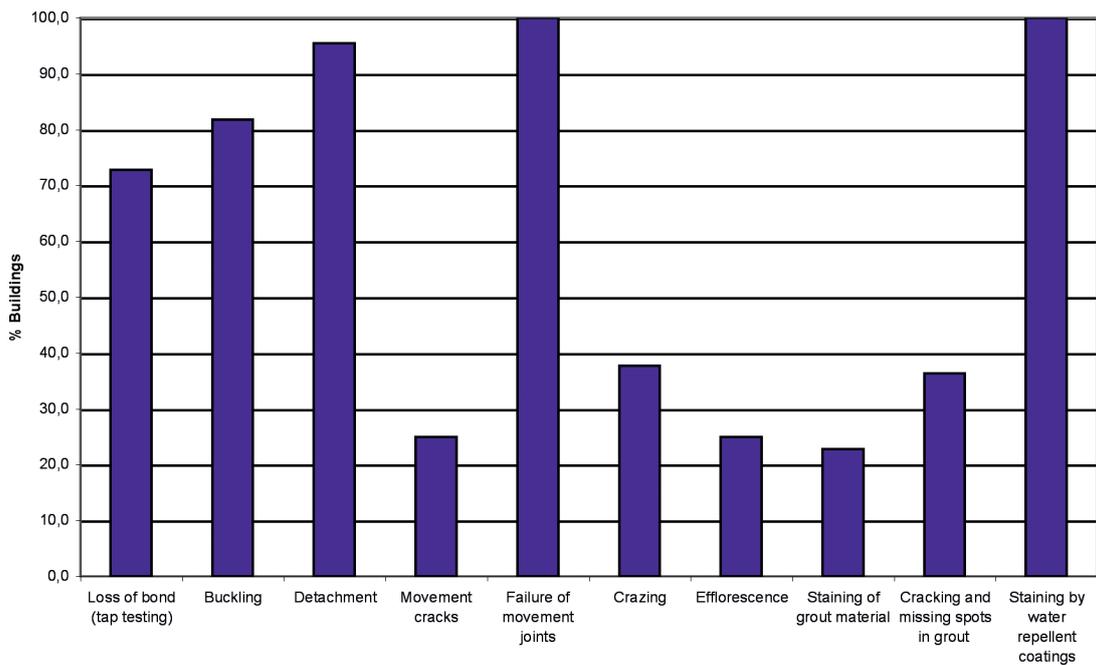
Figure 10. Summary of all observed pathologies.

The major pathologies observed at the buildings are summarized in Table 2 for aesthetics anomalies and in Table 3 for functional anomalies. Aesthetics defects affect the appearance of the facade but do not typically affect the safety while functional defects affect both appearance and human safety, as well as the integrity of other components of building. Figure 10 shows a graphic which includes all the pathologies observed in the buildings.

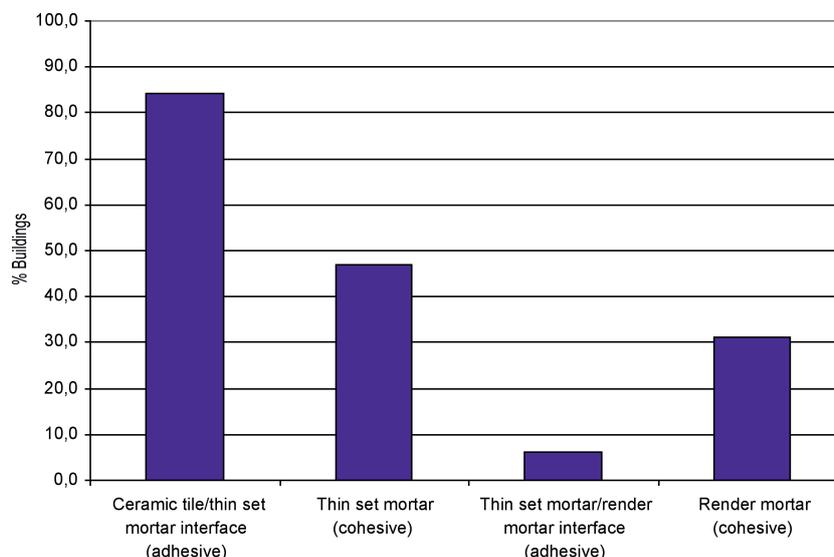
Figure 11. Rupture observed in the ceramics tiles under evaluation.

Other interesting information about bond failures is related to the location within the cladding system where the failure occurs. The graph in Figure 11 indicates that in 84% of evaluated buildings, in which was possible to identify the plane of rupture (32 of 44), it was observed a adhesive failure at the interface between cladding and polymer modified mortar, followed by 47% of cohesive rupture at adhesive mortar. In some cases, two or more planes of rupture were verified at the same building. These values are expected considering that several papers that reported the behaviour of ceramic tile coverings obtain higher shear stresses in tile/tile bed interface, when considering stresses caused by moisture expansion or thermal movements.
