# TILING FAILURES THROUGH THE LENS OF A MICROSCOPE

**Wong Chung Wan**

Setsco Services Pte Ltd, Singapore.  
wcwan@setsco.com

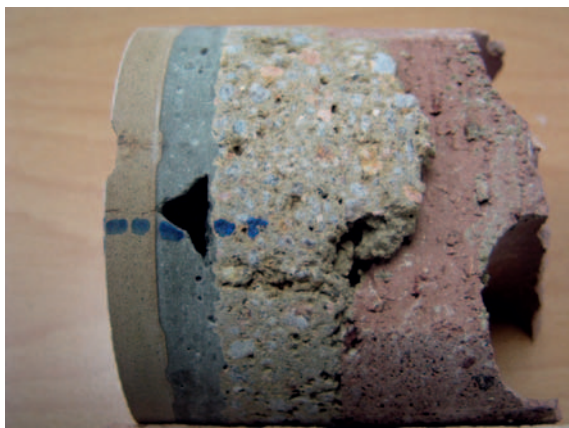
Figure 1.

In one case involving cracking of glazed wall tiles a few months after installation, removal of core samples across the cracks showed that some of the cracks on the tiles coincided with large voids within the bedding as seen on the hand sample in figure 1. This shows that the sharp triangular void in the bedding has played a significant role in causing cracking through the ceramic tile, probably due to shrinkage of the bedding. Such shrinkage of the bedding adhesive can be aggravated by the use of a rich mix resulting in stress concentration around the voids which may then be transmitted onto the tile layer. Under fluorescent microscopy, high capillary porosity of the bedding just below the interface with the ceramic tile was noted as depicted in figure 2. This is typically caused by an increased in water cement ratio, either due to bleeding of the bedding or contamination of water for instance from soaking of the tiles in water prior to installation. According to the method statement of installation in this case, the tiles were not supposed to have been soaked in water before laying.

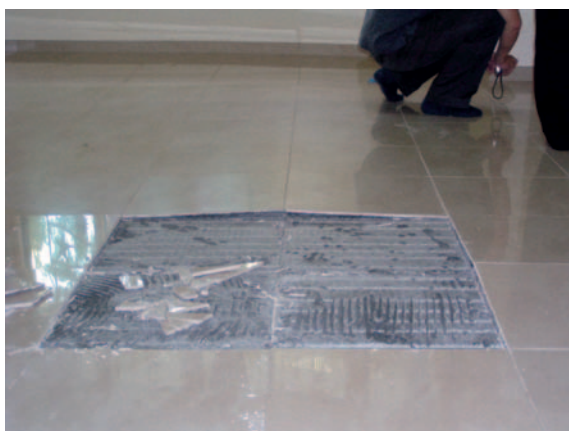
Figure 3.

One of the recent cases investigated involved buckling and debonding of homogeneous floor tiles as seen in figure 3. Examination of the mechanism of failure on site indicates detachment of the tiles from the bedding. Notch trowel marks could be seen on the exposed bedding with remnant strips of aluminium powder from the back of the tiles. The presence of the significant notch trowel marks infers that the tiles had not been pressed sufficiently onto the bedding during laying. It would also be naturally assumed that the aluminium powder has contributed to the debonding. See figure 4. Under the microscope however, as shown in figure 5, some of the debonding occurred within a thin layer of the bedding. The bedding appeared to be neat cement without any filler and characterized by massive shrinkage cracking as illustrated in figures 6 and 7. In figure 7 under fluorescent microscopy, there is also feature suggesting possible bleeding of water around the rectilinear crack; perhaps the cracks had occurred while the bedding was still fresh. Aside from the installation problem, the microscopic examination indicates that there could well be a problem with the adhesive used which was later discovered to be a formulation of latex and neat cement in proportion arbitrarily prepared by the tiler. In cases like this however, the cause of the compression stress induced onto the tiling layer should inevitably be checked as well.

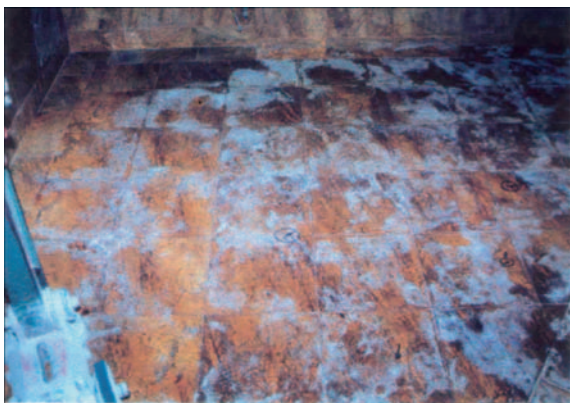
*Figure 8.*

Recalcitrant formation of efflorescence on the surface of natural stone tiles toilets in a hotel had been reported a few years ago. After cleaning off the whitish powdery surface deposits, within the next 1-2 days, the efflorescence reappeared as shown in figure 8. Under fluorescent microscopy, channels of very high capillary porosity were evident in the stone and this has caused uptake of water by the stone through capillary force. See figure 9. The capillary rise of the water from the cementitious substrate carried with it dissolved alkaline salt causing the formation of lime bloom on the surface of the stone.

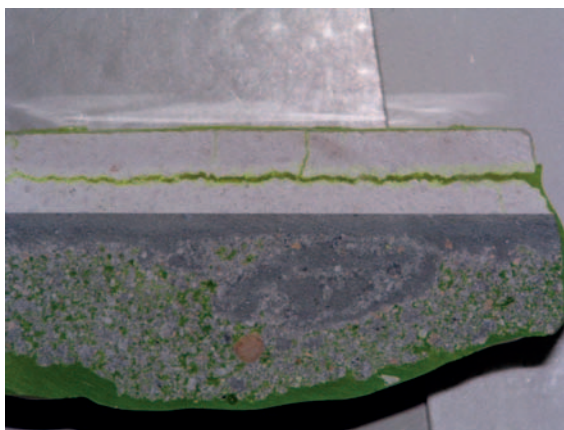
Figure 10.

In a hotel development, buckling and cracking of compressed marble tiles laid on the floor of a bathroom has been reported. Removal of the buckled tiles indicates that the tile had fractured horizontally within the thickness of the stone. See figure 10. There also appeared to be two bands of different shades of colour along the centre of the stone thickness, close to where the horizontal fracture has occurred as shown in figure 11. Such phenomenon was not observed on unlaied tiles. Under fluorescent light examination of impregnated samples, higher porosity at the bottom half of the tile thickness was discerned. See figure 12. It would appear in this case that the resin used in the compressed marble has been attacked by the alkali from the cementitious bedding resulting in increased porosity of the bottom of the tile that is in contact with the bedding. Subsequent simulation and alkali resistance test on the compressed marble confirmed the observations and hypothesis. Suitable and compatible adhesive will need to be selected for such application. Figure 13 shows recrystallised coarse grained Portlandite within the entrapped air void in the bedding, an indication of leaching or persistent dampness in the bedding.
