# **GLASS TILE CRACKS AND DELAMINATION: MICROSTRUCTURAL EVALUATION OF FAILURE CAUSES**

**(<sup>1</sup>) A. A. P. Mansur, (<sup>2</sup>) O. L. do Nascimento  
(<sup>1</sup>\*) H. S. Mansur**

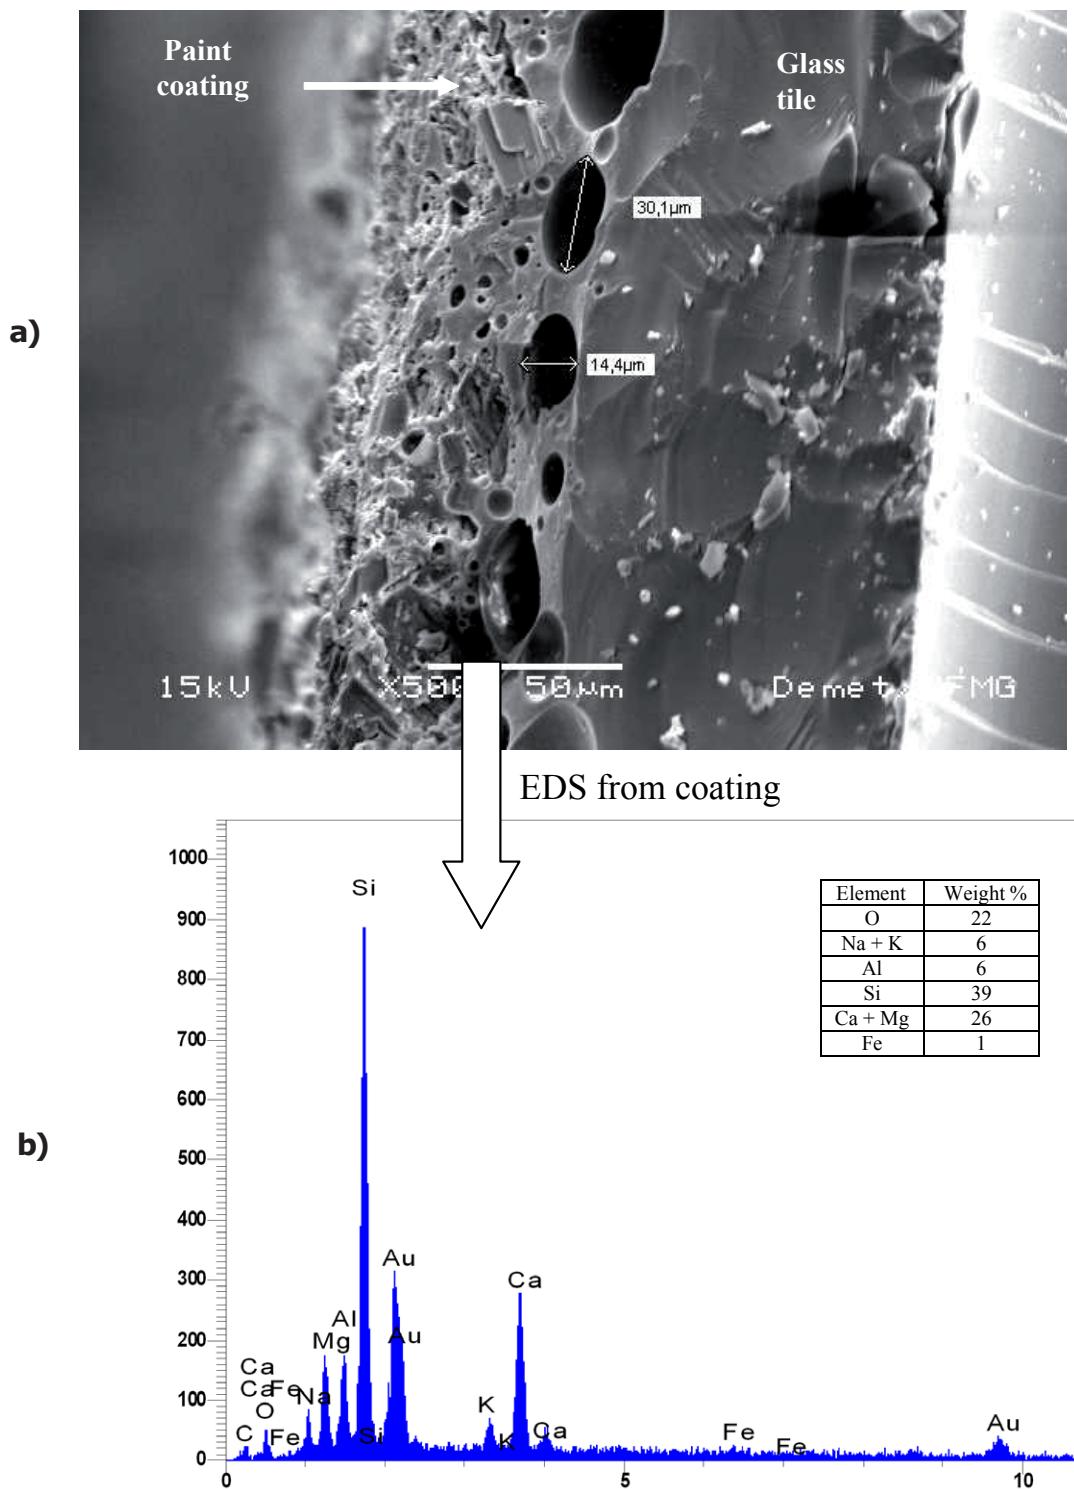
SEM images revealed that the paint film of the tiles involved in the detachments presented high porosity with both closed pores and interconnected pores. The paint layer thickness was between 40 and 80  $\mu\text{m}$  and the pore size ranged from 3 to 30  $\mu\text{m}$  (figure 1a). EDS coating analyses have shown Si, Ca and Mg as major constituents (figure 1b). In addition, the images obtained from glass tile systems with the mortar adhered on the back have indicated the presence of cement hydration products inside the interconnected porosity (figure 2).

In view of the results, it may be considered that coating processing parameters are not well established. High content of materials that decompose at elevated temperatures releasing gases, firing time or coating viscosity favouring bubble entrapment, and bloating phenomena must be avoided by raw materials selection and the firing profile. Paint layer porosity, when considering the possibility of mechanical anchoring of mortar, is a positive property. On the other hand, high porosity considerably reduces the cohesive resistance of this layer, which favours the verified rupture mode.

Figure 1. (a) Glass tile cross-section showing coating features. (b) EDS from coating layer.

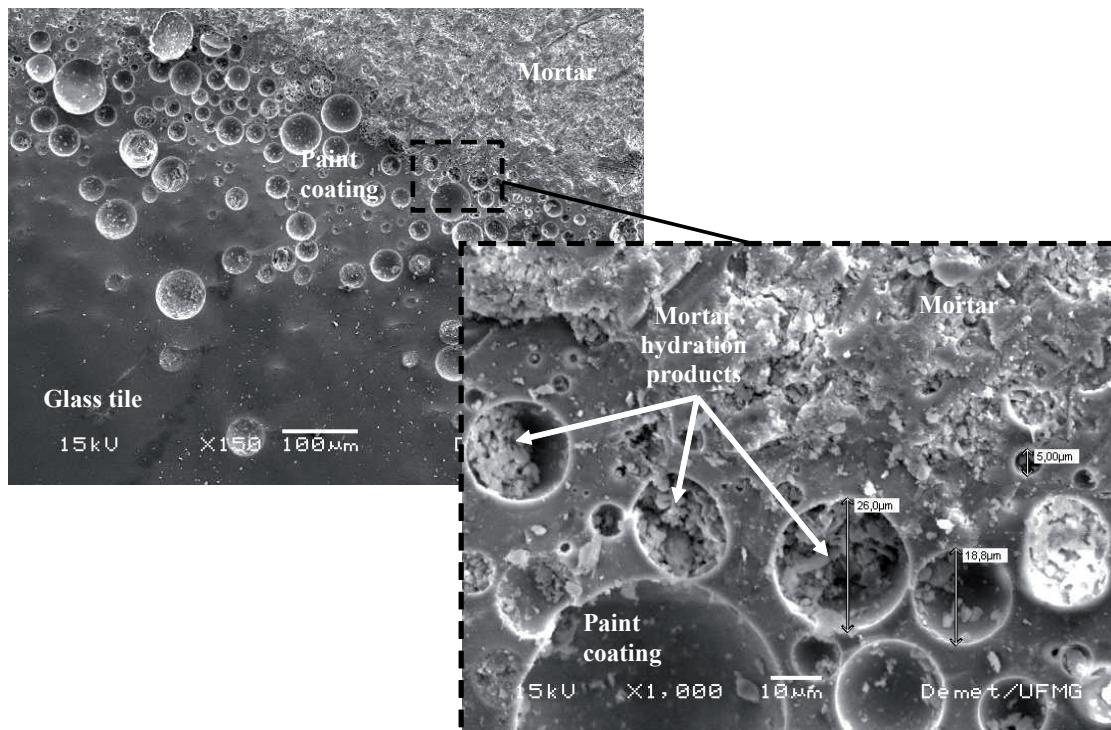
Figure 2. Hydration products inside the interconnected porosity of the paint coating.

SEM evaluation coupled with EDS spectra revealed that mortar filling of the interconnected pores of the surface coating may introduce and transfer stresses that exceed the resistance of the paint, resulting in the cracks and delamination observed.
