DEVELOPMENT OF NOVEL AND COST-EFFECTIVE COATINGS FOR HIGH-ENERGY PROCESSING APPLICATIONS.

H2020 FORGE PROJECT

A. Mezquita(1), E. Blasco(1), J.L. Amorós(2), A. Bianchin(3), F. Fanicchia(4), H. Friedrich(5)

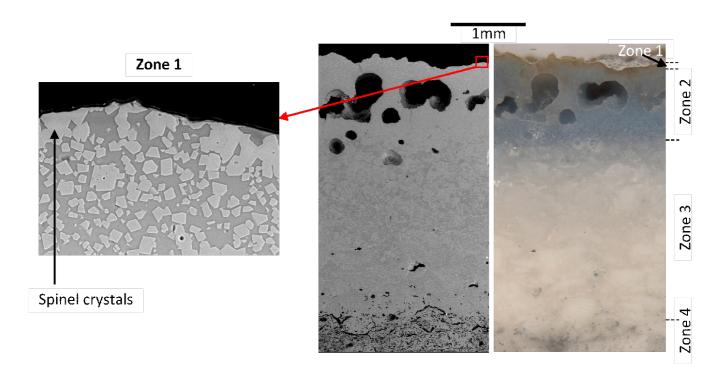
The attack of industrial refractories by metallic elements was determined by SEM-EDS. Four zones of different appearance were observed:

Zone 1 consisted of a thin brown layer. It was composed mainly of crystals containing aluminium, zinc, magnesium, chromium, and iron (probably spinel) embedded in a glass matrix of similar composition.

Zone 2, glassy in appearance and with large pores, was characterised by a high content of transition metals (Cr, Fe, Zn) and alkali metals (Na and K). Small spinel crystals were also observed. This layer was about 1mm thick.

Zone 3 also had a glassy appearance but was less porous. Alkali metals and transition metals were detected, the latter in a very low proportion. As the distance to the surface increased, the alkali metal content decreased, and the composition and microstructure of the refractory became closer to that of the original. The thickness of this layer was about 3 mm.

Zone 4 had a microstructure similar to that of the original refractory. The most substantial difference was a higher potassium and sodium content.

Figure 1. SEM and stereoscopic micrographs of the cross-section of the attacked refractory.

The attack of the refractories by the kiln gases involves their diffusion through the pores of the firebrick and their chemical reaction with the components of the refractory. This causes an increase in the content of the glassy phase of the material and a decrease in its viscosity, which results in a deterioration of the material as a consequence of undesired sintering, forming a glassy layer in its surface, and a decrease in the mechanical resistance to compression of the refractory. As a result, stresses are generated between the inner region and the surface of the firebrick, leading to crack formation. In addition, the sintering of the glassy layer results in loss of its insulating capacity.

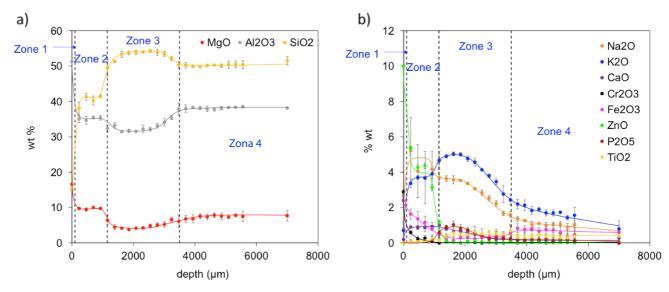
Figure 2. EDS depth profile of the cross-section of the attacked refractory: a) major oxides and b) minor oxides.

In the attacked refractories, four zones of different appearance were detected. These regions contained different amounts of transition and alkali metals. The former were mostly located in the most superficial attacked zones. The latter, on the other hand, were preferentially located in the inner attacked zones.
