TILING FAILURES – A CHRONIC PROBLEM RE-VISITED

Wong Chung Wan

Division Director
Construction Technology Division
Setsco Services Pte Ltd
18 Teban Gardens Crescent, Singapore 608925
email: wcyan@setsco.com

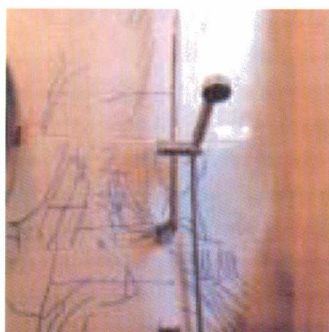
Picture on left shows massive random fine cracks on the surface of the glazed tiles. These cracks were due mainly to shrinkage in the bedding/plaster. Picture on right shows regular pattern cracks on the glazed tiles, partly contributed by movement in the brick wall, especially along the brick mortar joints.
