HOW TO GATHER ACCURATE AND VALID DATA WHEN INVESTIGATING A TILING DEFECT

Colin Cass

Techtile Services Pty. Ltd. Australia.

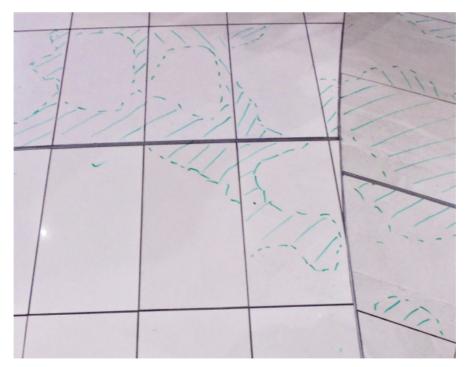
Figure 3. The repeat mark-up by a different operative about a year later, taken without reference to the first photo found a slightly greater area of hollow tiles. This could indicate that the hollowness is expanding, or it could just be operator variation in perception or equipment used. Either way the assessment of the hollow sounding areas has been made more valid and reliable because it can be repeated. This is good but not perfect.

Below are two photos taken about a year apart of areas of hollow tiling marked out by different parties that allowed for relatively accurate comparisons to be made of the area of tiling that was tested.

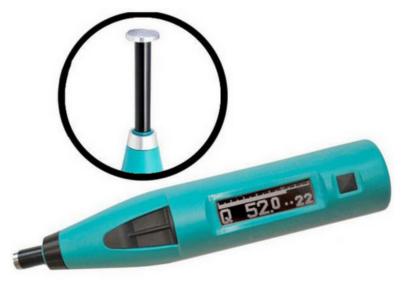
Figure 5. A "low impact" Schmidt Hammer with mushroom head (circled) for testing thinner more brittle surfaces such as ceramic tiles. (NOTE: Some surfaces such as thin ceramics and mosaics may still be damaged by the mushroom head).

Schmidt Hammer testing, also known as rebound hammer testing, is a nondestructive method used to estimate the compressive strength of concrete, rock, and other hard materials. The rebound value is usually denoted as R or Q. It is a rating between 0 & 100.

The Schmidt Hammer test is similar to ISO 10545-5: "Determination of impact resistance by measurement of coefficient of restitution".

The Schmidt Hammer can be used to correlate physical resonance testing or 'tap testing' of tiles (e.g. figure 4 above) to estimate if solid sounds recorded are linked to a tile bond sufficiently high to indicate well bonded tiles. From experience, Q 1-30 equals a low compressive or bond strength, A Q above 50 indicates a high compressive or bond strength. A Q reading between 30-50 could indicate a suspect bond or tiling system possibly installed over a decoupling system, a crack isolation and/or waterproofing membrane.

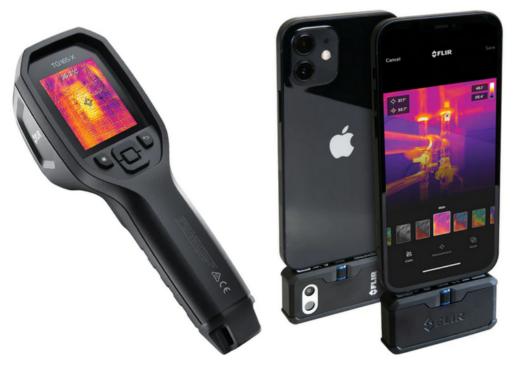
Figure 6. FLIR thermal imaging cameras can be large, or as small as accessories for mobile phones.

FLIR (Forward Looking infra-Red) are thermal imaging cameras usually used in construction to monitor energy and water leakages in structures, but they can also be used to undertake non-destructive bond testing of ceramic tiles.
