# **SPECIFYING ALTERNATIVE TILE INSTALLATION SYSTEMS- AN EDUCATED DECISION, OR DECISION THAT EDUCATES?**

**Tim Christopher**

**Consultile, Australia.**

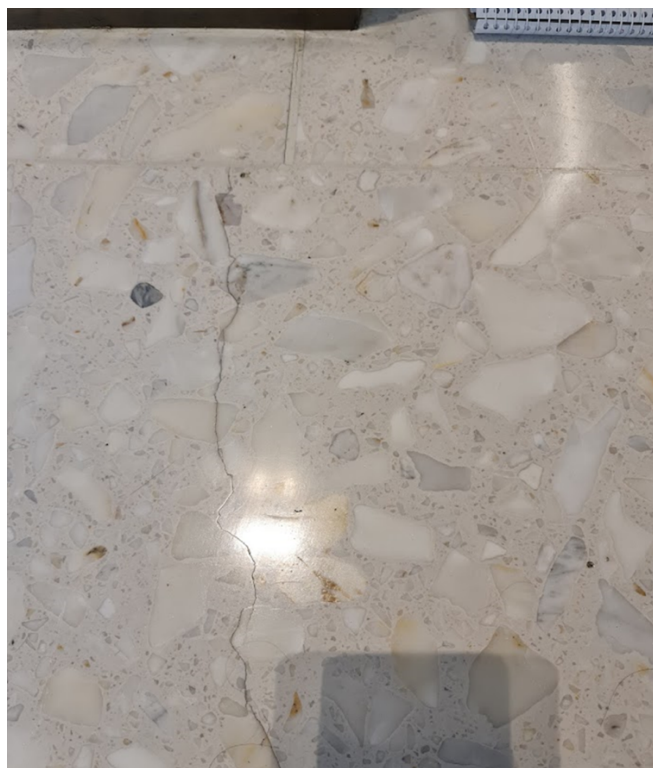
Problems begin to arise (see photograph 1) because the product specified is not available nationally or is substituted with a similar product expecting a corresponding performance requirement. Additional elements such as primers, leveling compounds, and adhesives which have been tested with the specified crack suppression system may not be available or sourced as a portion of the complete system. Similar locally available components are often sourced to make up the shortfall to implement the installation.

**Photograph 1**-Commercial shopping centre cracking in quartz tile at a cold joint location.

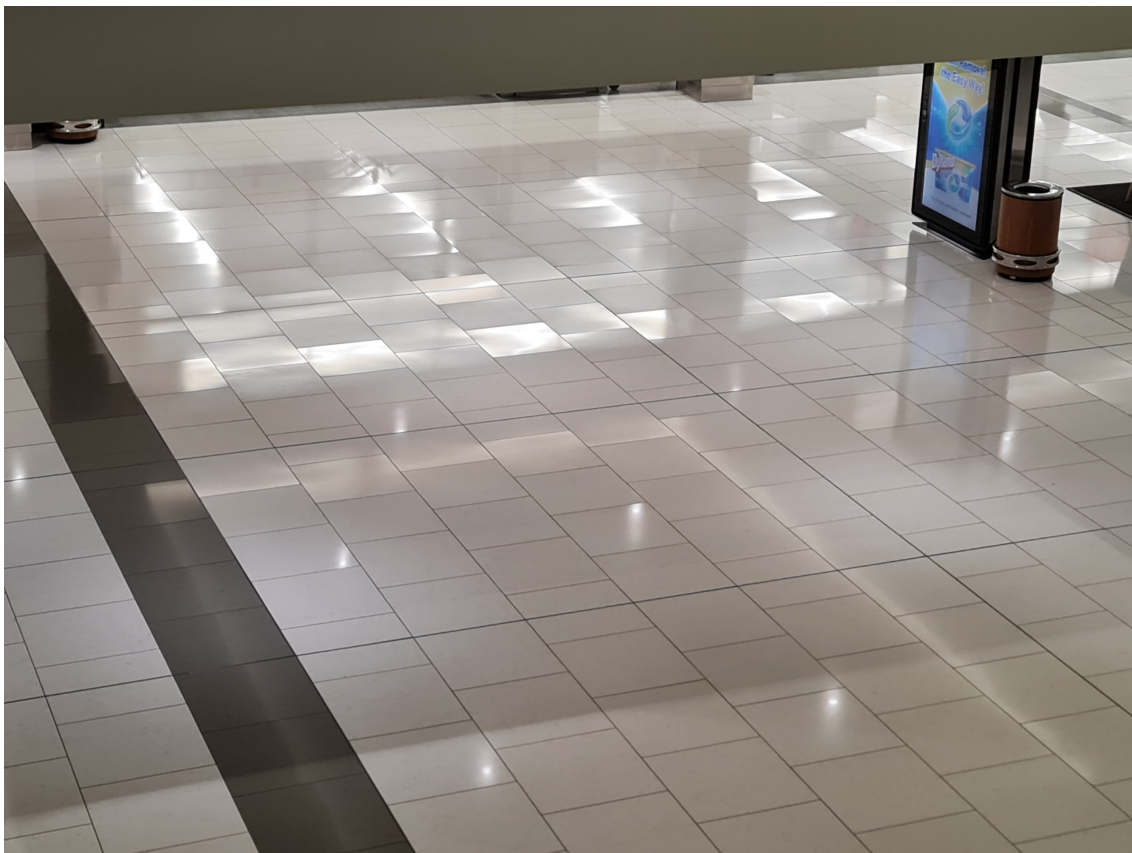
**Photograph 3**-Stone tile flooring which has cupped and curled in a commercial shopping centre.

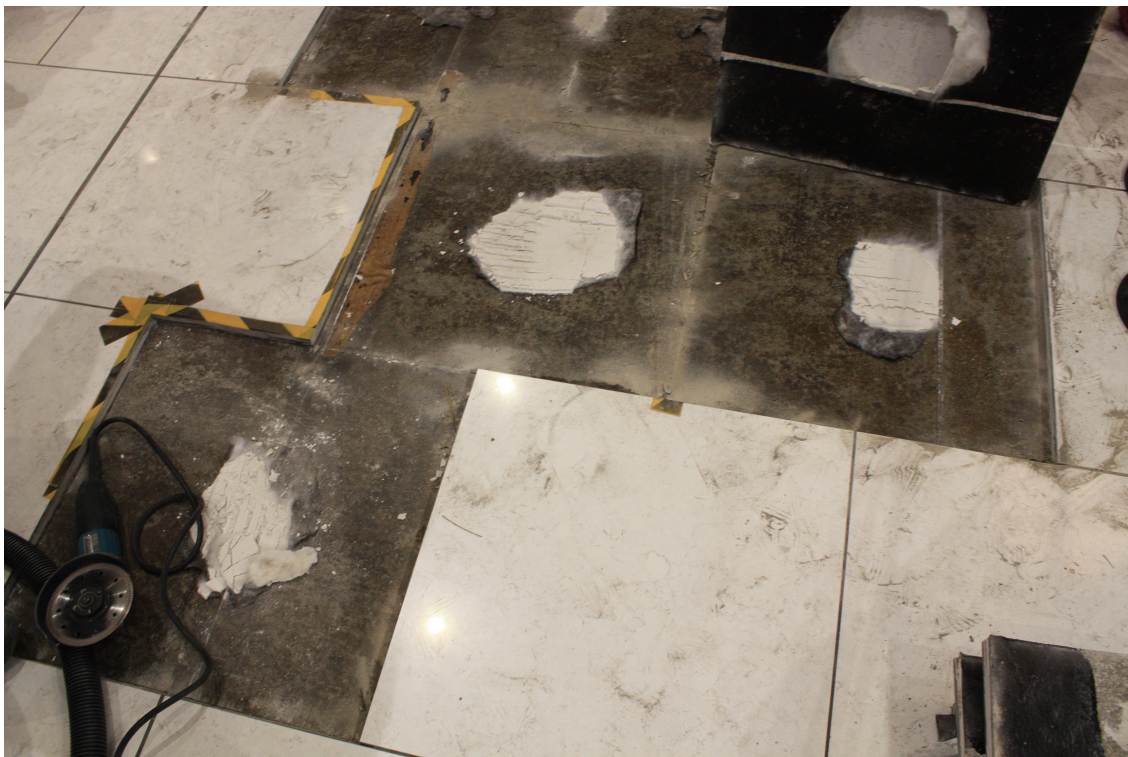
Specifying some types of adhesives or crack suppression systems may lead to engineering additional problems into the installation instead of improving it. Installing moisture sensitive stone onto some crack suppression mats can create additional issues not present when substituting for porcelain or ceramic tile. For example, curling and cupping through exposure to UV light, heat and/or moisture will cause these types of stone to deform as some substrates have reduced or insufficient capability to restrict vertical shear movement that can be present when stone tile curls and warps. These considerations are not required when installing a porcelain or ceramic tile and can lead to tile failure through delamination from the substrate when elements within the installation are sourced in isolation or not fully understood. Often the associated test methods which apply to the individual products are not considered when the specification is put together. In many cases once a failure has occurred, workmanship is regarded as the cause of failure. If the contractor has achieved the recommended installation requirements such as adhesive coverage and movement joint installation, there is subsequent confusion on why the tile installation is experiencing problems.

**Photograph 4**-Engineered stone tile installed on a crack suppression mat and subsequently curled and partially delaminated.

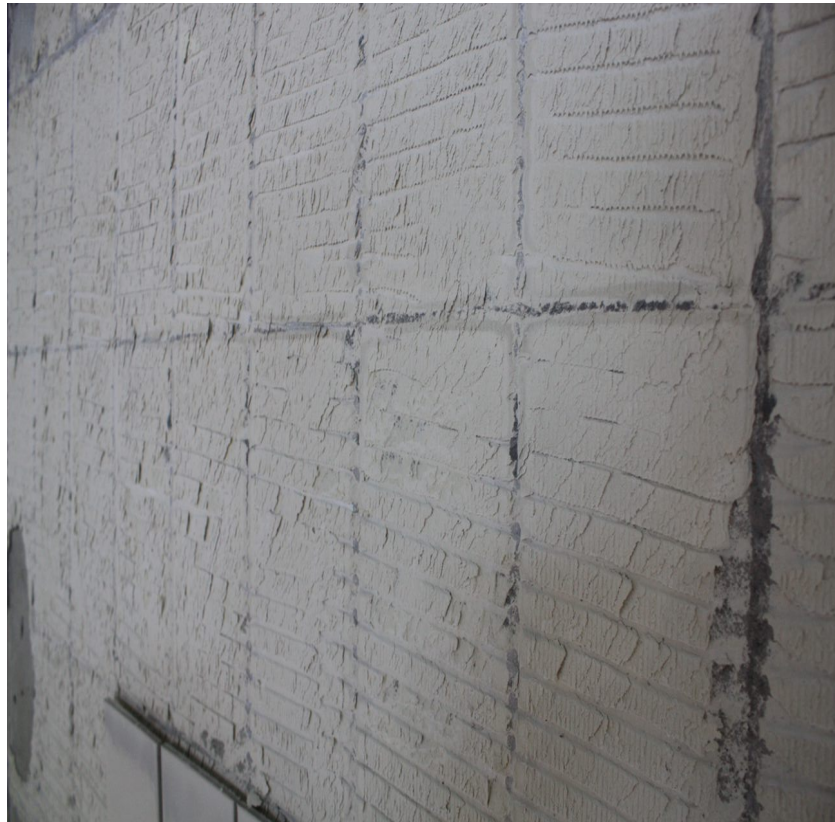
Installing tiles into chemically aggressive environments such as commercial swimming pools can be problematic if the complete performance capability of an individual product is not known. An example of this was observed in a commercial swimming pool in Australia (see photograph 5). There was an extensive tile failure inside the Olympic sized pool which became the subject of extensive investigations to determine the cause.

The initial observations of the tile installation led to conclusions that tile failure was attributable to excess movement within the pool shell structure and insufficient movement joint installation within the pool. When the adhesive underneath the delaminated tiles was observed, strong shear forces appeared to be present. The profile of the adhesive which remained on the substrate was sharp and angular suggesting the tiles were ripped from the substrate by high pressure.

**Photograph 5** – shows evidence shear forces on the tile adhesive inside a pool where failure has occurred.

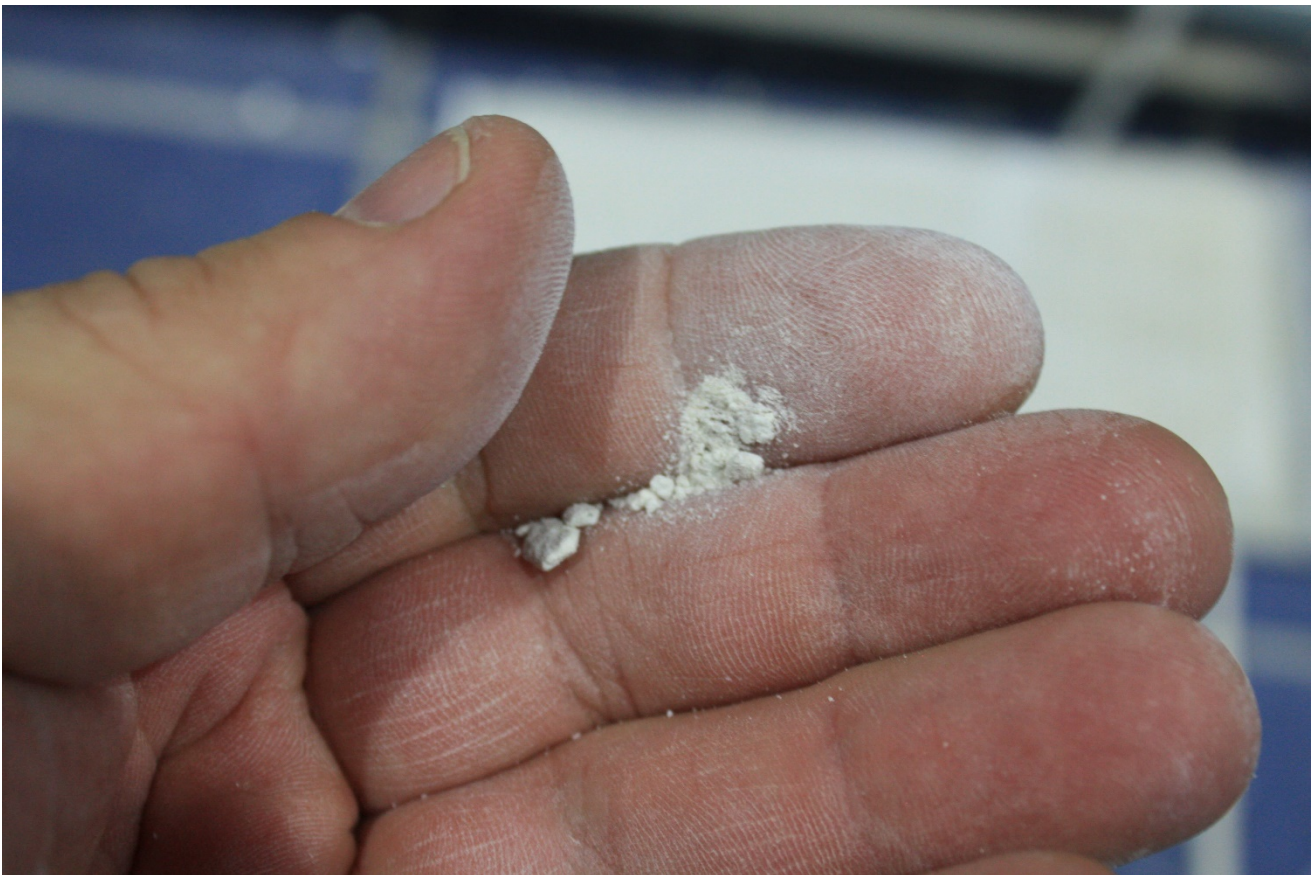
As the adhesive was the final outstanding component, this was examined in more detail. A simple examination consisting of removing tiles and manipulating the adhesive remnants by hand demonstrated the adhesive to be of a powdery consistency and large portions could easily be ground into a powder by hand. Investigation into the adhesive used led to the conclusion in photograph 6. The adhesive was not commercially available in Australia and had been imported by the contractor. The adhesive installation recommendations had been revised by the manufacturer to restrict the use in commercial pools post after the completion of the failed installation. Furthermore, the adhesive was withdrawn from sale altogether in the country of manufacture sometime after.

**Photograph 6-** *shows adhesive crumbling into a powder.*

The pool operator was in receipt of the chemical maintenance and testing records to support the correct chemical water balance within the pool had been maintained. The conclusion was that the imported adhesive was degrading in the permanently submerged conditions of the pool and not able to maintain the integrity of the tile installation. There was no recourse available back to the adhesive manufacturer as they maintained no commercial presence in Australia and were not involved in the specification for the pool installation. The pool was rectified with a complete pool tiling installation system available within Australia onto the existing pool shell. The system has been performing without issue for several years post rectification and with no works required on the concrete pool shell.
