ASSESSING THE CHALLENGES AND IDENTIFYING SOLUTIONS FOR PORCELAIN TILE INSTALLATION ON PEDESTAL OR RAISED FLOORING SYSTEMS IN THE ABSENCE OF CURRENT OR RELEVANT INTERNATIONAL STANDARDS

Christopher Repeti

Techtile Services Pty Ltd Australia.

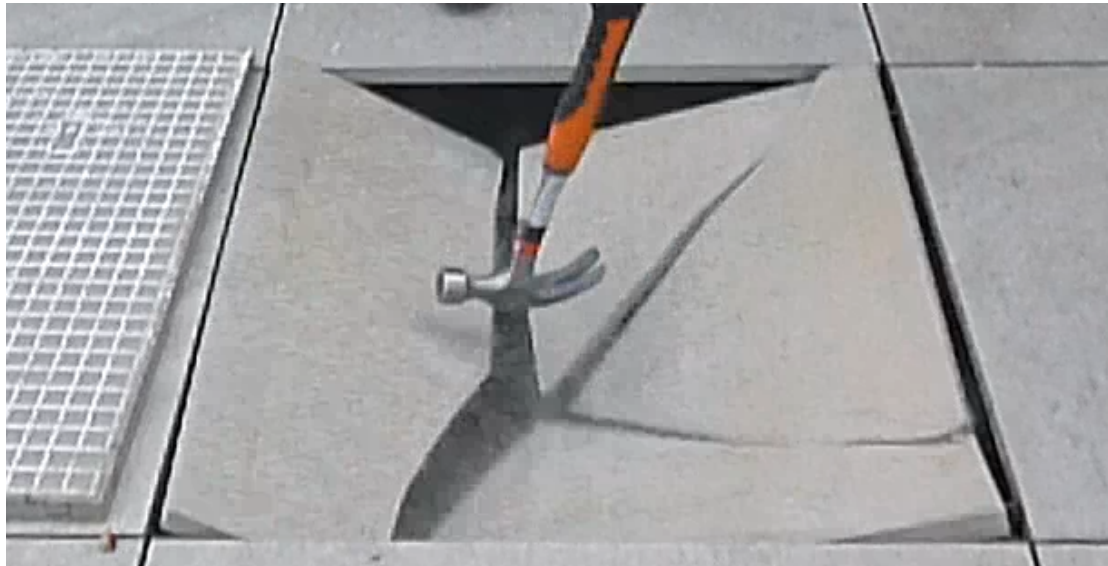
Photo 4. Screen shot from a video where I was able to break a 20mm porcelain tile dropping a 906g (2lbs) claw hammer from 600mm).

The hammer load above was dropped from 600mm however the weight was less than 4x the load as designated by the Dynamic Hard Impact Test in EN1825. The tile that I broke had been independently tested for a breaking strength of over 11000N under ISO 10545-4, a strength which the nominated engineering authority deemed safe for this application.

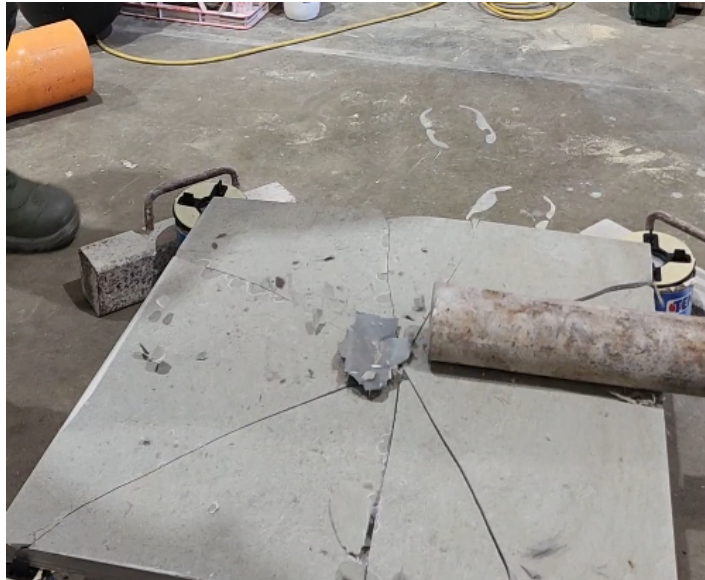
Photo 5. Tile fractured on pedestals, reinforced with a fiberglass matting adhered with cementitious adhesive. Load used to break the tile was a 10kg steel weight with a diameter of 60mm.

The ANSI standard does consider reinforcement backing where the EN does not. I have tested varying types of backing to support the tile and tested large loads (10kg/22lb+) and found particular fiberglass-based products capable of allowing a 20mm tile on pedestals to remain completely load bearing even where fractured or broken in multiple pieces, significantly reducing if not eliminating safety risks of otherwise unreinforced systems. See photo 5 below.

The idea of incorporating reinforcement on porcelain used on pedestal applications, is not to eliminate potential from cracking or impact, as this would be difficult or impossible. The aim is to change how the system performs so when the porcelain invariably breaks or fractures due to accidental or unexpected impact, it does not collapse, but rather the reinforcing acts as a laminate that is self-supporting that allows the broken tile to remain load bearing prevents a person falling into an open void, potentially resulting in serious injury.
