# QUALITY IN CERAMIC TILE SETTING

by **Vicente Sanchís León**

TECHNICAL ARCHITECT

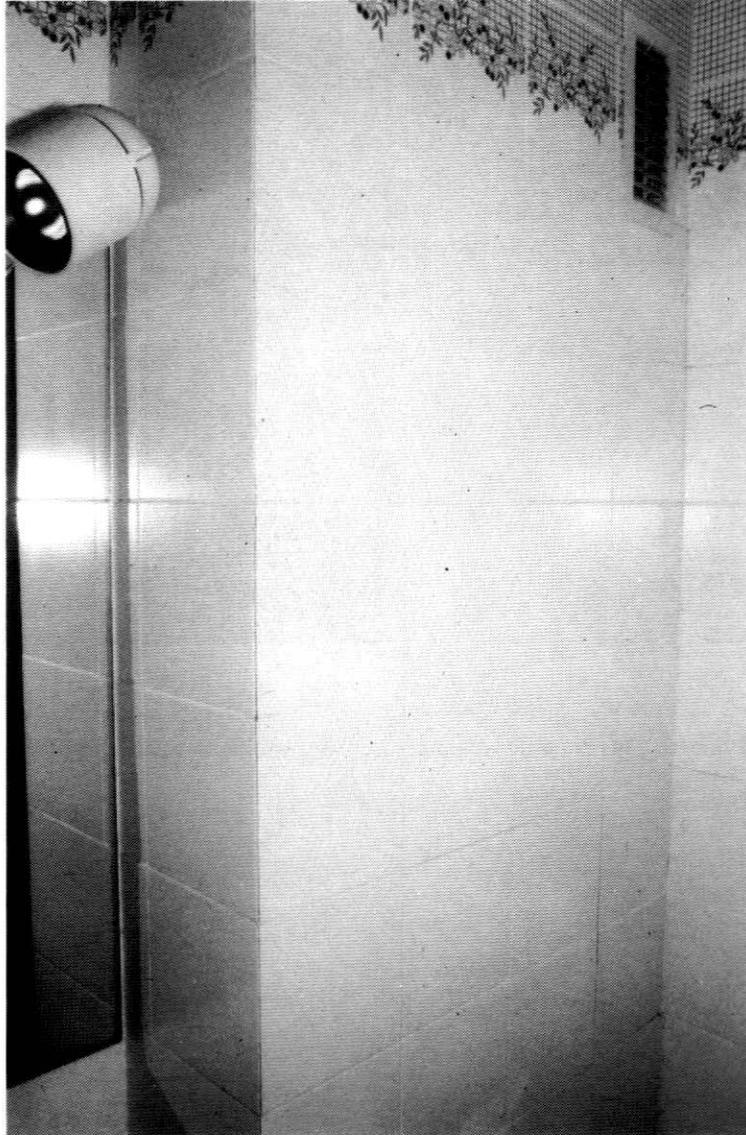
Photo 3 bis.-The heterogeneity of the base is one of the causes of tiles coming

Another aspect of the base surface which can cause problems when laying tiles and which makes them liable to come off is the heterogeneity of the base, as in the case of a joint between brickwork and reinforced concrete pillars. The different movements of these heterogeneous supports, and the differences in the adherence factor make it difficult to ensure proper adhesion. The consequence is that the tiles come off.

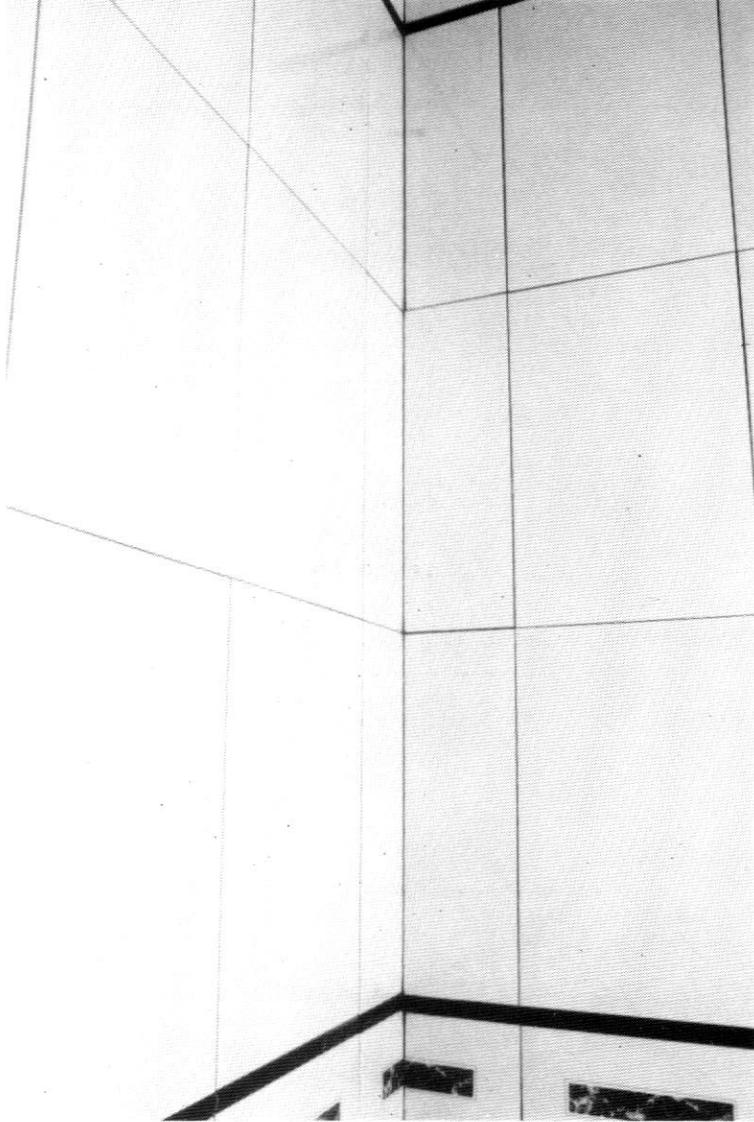
Photo 8.-The shape of the pieces used conditions the possible joints.

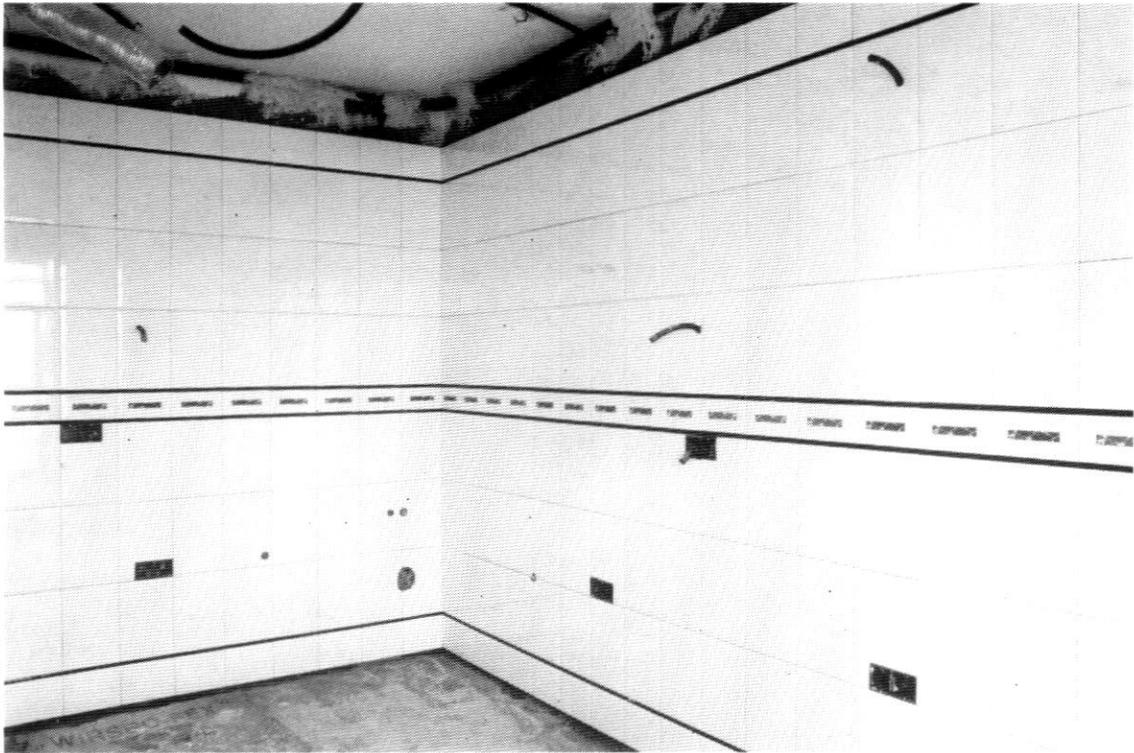
Photo 11.-The joins between the tiled area and the fixtures and fittings must be carefully planned in advance.

Another joint which is frequently badly constructed is that produced by the openings for the water pipes or drains. Openings for these fixtures should be made by drilling the tile, and not by first cutting it in half to make it easier to cut the opening.

Electrical fittings are also extraneous elements which, depending on how they are organised, can deteriorate the finish of the tiling job.

Sometimes, owing to poor planning, these fittings coincide with the border or frieze of the tiled area producing a dissonant result.

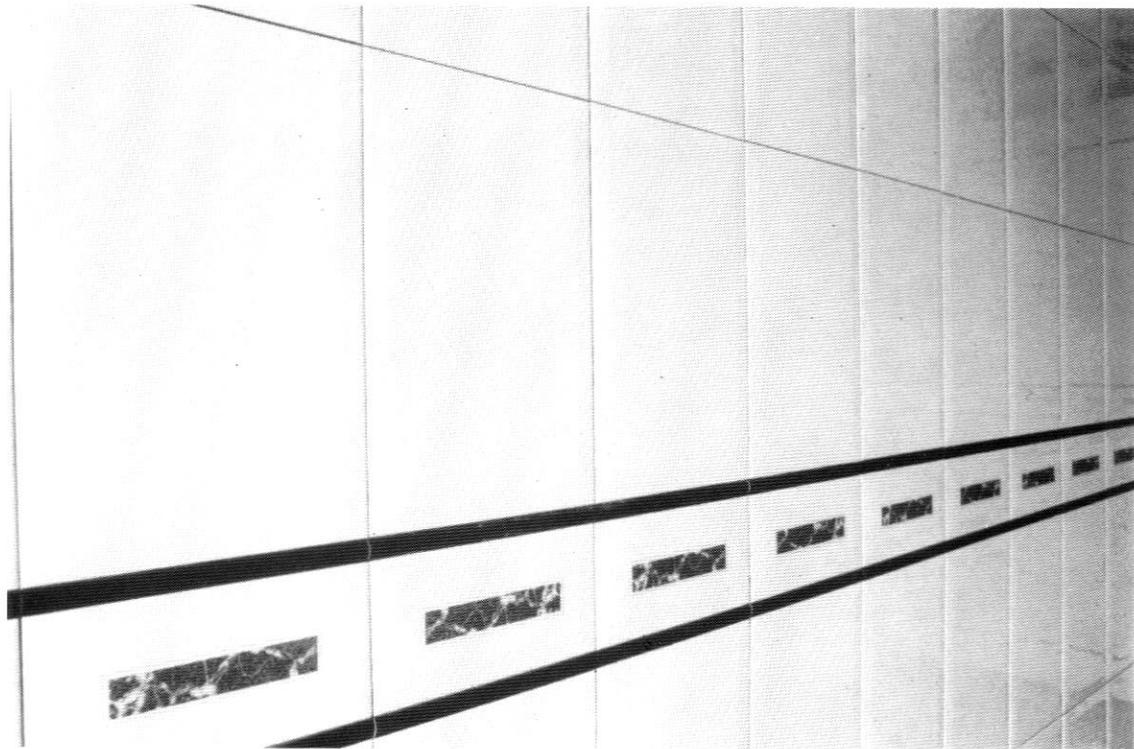
Photo 12.-Designs like this one make it possible for the listel and the most projecting parts of the tile work to be on the same plane.  
The most difficult part is the organisation of the corners.

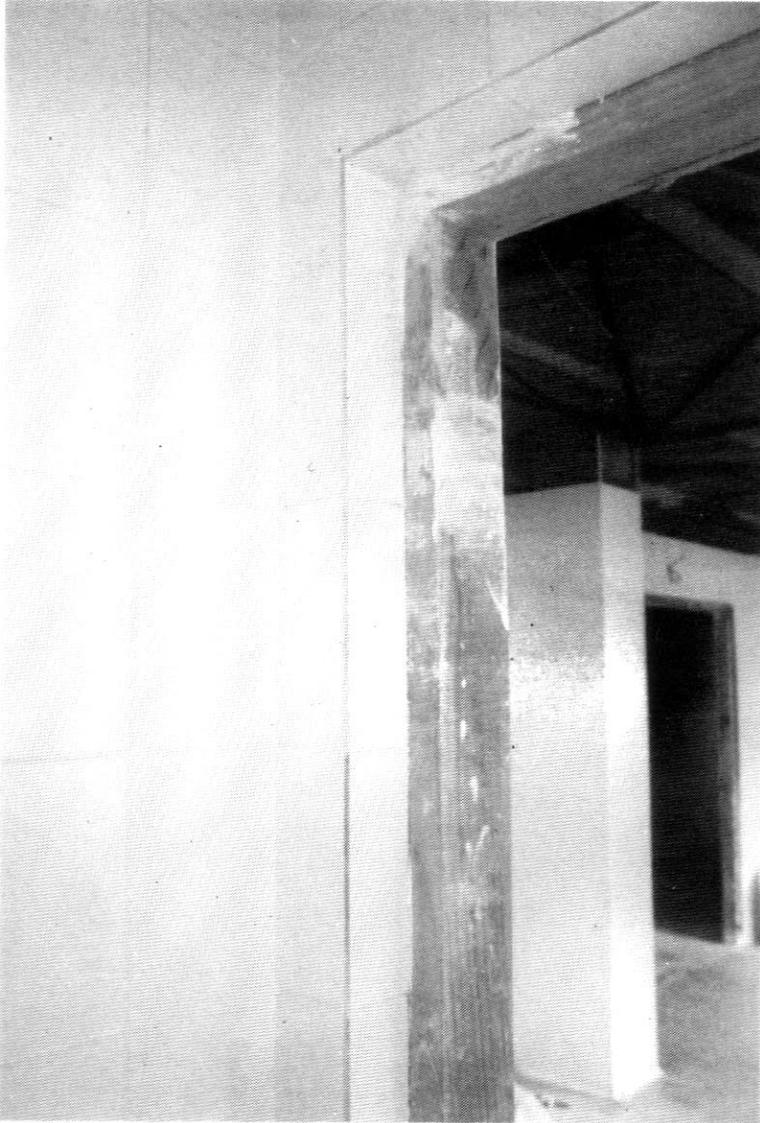
Photo 15.-Tiling which leaves the biscuit base of the tile visible, as in the case of this corner, does not offer even the most elemental level of quality.

One of these is the correct formation of the bevelled pieces. If the pieces which form the mitre do not form the correct angle at the corner, the unglazed interior of the tile may be seen, which will mar the finish of the job.

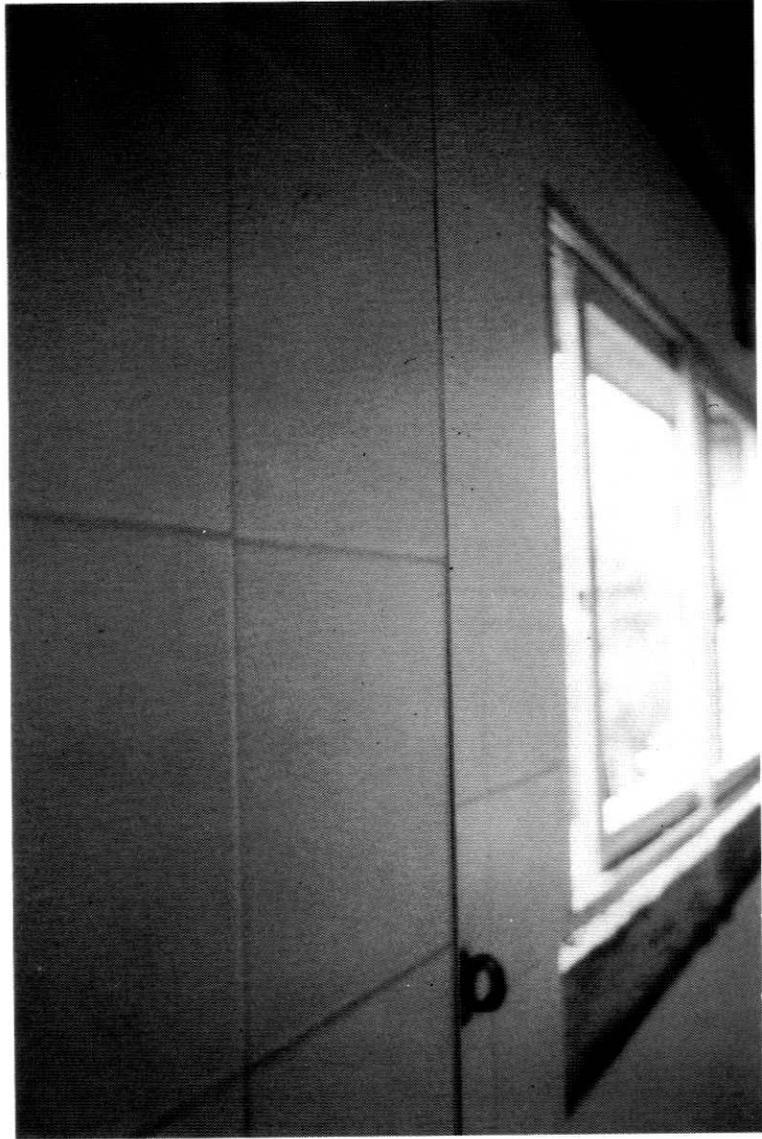
Photo 16.-Finishing touches such as this corner bracket must be correctly lined up in order to achieve continuity and tangence between the sides of the angle.

The proper or improper use of several products currently on sale is another important factor in the job of tiling. Such is the case with PVC corner brackets which are used to achieve a proper finish in cases where the use of certain ceramic materials for tiling makes it difficult to make corner joints. The corner brackets must form a surface which is correctly connected to those which form the two planes of the tile.

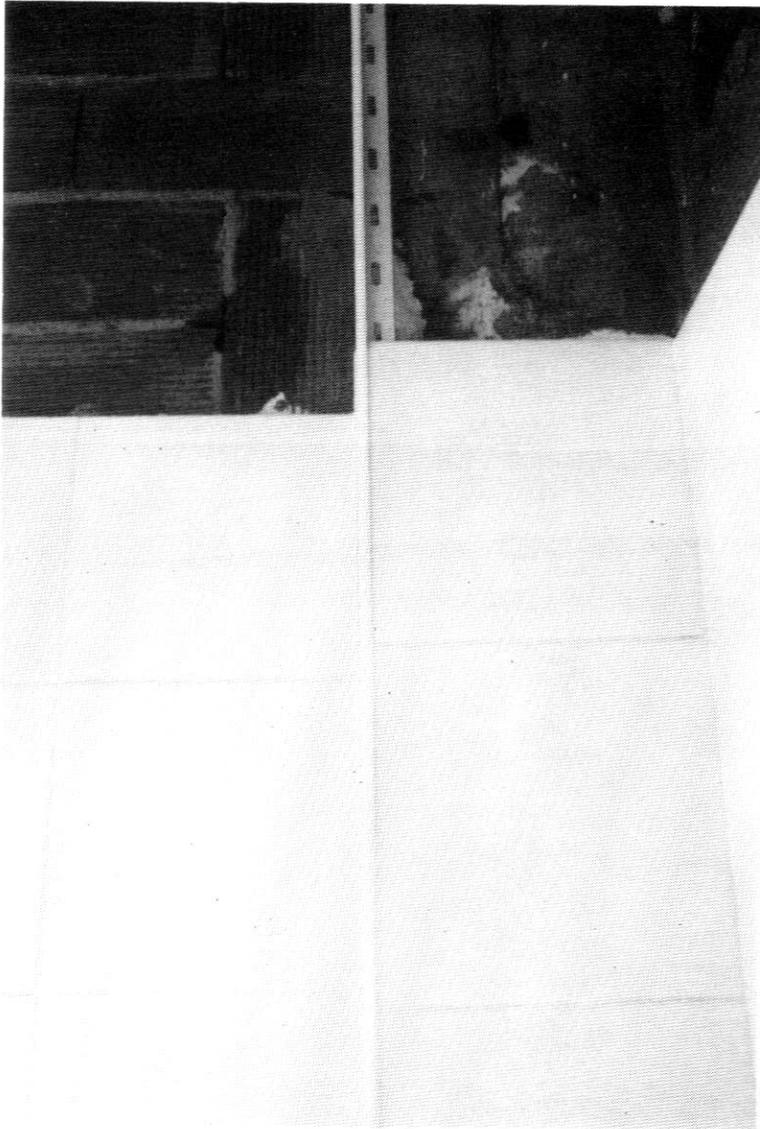
Photo 17.-The adhesive material permits the raising of ceramic tiles to the same level as the edge of the corner bracket. If this is not the case, surface continuity will not be true.
