# THE EFFECTS AND CONTROL OF MOISTURE IN CERAMIC TILE FACADES

by Richard P. Goldberg, B. Arch., AIA, CSI

Director of Technical Services  
Laticrete International, Inc., Bethany, CT, USA

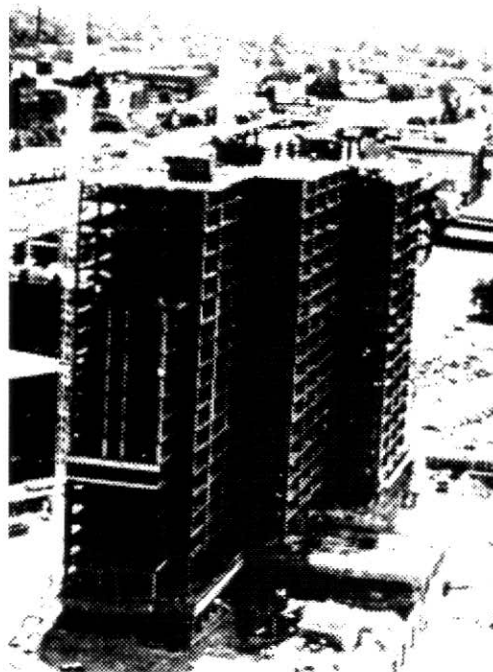
**FIGURE 2** SKELETAL STRUCTURAL FRAMING SYSTEM

Today, modern steel and concrete skeletal framing systems provide structural support for most buildings. As a result, thin, lightweight ceramic tile facade systems have evolved solely as enclosure of buildings (figure 2).

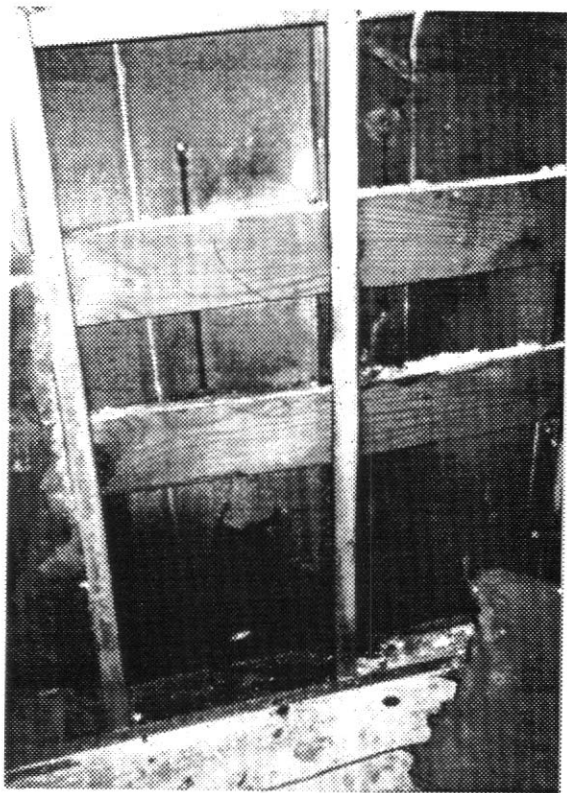
FIGURE 7 MOISTURE CONDENSATION (interstitial space)

Moisture can enter a ceramic tile facade through cracks in the grout joints between ceramic tiles, or directly through the face of an improperly selected porous ceramic tile. It can also penetrate around improperly designed or constructed coping and roof flashings, and at flashings and sealant joints at wall openings (windows, doors) and expansion joints. In addition, wind driven rain can pass through both clear coatings and the ceramic tile itself, moisture can rise up from the foundation, and moist air can condense in interstitial spaces (figure 7). In effect, moisture problems are ubiquitous; moisture can be controlled but not eliminated.
