A FINE EXAMPLE OF XIXth CENTURY TILE FLOORING PRESERVED IN THE MUSEUM OF ARCHAEOLOGY OF MURCIA. AN EXAMPLE OF SAFEGUARDING AND TRANSFER

Victoria Santiago Godos
Doctor of Fine Arts.
Specialist in Conservation and Restoration.

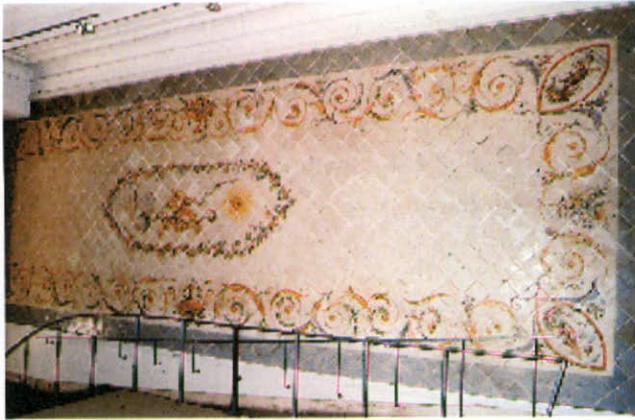
1. A general view of the ceramic flooring from the main room in the house, now installed on a side wall in the Museum of Archaeology of Murcia.

In another great hall of the Museum of Archaeology, the entire set of tiles was loosely arranged on the floor, in order to make a pre-setting layout that would help give an idea of its final relocation. When the great ceramic puzzle had been laid in order, they started to prepare the wall so that it could fulfil its new mission of being able to support the tiles. Therefore the total space was measured, marking the outside boundary lines, especially above, below and to the left-hand side as the right-hand side was very near the corner angle.

Then the chipping of the wall, which was similar to the other walls in the room -i.e. plaster covered with paint- began until they reached the bare brick.⁶ When the dust was removed, the surface of the wall was moistened, and following this, a first layer or coating of a mixture of clay and rough black plaster was applied to the wall, so that the wall remained rough and scratched. Therefore the roughness would help the ceramic tiles to adhere better when placed on the wall.

Given that the original layout of the tiles was rhomboid, which made their installation slightly more complex, a system was devised that would facilitate this procedure. The system was the following, a timber frame or grid made of tight string was set, which followed the rhomboid pattern. It was suspended 10 centimetres above the surface so that it would not obstruct the fixing of the tiles. This was held at the edge by a wooden frame.

The tiles were placed on the wall one by one, starting from the bottom upwards and from right to left, calculating their position by sight because not all the tiles were exactly the same size. The process consisted of applying coloured mortar and white plaster to the wall and then installing each previously moistened tile on this surface. Mortar was made for each tile because in that way the correct setting point was obtained. The mortar was made up of one part clay and two parts plaster. After placing each tile in position it was

So in this way the tile flooring was installed in its new enclave. Later the joinings and spaces were filled in and also the chipped edges of the tiles; likewise a plaster moulding was fitted around the flooring this was to delimit the space and cover up the difference in level between the surface of the wall and that of the tiles.

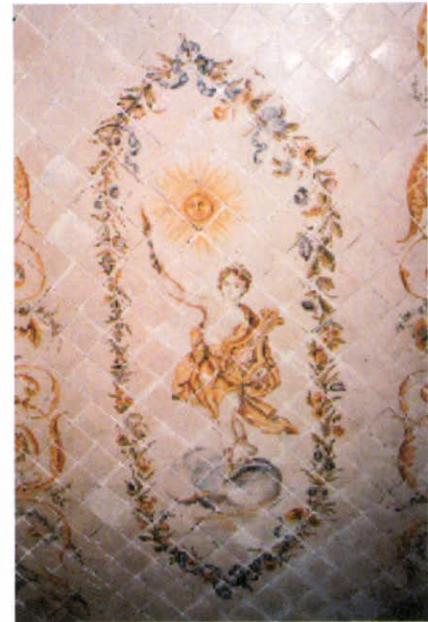
2. Detail of the God Apollo in the centre of the tiling.

These tiles of Valencian origin belong to the Nineteenth Century and although they have not been exactly dated, we can tell from their style and characteristics they are likely to be from the middle XIXth Century. In this ceramic flooring an interesting composition is represented, in the centrepiece the figure of the God Apollo appears surrounded by a floral ribboned medallion. All around the edge runs a great vegetative border with beautiful ornamental motifs of scrolls, flowers, urns and bouquets that link four allegoric representations of the Seasons of the year in the respective corners, each of them in its own surrounding ornamental border linked by interesting garland patterns and various decorative elements. All this is surrounded by a blue ribbon running around the perimeter that accentuates the soft colourful tones interspersed with figures and patterns. The style is reminiscent of the Baroque period from the types of figures and the use of floral borders running round the outer edge but from its general composition it belongs more appropriately to that of a late Imperial style characterised by the neatness and order that the Neoclassic style imposed. (Photographs 2 to 4).

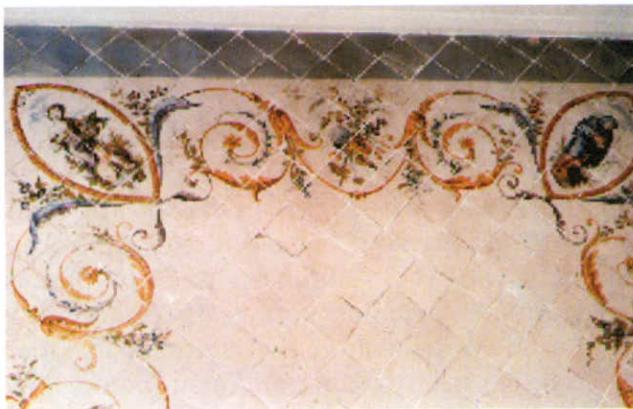
3. Detail of one of the minor sides of the tiling depicting the Seasons with ornamental borders.

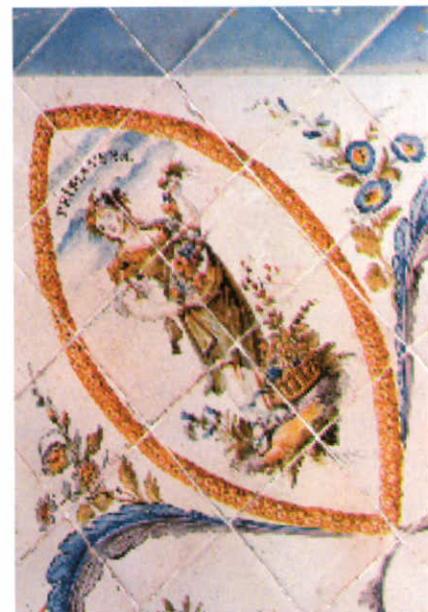
4. Detail of the allegory representing Spring in a corner of the tiling.
