RESTORATION OF A VALENCIAN CERAMIC FLOORING IN THE PALACE OF THE VARONA FAMILY. VILLANAÑE (ALAVA)

Javier Martínez de Aguirre Ortiz de Zarate

Diputación Foral de Alava

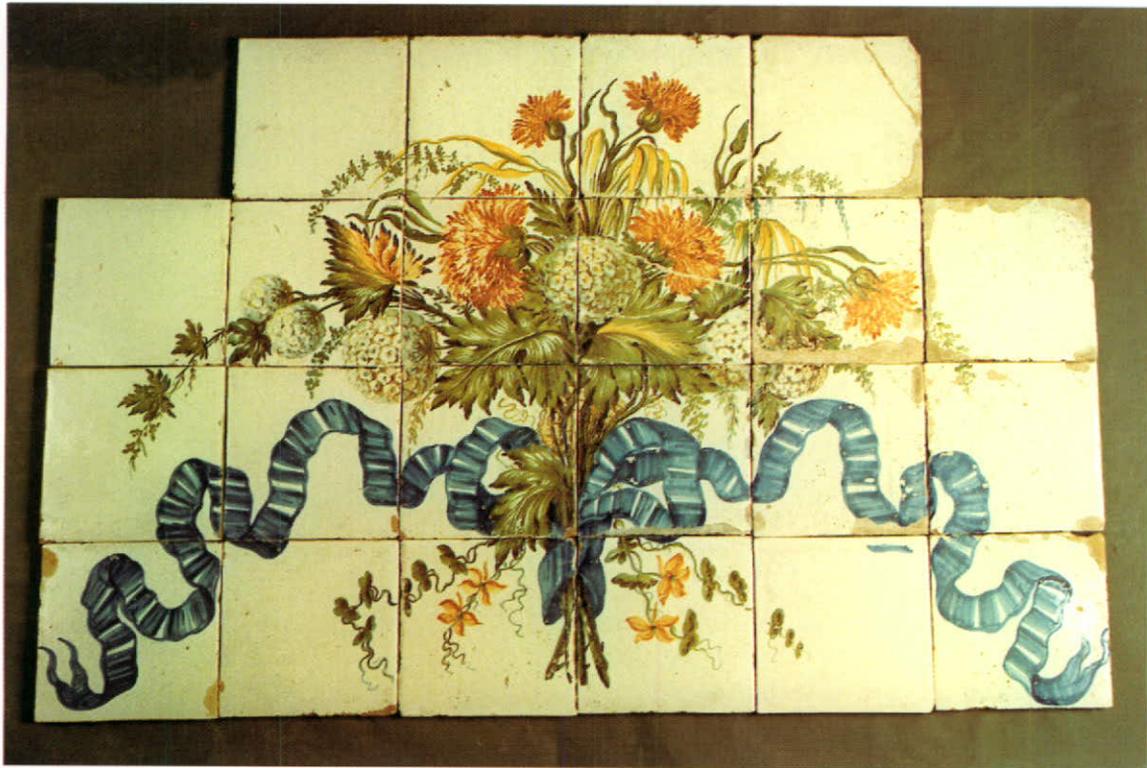
The main problem detected after the first restoration process involved the ARALDIT glue used and the refilling of the tiles in hard plaster.

An excessive amount of glue was poured into the cracks to join the tiles together and most of the tiles were not aligned correctly, as there were differences of up to 2mm in some parts of the tiling. Also, all the tiles that were refilled with plaster had irregular and uneven surfaces.

With regard to the chromatic and decorative restoration process, it was obvious that

Detail of the ceramic flooring prior to restoration

the colours were not uniform and the shades used were not exactly the correct ones, so that one's perception of the room was altered.

For these reasons, all glue and plaster refills were stripped in order to perform the restoration correctly.

- Tile surface and cracks in the glaze were cleaned.
- Tiling was strengthened.
- All plaster refills that were carried out incorrectly in the first restoration process were removed.
- All the glue that was not applied correctly was removed.
- Loose tiles were bonded again.
- All the gaps in the tiles were refilled with hard plaster, after removing the previous fillings, in the clay and the glaze.
- All tiles that needed to be repainted were restored and all the refills were specially protected.

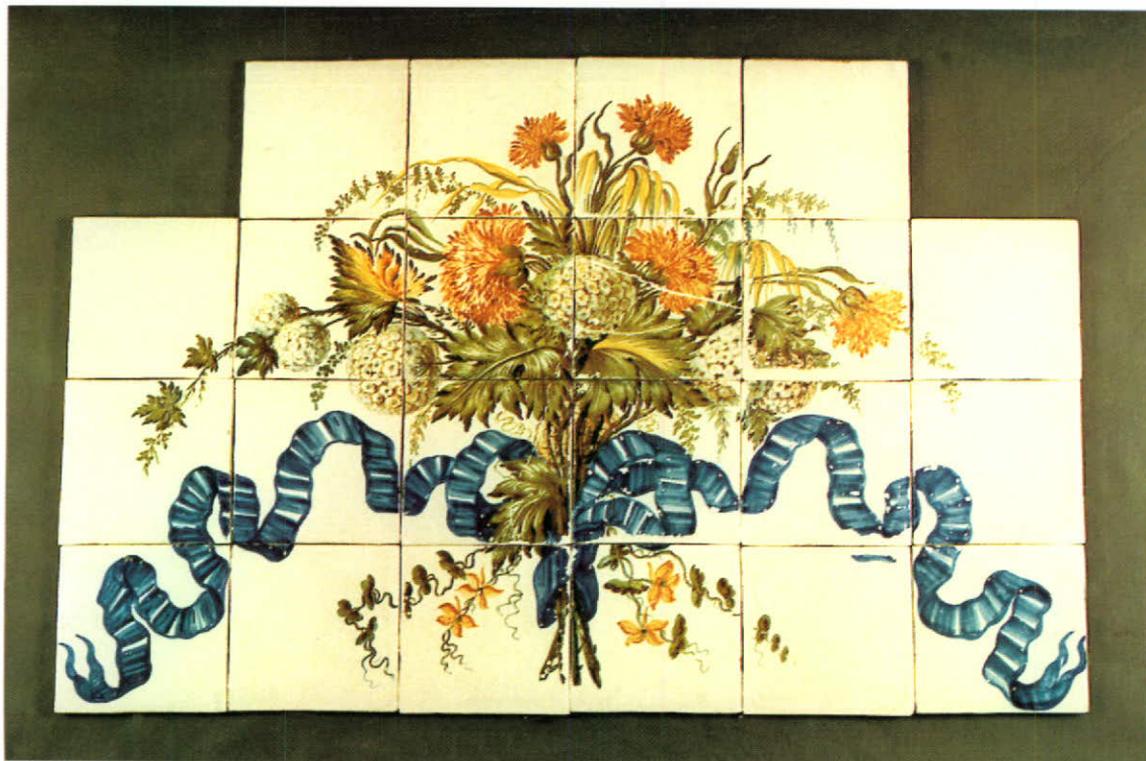
Detail of the ceramic flooring after restoration

Before putting the tiles back into their place, a product that prevents salt from the background from getting through to the tiles was applied to the floor, and then the tiles were installed with lime and sand.
