# SELF-BEARING SYSTEMS IN TILING RESTORATION

**Jaume Coll\* and Antonio Perla\*\***

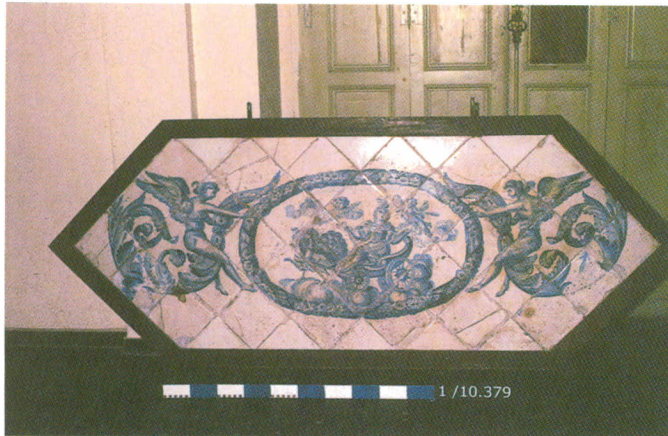
1- Front view of a tile assembly on a wooden frame, with mesh and plaster made about 1950.

The assembly with mobile panels held in a metal frame was used systematically in some important collections, such as the installation of the tilings of the Gulbenkian Foundation in Lisbon. At the national Ceramic Museum established by Manuel González Martí in 1954, the panels were mounted on metal lath with an L-shaped metal frame, fastened to the wall by hooks welded to the structure. In other cases, the panels lost their mobility by being fixed to the walls. For smaller panels, designed to be moved the tiles were adhered with plaster and nails to a base consisting of mesh or chicken wire together with the wooden frame.

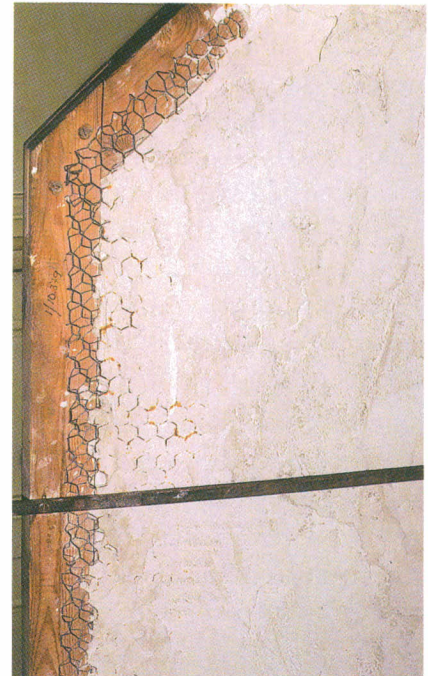
2- Rear view of the foregoing assembly.

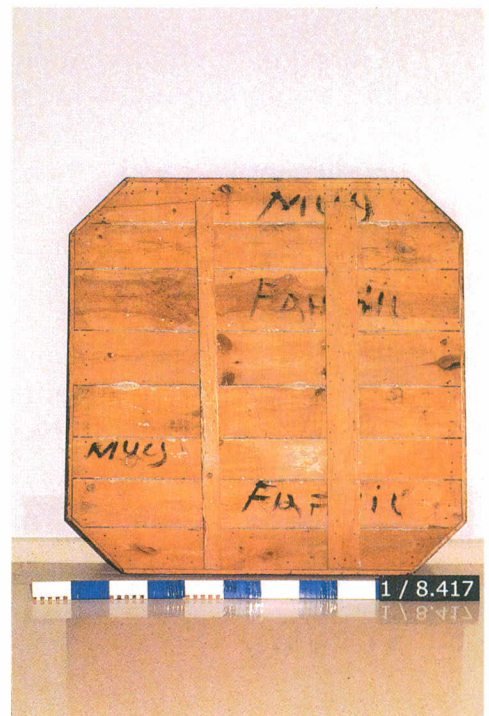
4- Rear view of the foregoing assembly.

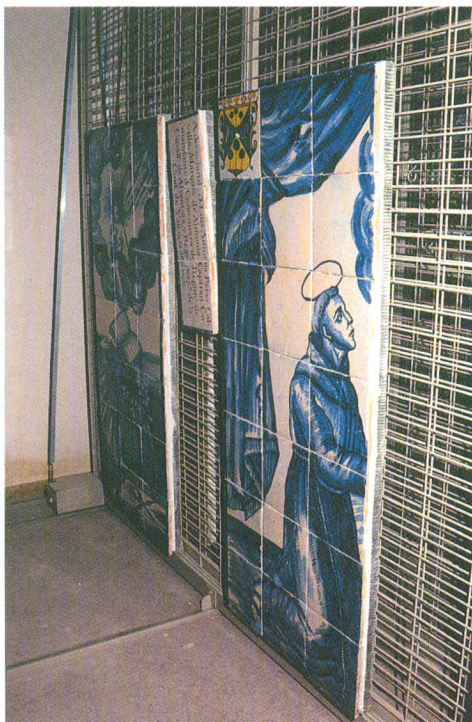
5- Ceramic panelling mounted on selfbearing systems of aluminium honeycomb core resin.

In 1989, when the restoration was to be tackled of the small Mudéjar Cloister in the Cartuja de Santa María de Las Huertas in Seville <sup>[2]</sup>, it became necessary to use a wholly inert material that could be used risk-free outdoors. As a result of news on the supports that had been recently tested in Italy for transporting mural painting backing, it was decided to use *sandwich board comprising two glass fibre and epoxy resin surfaces with an aluminium honeycomb core*. The material's very high performance characteristics are undoubtedly the result of its original use for making structural features in the aeronautics, automobile and building industry. Its resistance to torsion and deflection, shear, impact and compression resistance, and low specific weight <sup>[3]</sup>, together with ductility and ease of handling, make it a particularly suitable material for use in self-bearing supports. The multiple possibilities of creating fastenings and supports in the same panel, without needing to fit any type of auxiliary structure for ensuring its stability are other features of its suitability.

Finally, in this type of supporting surface, the board edges need to be well protected and insulated to prevent the cellular core from deteriorating and coming off the glass fibre surfaces. This point needs to be stressed, because some assemblies have been found in which this was not done, and it could undoubtedly affect the future of the assemblies. The edges can be protected in a variety of ways, although the simplest involve sealing the channel that is left on slightly flattening the core with an epoxy resin mortar or fitting a sealed U-shaped aluminium strip in the core.
