# RESTORATION OF THE MARTORELL MUSEUM TILES: CHARACTERISTICS, PROBLEMS AND SOLUTIONS

**Neus Campmany Queralt**

**Montserrat Farreny Agràs**

Martorell Town Council. Board of Trustees for Culture. Museums

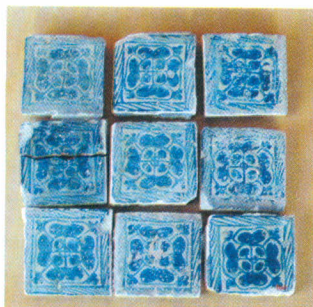
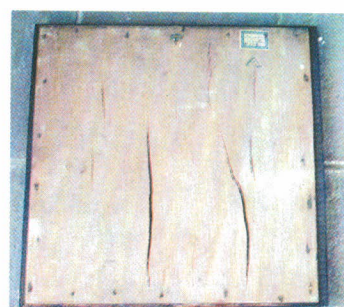
*Typical l'Enrajolada assembly. Santacana museum-house.*

Two types of assemblies are found at L'Enrajolada: tiles framed like paintings and tiles fixed to the wall. The former have a wooden frame and some type of fastening system at the front and/or at the back (frame with a certain profile; some little nails at the front of the frame and sometimes between the tiles; plaster at the back, at the sides or between the joints of the tiles; or a wooden panel at the back). In the compositions fixed to the wall, the use of lime and sand mortar was detected in pieces that had come off the wall or that threatened to fall off as a result of problems of moisture.

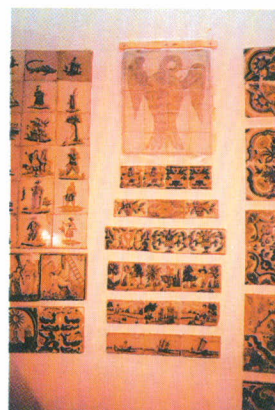
*Mir collection. Vincenç Ros Memorial Museum.*

At the Vicenç Ros Memorial Museum, where the Mir collection was housed, all the pieces were fixed to the wall, either directly or by means of the assembly that they had been mounted on, based on a combination of the following elements: plaster, cement, impact adhesive, paste, metal mesh, wooden boards, reeds, sacking, wire, nails or metal frames. While certain items were fixed with mortar, others were fastened to the brick wall by metal staples subsequently trimmed with a cement edging.

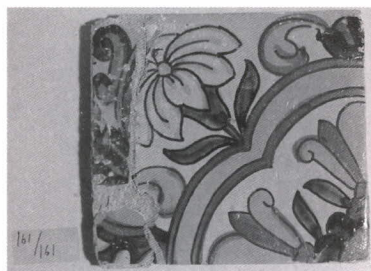
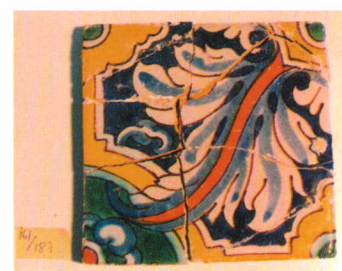
*Details of various defects found in the tiles to be restored in the Ros collection.*

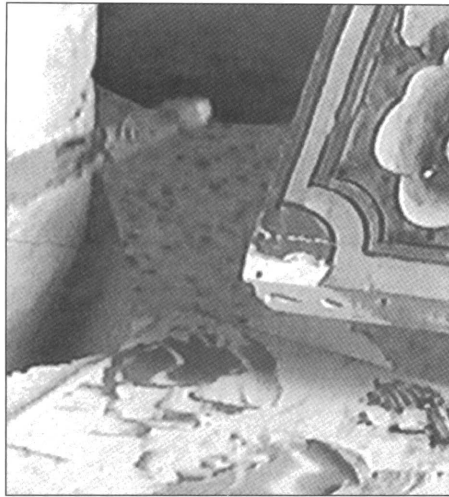
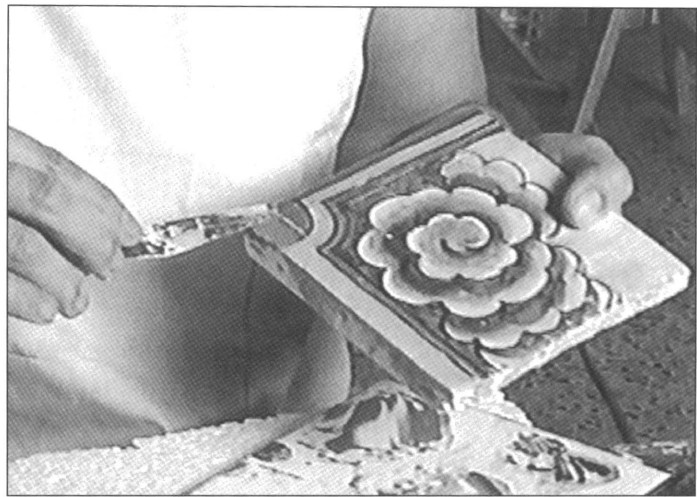
At first, retouching was done in an archaeological way, softly colouring all the reintegrated parts in a colour similar to that of the original tile.

The missing parts of the body and surface layer were reintegrated by filling the gaps with plaster and the more superficial layers with stucco. After sandpapering these areas, the reintegration was consolidated with paraloid B72, then retouching with a brush using

acrylic paints, which allow working faster than oil paints that take longer to dry. Finally, a varnish was applied regardless of the repair process used.

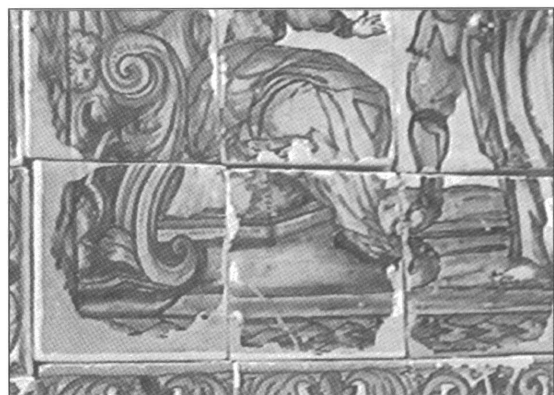
At this point in the reintegration, the issue was also raised of the type of retouches. Given the great number of tiles to be dealt with and the characteristics of the compositions, the archaeological retouching approach was rejected, to keep the evidence of the repairs from affecting the beauty of the sets of items. An illusionist retouching approach was chosen, which although not readily perceivable, can be distinguished if

looked at closely. Moreover, the retouches were graphically documented to record these and allow them to be individually examined.

Subsequently, in 1995, as it was intended to restore most of the material that was left of the Ros collection, a different reintegration approach was adopted. To speed up the work, colour was applied during the reintegration, i.e., the stucco was tinted before being applied according to the prevailing colours and sometimes following the tile pattern. Though the colour of the stucco faded a little on drying, this was solved by the consolidation with paraloid, which heightened the colour so that the reintegration resembled the original colour more closely. This yielded enhanced integration, with a heightened stability and colour strength compared to the traditional way of working, which involves superimposing many materials in the same repair area. With this method there were only two materials, the stucco and the consolidating agent.

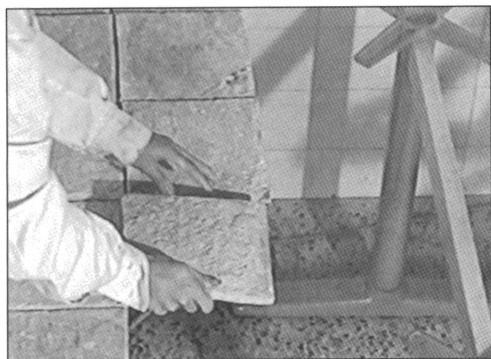
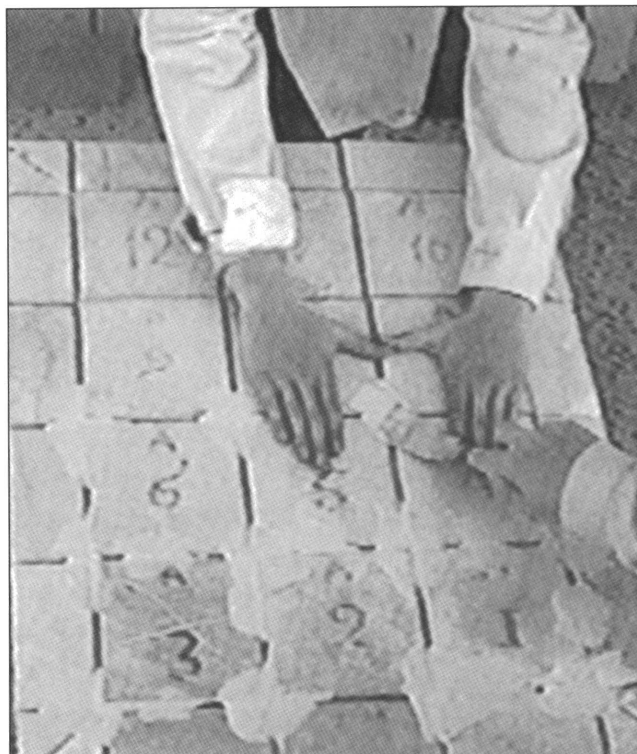
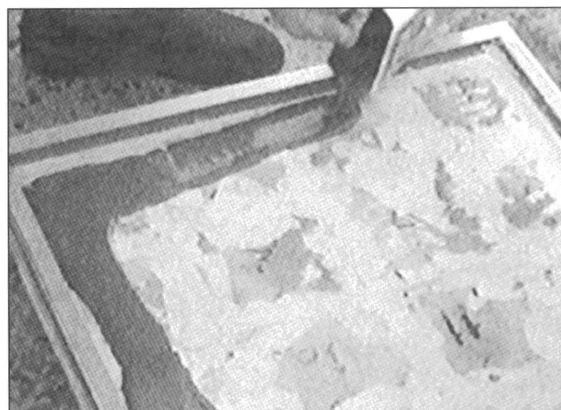
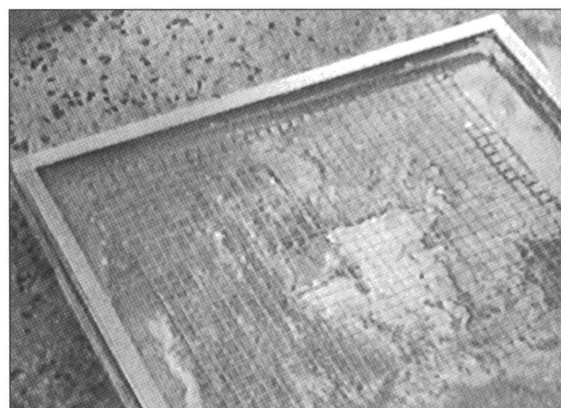
*Different stages in the assembly with polyurethane foam (1st part).*

This support was made as follows:

- 1° All the tiles making up the soffit were laid face down on a sufficiently high glass table, to allow checking from beneath to make sure that all the pieces were properly arranged.

- 2° Tiles are usually not perfectly flat. To keep them from moving, they were levelled with little pieces of cardboard placed at the ends of each tile until attaining the flattest possible surface.

- 3° A spatula was used to spread the adhesive paste joining the tiles to each other, leaving no unfilled opening and ensuring that nothing moved. The product used was Fermafix, an adhesive paste made and marketed by a company that specialises in producing industrial mortars made up of synthetic resins in an aqueous dispersion with mineral fillers. It has a mass density of  $1.7 \text{ g/cm}^3$  and  $\text{pH}=9$ . It is used for fixing ceramic wall tiles on internal walls. The product is flexible, has a correction time of about 40 minutes and a total hardening time of 6 to 8 days, which varies according to thickness and temperature. The material is reversible and can be removed with acetone.

- 4° The exact measurements were taken of the soffit perimeter and the frame was fitted with the U-shaped aluminium profile, riveted at the four ends. The frame was adhered to the tiles with the same adhesive paste, pressing to achieve a good bond. The assembly was left to dry for 36-48 hours at a temperature of  $18\text{-}22^\circ\text{C}$ .

- 5° The framed tiles were placed on a foamed plastic sheet of a certain density as a cushion for protection. A conglomerate board was prepared with a hole in the middle to let out the excess material and have the polyurethane expand uniformly. Weights were also prepared of 25 or 30 kg, according to the soffit surface area. A piece of galvanised aluminium mesh was then cut and the proportions of the two polyurethane components were prepared.

- 6° The polyol and isocyanate were vigorously mixed to a homogeneous solution as fast as possible. The liquid was poured into the flat box made up of the tiling surface and aluminium frame and quickly spread, positioning the mesh used to reinforce the support and provide it with a greater consistency. This was then covered with the conglomerate lined with plastic, to keep the polyurethane from sticking to the wood, and weight was put on top to keep everything tightly sealed. This was allowed to stand for a few minutes to allow the polyurethane to expand and harden.

- 7° Finally, after verifying that the sample had hardened, the weight was removed, the wooden lid was lifted and the support was ready.

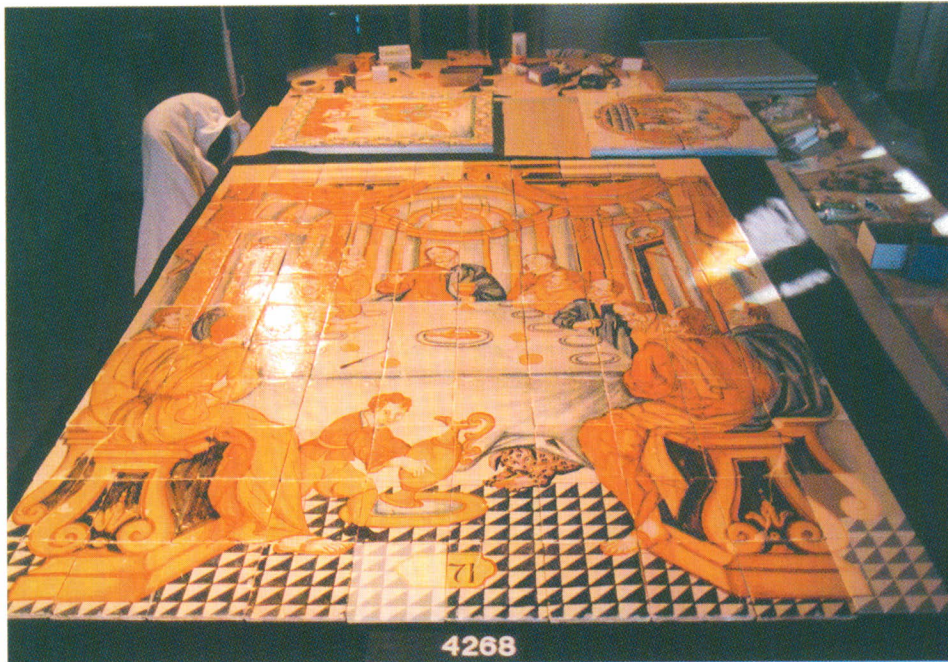
*Preparation of the restored tiles to be mounted on Aerolam. Item from the Mir collection.*

This material is supplied ready for use in sheets measuring 122x244cm, in thicknesses of half and one inch, i.e., of 13.7 mm and 27.4 mm, respectively. It consists of two glass fibre panels sandwiching a beehive aluminium structure, which can be cut relatively easily. It is an excellent insulating material and withstands weight without deforming. It is a well-known material in the field of restoration work, but its high cost is an important drawback. Most of the tiles that were installed on Aerolam were groups with many items and large sizes or irregular shapes, as this support could be cut in the desired shape. There were also complicated tile composition arrangements that were easier to lay face up. Some individual tiles were also set on this base, which allowed using scraps of material, and also speeding up the work.

The soffit to be installed was set out, measurements are taken and the Aerolam was cut with an electric saw. The profile was covered with an aluminium frame that covered the Aerolam thickness and a little over half that of the tiles. The large compositions were split up into manageable modules, in terms of weight and size.

The same adhesive (Fermafrix) was used to adhere the tiles to the Aerolam as with the polyurethane. After drying completely (6-8 days), the soffit was placed face down on a foamed plastic sheet and framed with an L-shaped aluminium profile, riveting the ends. The profile served to hide most of the support, to keep from cutting oneself on handling it, protecting the tile profile and making the soffit more compact and stronger. The same operation was performed with the items arranged in modules, however without covering the contact areas with the profile, to provide a better fit. The choice of Aerolam thickness depended on the weight to be withstood.

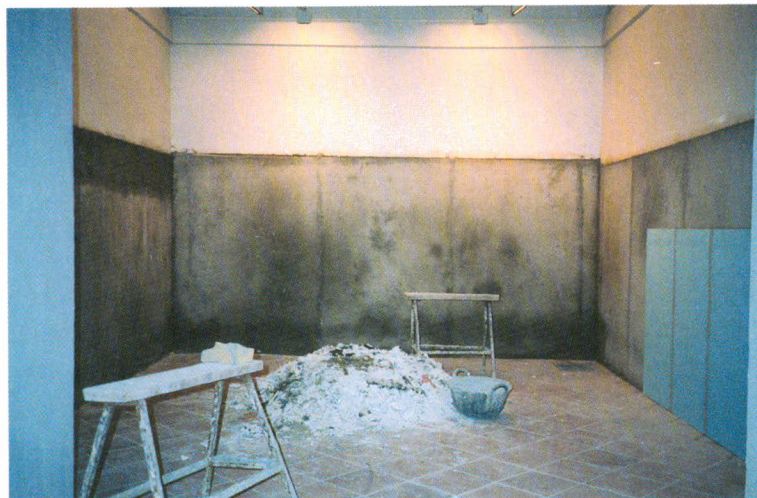
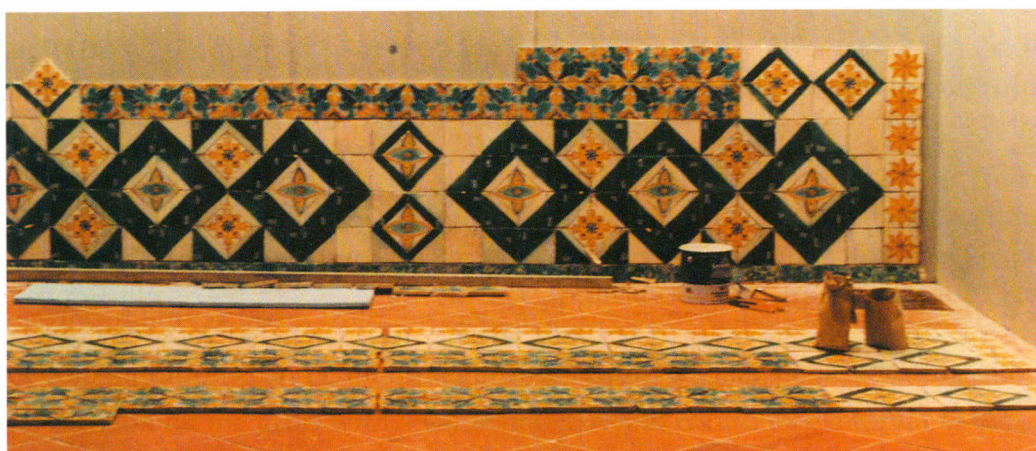
*Preparation of the walls, insulation and tile assembly in situ.*

The system was used for all the tiles that belonged to the large dado compositions. The problems relating to the moisture in the walls where the tiles were to be installed needed to be solved first. The walls were cut away until sound material was reached, subsequently applying the rendering and fitting sheets of insulating material of the foamed type of great density (Estiropor). These were levelled, and the surface was prepared for tile installation, using the same adhesive paste as in the other supports. In this process, after restoring the items and organising the compositions for their correct installation, the restorer watched over the tile installation by the tile fixer, ensuring that all the materials used were reversible, compatible, quality materials. Finally the restorer applied the grout filler

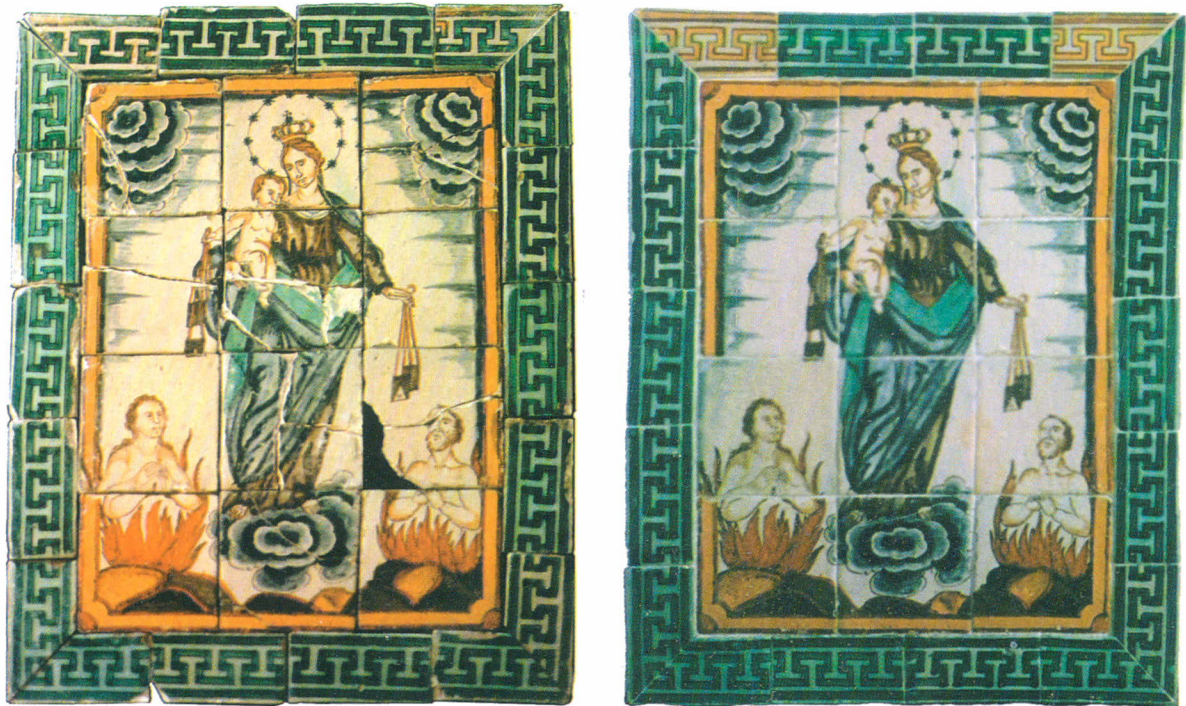
*Comparison of the initial state of a composition after removing the gauze and end state.*
