WHY DOES FACADE CERAMIC TILING FAIL?

Jonas Silvestre Medeiros

Dr Eng., C Eng., Professor at the Department of Civil Engineering Construction of the Polytechnic School of the University of São Paulo - Brazil

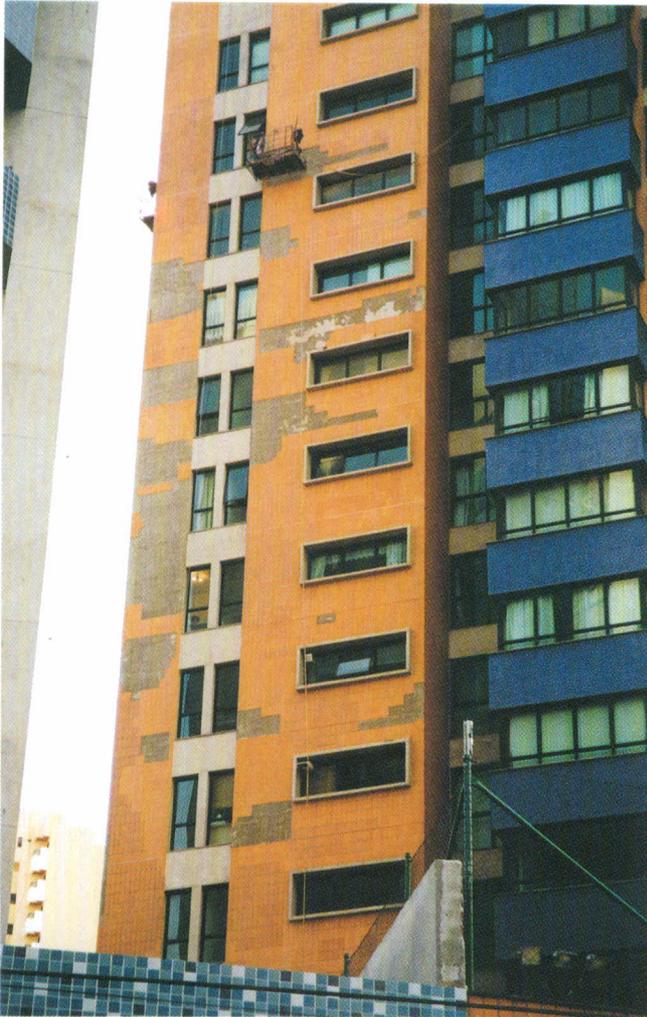
Figure 1. View of building facade where the bond between adhesive and tile broke. Correction requires removing of tiles and preparation of surface when cement-sand rendering remains adequate.

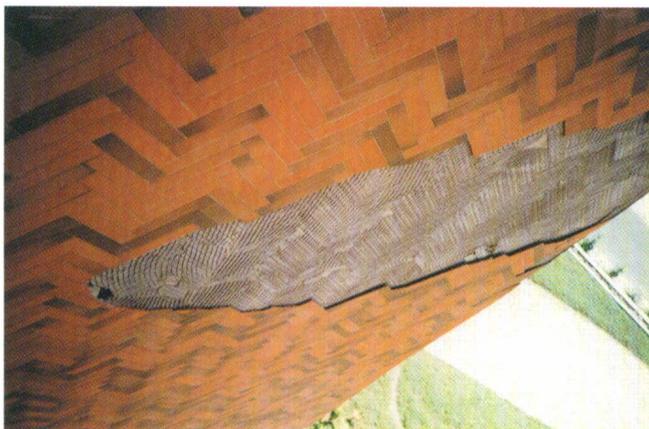
Figure 2. Detail shows bond installation problem but tiling also presents inadequate joint thickness, no control joint and very rigid adhesive mortar and grout.

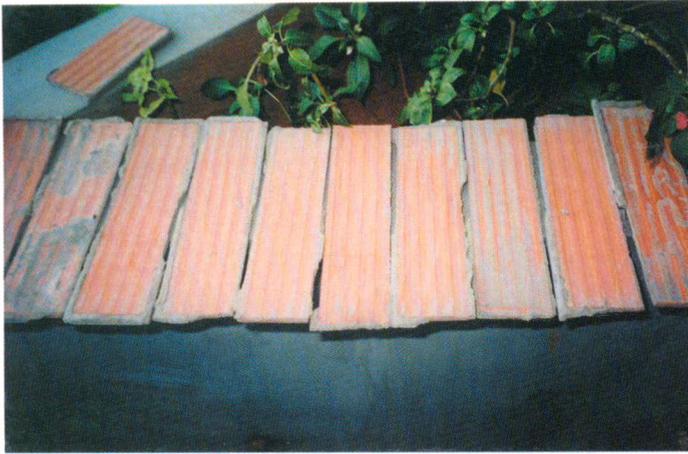
Figure 3. Tiles removed from the facade show problem of fixing. Inadequacy of setting together with wrong specification of material caused failure.

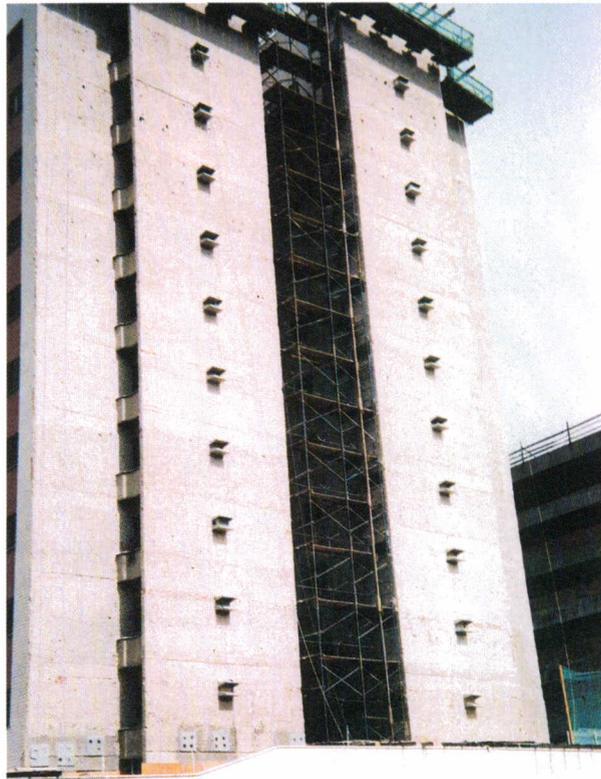
Figure 4. Cement-sand render substrate shows rupture. Inadequate specification of mortar was considered main cause here. Creep of concrete framework and differential movements of masonry infilling contribute to the situation. There were horizontal joints but they were incorrectly positioned.

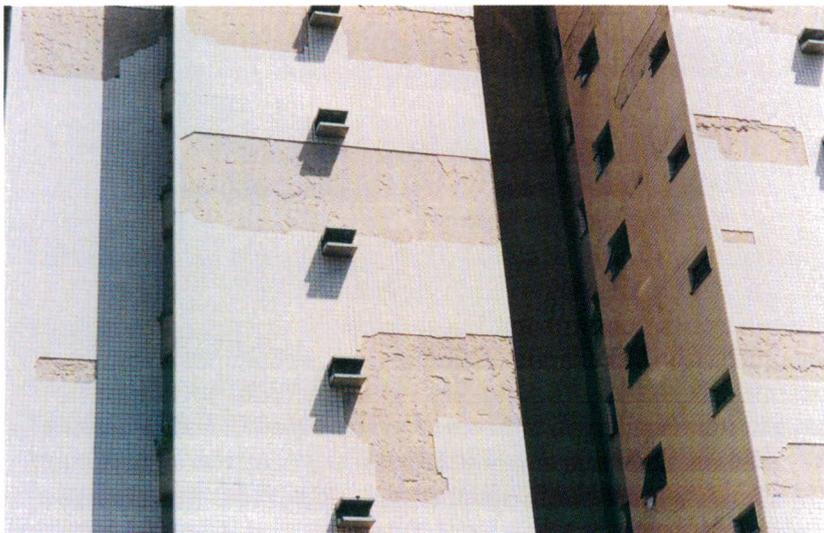
Figure 5. Here the entire system has been removed. This costs about 100 % more than initial costs but there was no other way to fix the problem.

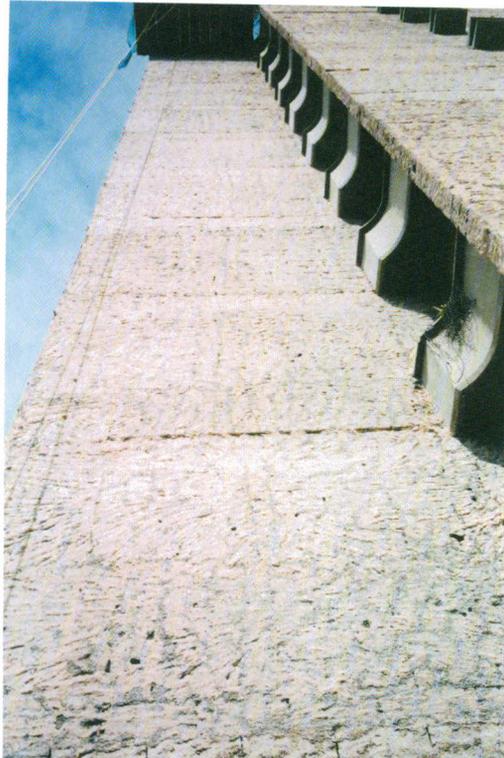
Figure 6. View of facade where old ceramic tiling has been removed. Surface cleaning was necessary to allowing bonding new layers.

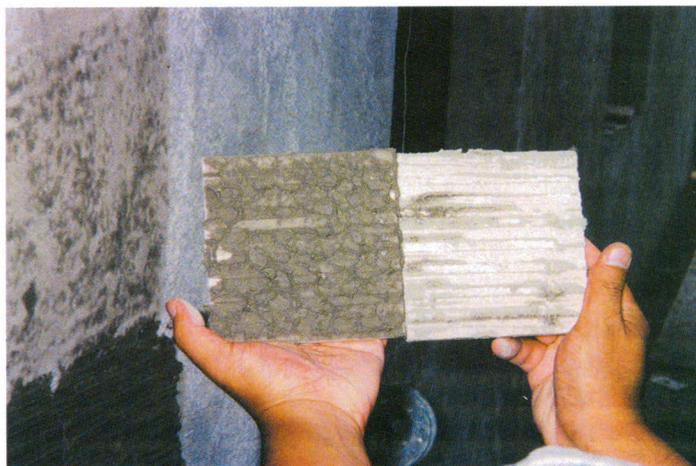
Figure 7. Left: full coverage where accurate setting was used. Right: the lack of adhesive material often causes failure. Technique, tools and quality control play an important role.

Quality control of application is essential to the performance and durability of ceramic tiling. It involves design constructibility evaluation and fulfilment of techniques and material use before, during and after the application process. Figures 7 and 8 show differences between correct and wrong tile setting techniques in adhesive coverage.

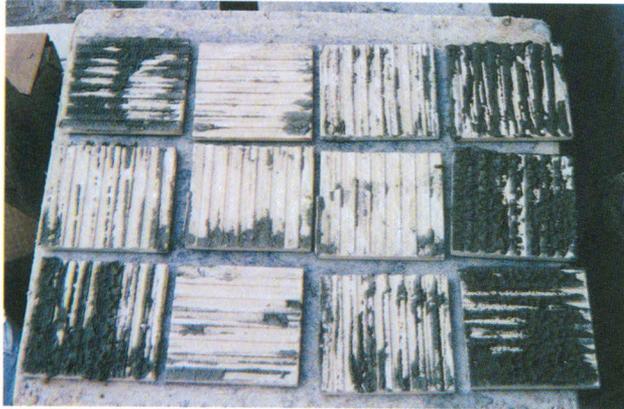
Figure 8. Different tile fixers achieve different results when training and control are put into practice. Here the coverage is not enough. A facade requires a 100% covered surface.

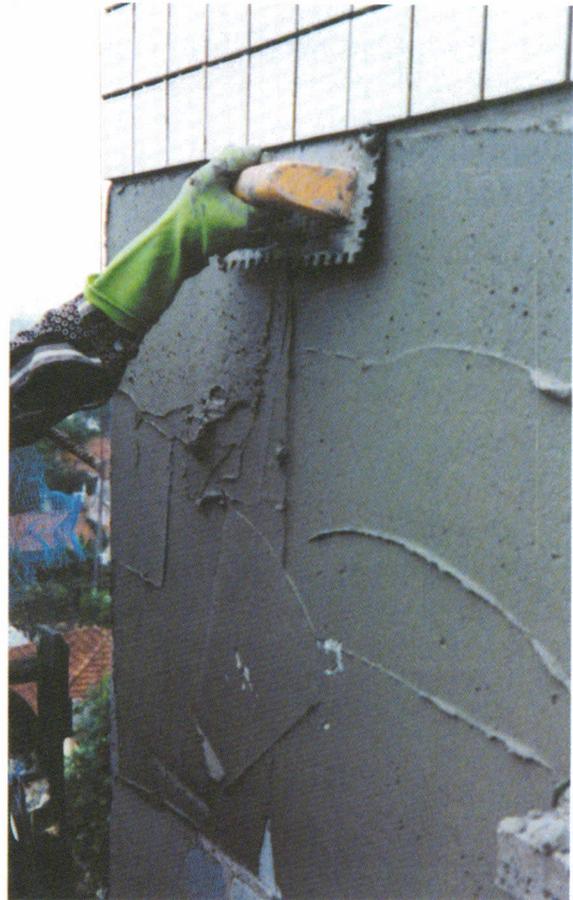
Figure 9. Adhesive mortar is spread first with the flat edge of the trowel to guarantee coverage of the background. In this case, a square shaped, 8mm height notched trowel was used.

In facade applications, tile-setting techniques are very important. In these cases, double fixing technique is essential to achieve good results. Double fixing setting includes application of mortar on tile reverse and on substrate or background surface. When applying mortar on surface, the tile fixer should first use the flat edge then the notched edge of the trowel as shown in Figures 9 and 10.

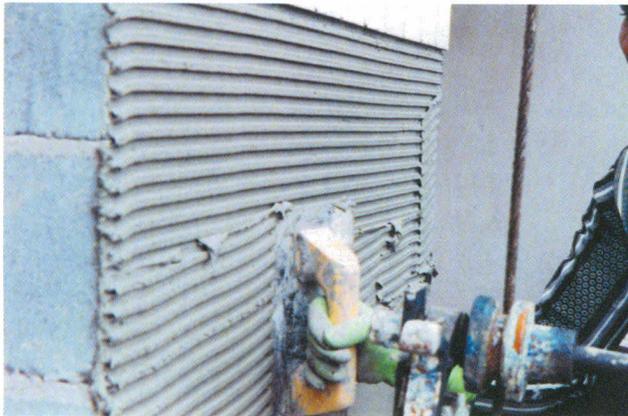
Figure 10. The notched edge of the trowel is used to prepare the surface for adequate fixing. Horizontal stripes are preferable to avoid eventual water leakage.

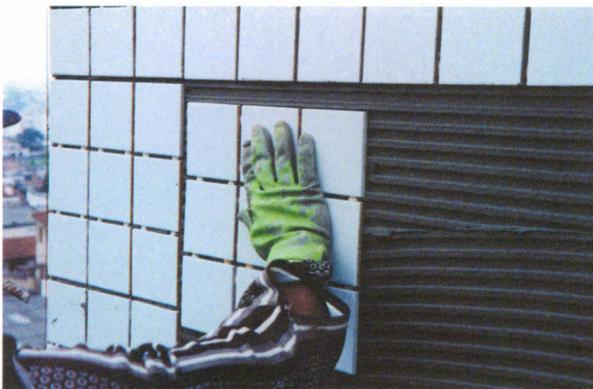
Figure 11. Tiles are positioned by offsetting them from their final place so the adhesive can be fully spread. The technique is very simple but gives good results to improve coverage.

Tools are an important part of the application method and their correct utilisation depends also on training. The trowel is the most important tool in ceramic tiling but mixers and brushes play an important role too. Adhesives and grouts must be mechanically mixed and joint grouting requires previous accurate cleaning. The height and shape of the teeth are important parameters for the adequate selection of the trowel. Figure 11 to 19 shows some features of the application method.

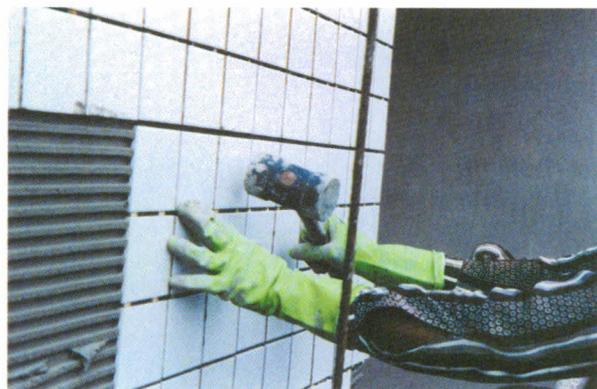
Figure 12. The tiles are pressed against the background, not only to improve coverage but also to prevent slipping. The material is isotropic and squeezes when pressed by percussion.

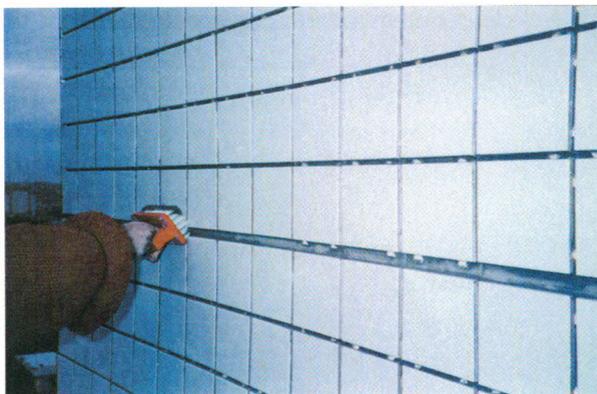
Figure 13. Joint cleaning is very important to let the grout fill the joints completely. Here a brush is used.

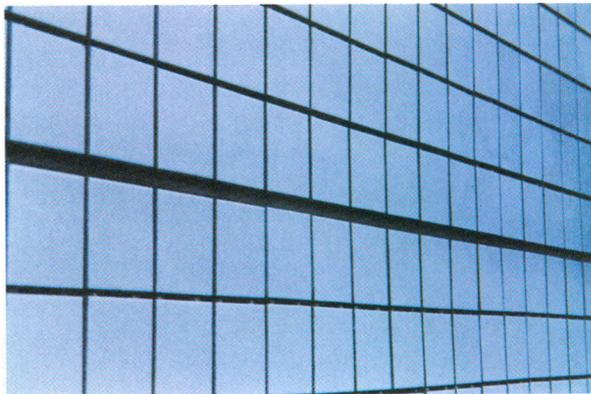
Figure 14. View of the cleaned ceramic tiling, ready for the application of joint grout.

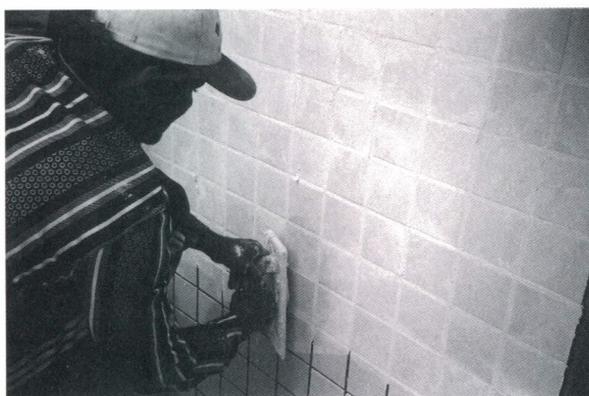
Figure 15. A rubber trowel designed for jointing is used here for adequate filling.

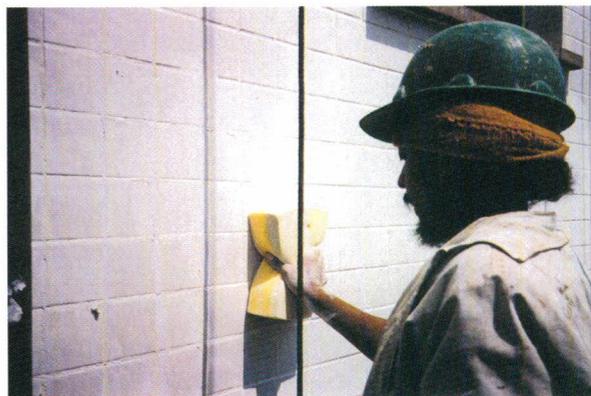
Figure 16. Primary cleaning of grout that spills out of the joint and remains on the surface of tiles. A sponge is used.

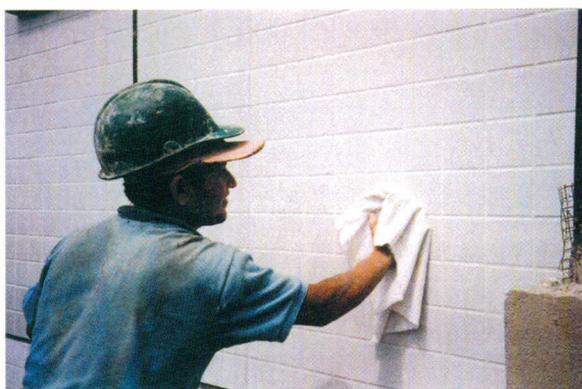
Figure 17. Secondary cleaning of the tiling surface. Beyond this step only final cleaning is required.

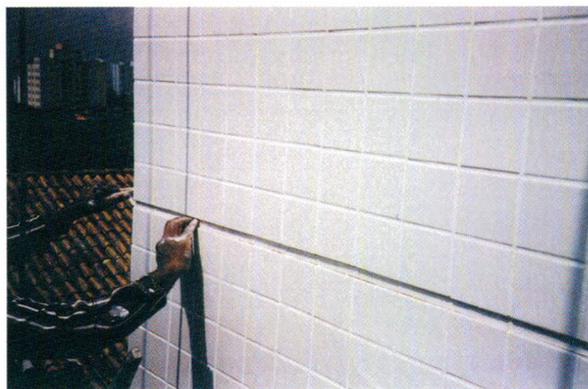
Figure 18. Back-up tape is used to avoid sealant bonding to the back of the control joint. The technique is essential to sealant behaviour and durability.

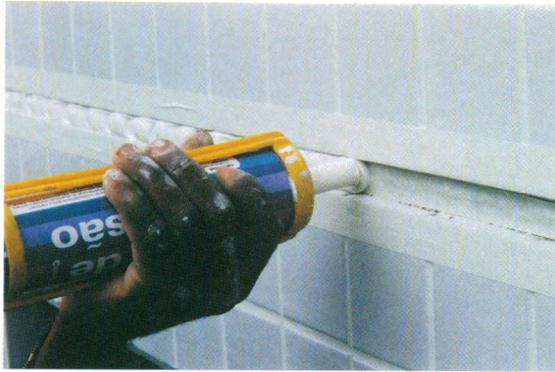
Figure 19. Sealant is applied in the control joint. Jointing is necessary after the preset time of the material. Note that tape used to protect tile edges.

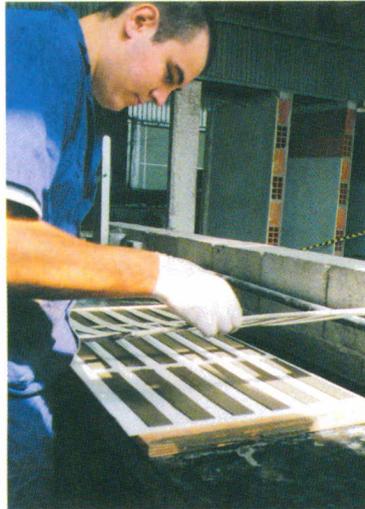
Figure 20. Flexibility test specimen is under preparation. Moulding the specimen in-groups avoids deviation of results. The specimen is simple to prepare and showed good results as described by MEDEIROS et al. (1998).

Specimen preparation is shown in Figure 20. The apparatus shown in Figure 21 was developed specifically for this purpose. Classes 3 to 5 are adequate for exterior use. The classification can also be used for the selection of grouts.

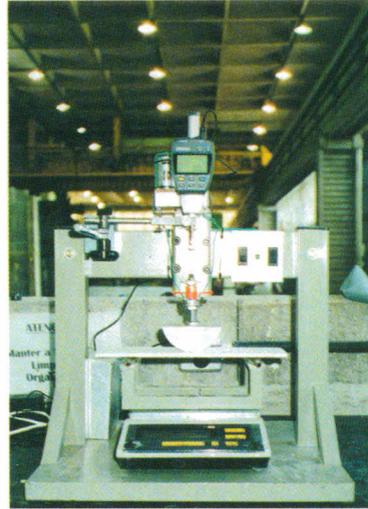
Figure 21. The apparatus shown was designed and built to make the flexibility test easier and cheap. Goods results showed its applicability. The apparatus costs about US\$ 1,000.
