# DESIGN AND CONSTRUCTION OF LIGHTWEIGHT FACADE PANNELLING WITH CERAMIC TILES

**José Antonio Sacristán Fernández (\*)**; **Rufino J. Hernández Minguillón (\*\*)**

Universidad de Navarra. Department of Building.

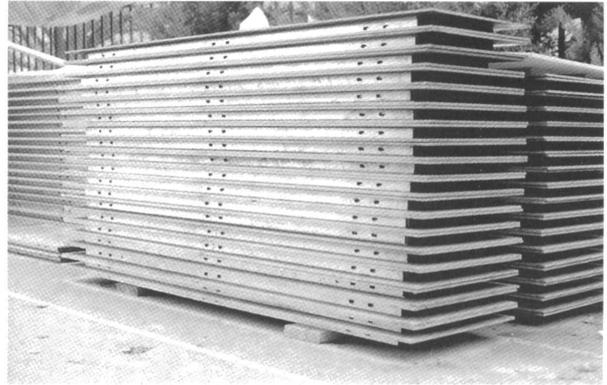
*Figure 11. Finished panels.*

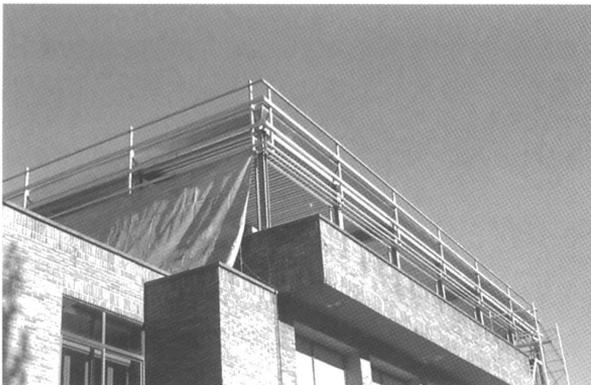
*Figure 12. Underlying roof parapet structure.*

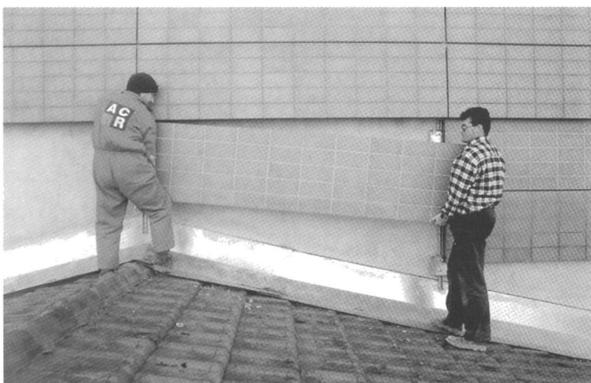
*Figure 16. Anchoring the panels on the roof.*

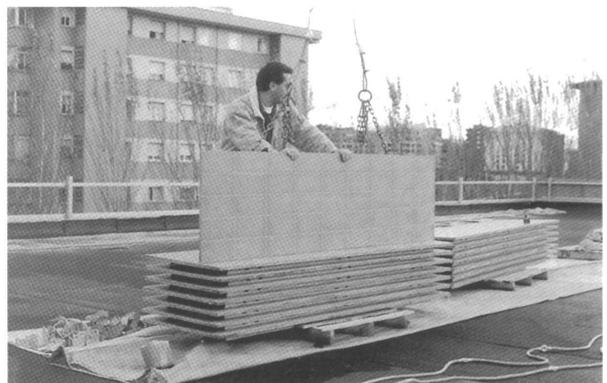
*Figure 17. Installing a backing panel.*

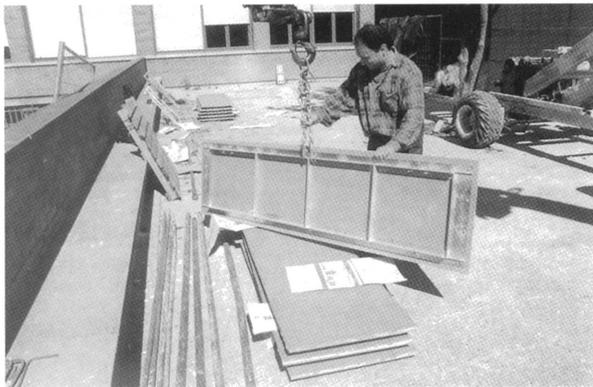
*Figure 20. Model 2 panel.*

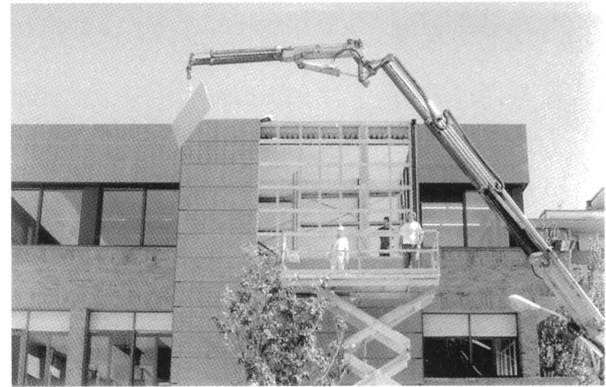
*Figure 21. Installation of Model 2 panels on the stair.*
