CHARACTERISATION OF FROST DAMAGE TO CERAMIC TILES IN SLOVENIA

Tinkara Kopar, Vilma Ducman

Slovenian National Building and Civil Engineering Institute, Dimieva 12, 1000 Ljubljana, Slovenia

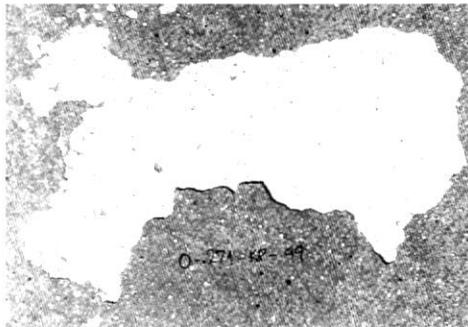
The most commonly detected type of damage observed on the dry-pressed glazed ceramic tiles after the freezing-thawing test was peeling of the glaze. In Figures 1, 2 and 3 large-scale peeling of the glaze of some tiles from Blb group, having a water absorption between 2 and 3%, can be seen. In Figure 4 the beginning of peeling of the glaze of ceramic tiles from group BIa, having a water absorption of 0.1%, is shown. The reason for this damage was probably the lack of adherence between the glaze and the ceramic body. Water entered the free space under the glaze, froze and then expanded. There was an increase in the pressure on the glaze from below, which caused separation of the glaze from the ceramic body surface, i.e. peeling. It was observed that the glazed ceramic tiles with a water absorption of between 0.5 % and 3 % (Figures 1, 2 and 3) suffered more extensive peeling damage than the glazed ceramic tiles with a water absorption below 0.5 % (Figure 4). The reason for such behaviour may be the lower firing temperature for products with a higher water absorption. At such temperatures hardly any melting takes place, and only dry sintering occurs.^[5] This process leads to a rather weak bond between the ceramic body and the glaze surface, which can after exposure to severe conditions result in frost damage. The reason for peeling of the glazed surface, especially of porcelain ceramic tiles, may also lie in the second firing of the glaze. The thin layer between the ceramic body and the glaze surface can therefore be considered as the "weak point" of glazed ceramic tiles regarding to frost resistance.

Figures 1, 2, 3: Peeling of the glaze of ceramic tiles group Blb after frost resistance test.

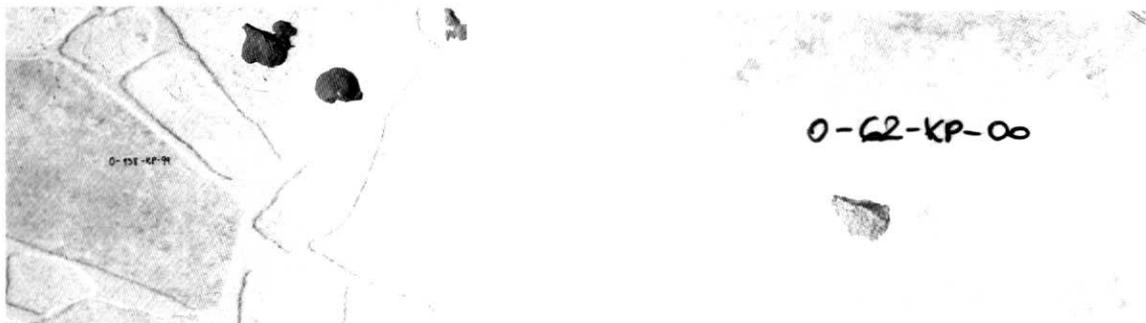
The second major group of detected frost damage was chipping, i.e. the breaking-off of cone-shaped pieces of tile consisting not only of the glaze but also of the ceramic body. This type of damage is presented in Figures 5 and 6. This type of damage is probably due to an increase in the volume of water that has penetrated into the ceramic body when the tiles were subjected to freezing. When water inside the pores freezes, the ceramic body is subjected to a considerable tensile forces, which can lead to damage.

Figures 5, 6: Chipping - frost damage to dry-pressed glazed ceramic tiles after frost resistance test.

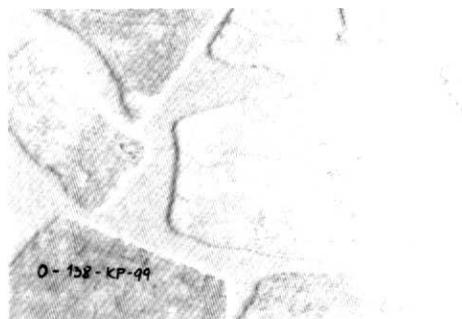
The glazed ceramic tiles which were exposed to freezing-thawing tests also suffered crazing damage, which can be seen, in Figure 7. This type of damage is probably caused by the stresses which occur, under severe exposure conditions, due to the different coefficients of expansion/contraction of the glaze and the clay body. As a result a network of hairline cracks occur on all or part of the glazed surface of the tile. After further exposure of such damaged tiles to cycles of freezing and thawing, other types of damage, such as chipping, may also occur.

Figure 7: Crazing of glaze of dry-pressed glazed ceramic tiles after frost resistance test.

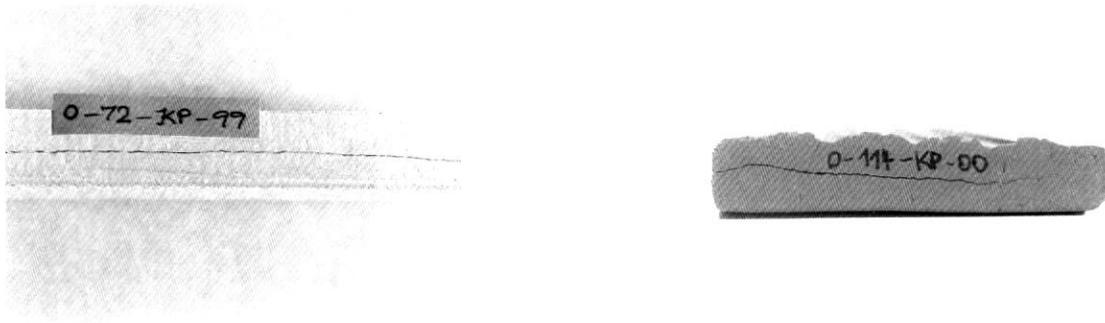
Figures 8 and 9 show damage in the form of lamination of the ceramic body of extruded unglazed tiles. In these cases the damage was probably due to the shaping process, because in general ceramic tiles of this type are frost resistant. The extrusion process may have resulted in a laminated structure. In this process the degree of de-airing and the time between the shaping and drying are very important factors.^[5] The result, after freezing and thawing cycles, was a de-lamination of parallel layers.

Figures 8, 9: Lamination of extruded unglazed ceramic tiles after frost resistance test.
