# **TEN YEARS OF FACADE PATHOLOGY INVESTIGATIONS**

**Mansur, A. A. P.; Nascimento, O. L. do; Mansur, H. S.**

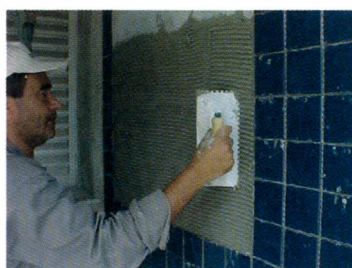
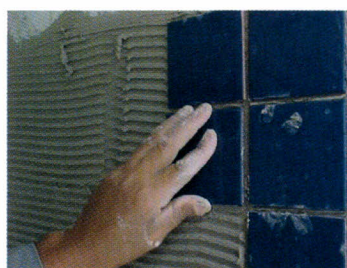
*Figure 1. Facade characteristics. (a) and (b) directly adhered ceramic tile installed in thin bed with dispersive powder polymer-modified cement mortar. (c) Grouting with polymer-modified cement grout. (d) Movement joints filled with sealant. In all these photos the use of small glazed ceramic tiles pieces (100 mm x 100 mm) can be observed.*

First, we should identify the major characteristics of facades built in our country in this period of time (Figure 1). The ceramic tile is directly adhered, the adhesive is dispersive powder polymer-modified cement mortar and the installation method is thin bed. The joints between pieces of cladding are filled with polymer-modified cement grout and movement joints filled with silicone or urethane sealant. The ceramic tiles size range is from 50 mm x 50 mm up to 400 mm x 600 mm, but the small sizes are more abundant. They are glazed and usually belong to BI and BIIa water absorption groups.
