## BUILDING FACADES WITH PORCELAIN STONEWARE TILES IN RECIFE - BRAZIL

### ABSTRACT

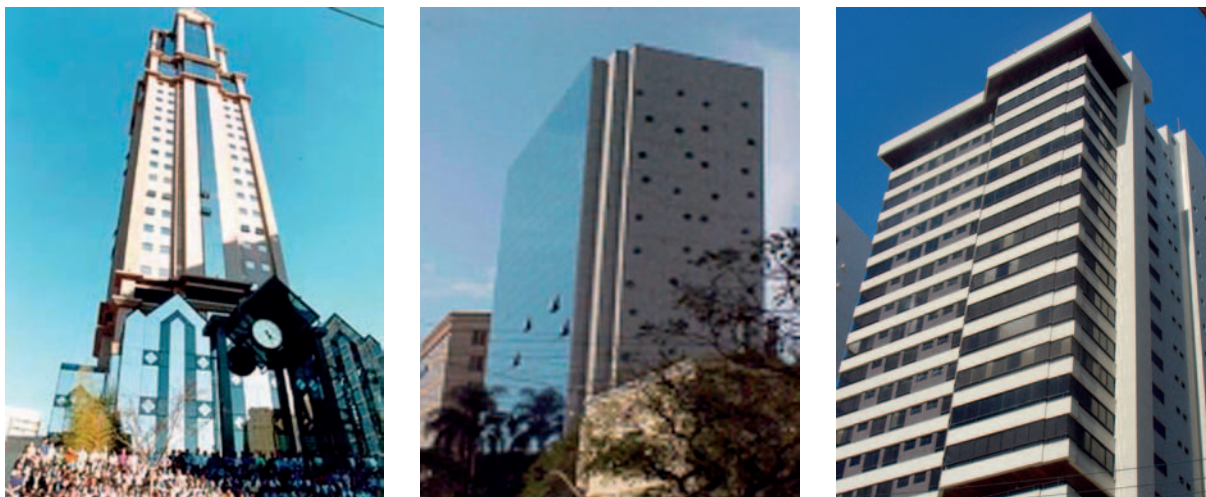
There is not a precise record of the first building to use porcelain tiles directly adhered on facade in Brazil. However, the *Curitiba Trade Center* building finished in 1995 in Curitiba, state of Paraná, deserves credit as a landmark in the country (Figure 8) as one of the first usages. In this construction, tiles and latex adhesive mortar were imported - the national production of porcelain tiles began two years later in 1997.

Figure 8. Important projects in Brazil where porcelain tiles were used in facades.  
From left to right: Curitiba Trade Center in Curitiba; Planet Work in Sao Paulo  
and Condominium Enseada dos Corais in Natal.

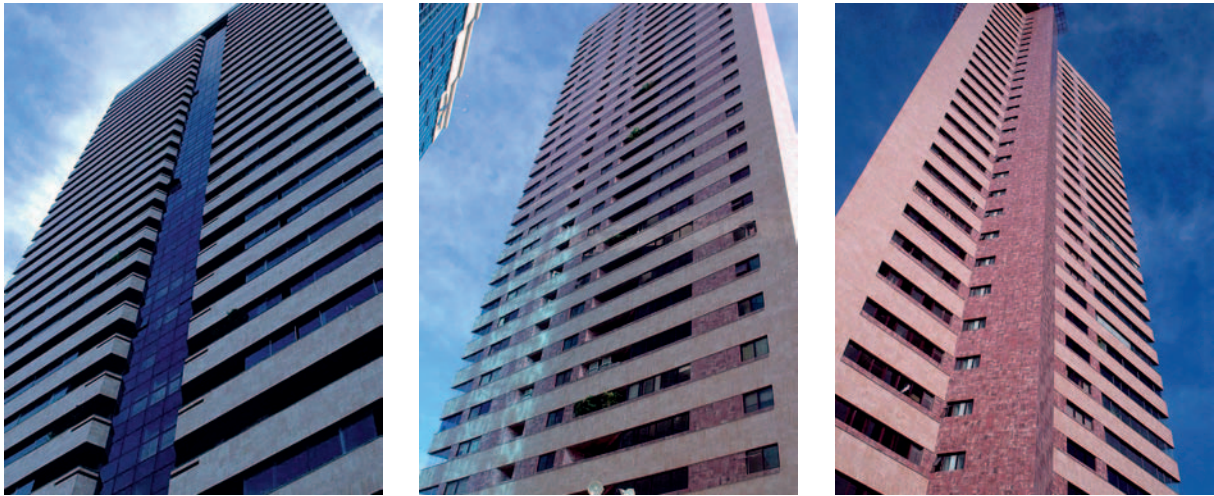
In Recife, the first important project where porcelain tiles were used on facade was the Principe de Marsala Building finished in 1996. In this project 30 x 30 cm polished tiles had been used in an area of about 10,000 m<sup>2</sup> (Figure 9).

Figure 9. Facade overview of the first great project in Recife where 30 x 30 cm porcelain tiles were used.

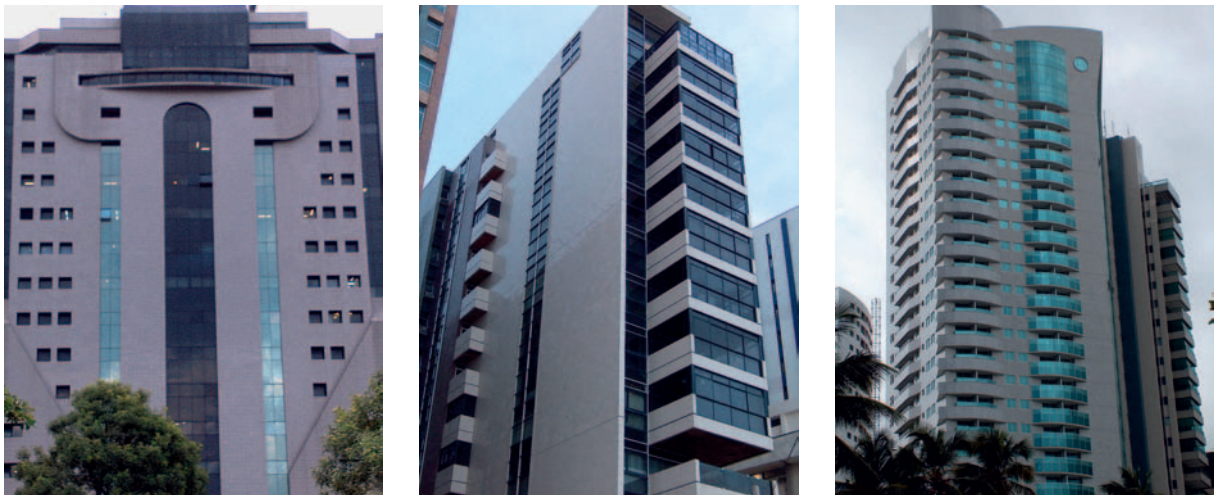
Figure 10. Porcelain tiles building facades in Recife. Most buildings have more than 20 floors. Facades architecture put together ceramic tiles, dimension stone and structural glazing.

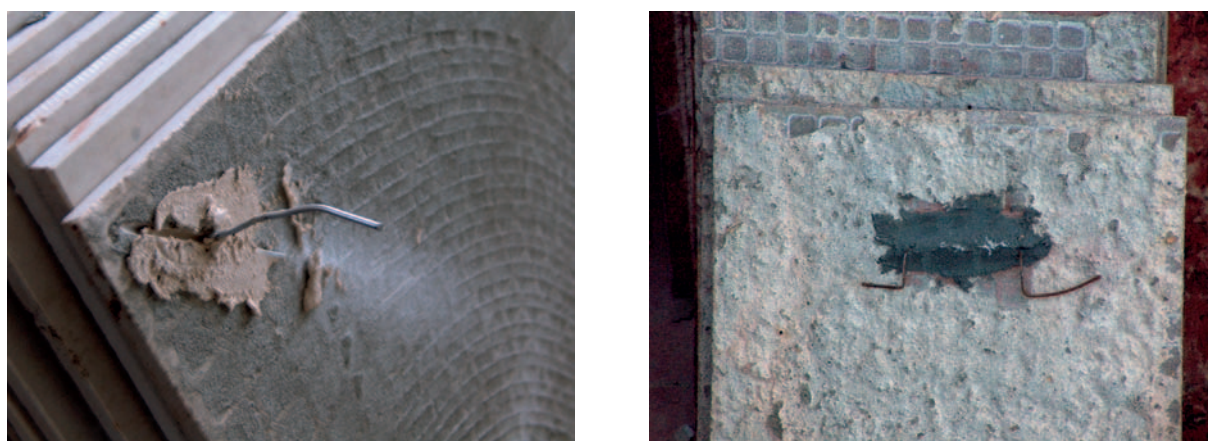
In many cases, adhesive mortar was applied to the back of tiles previously and sometimes cement-polymer spatter dash was used. Simple wire anchorage (Figure 11) aiming to reduce the risk of future detachment was also used. This kind of preparation was used in about 28% of the facades until 2000. Afterwards, this technique was used only for repairing purposes.

*Figure 11. Examples of simple wire anchorage to improve bond stability.  
Back surfaces of tiles were previously prepared with adhesive mortar or spatter dash.*

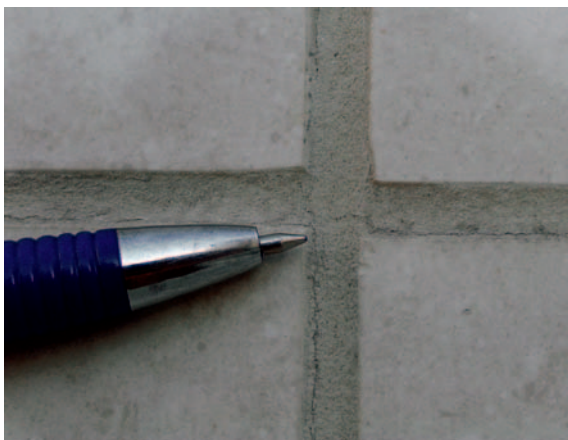
- (I) interface cracks between grouted joints and tiles, observed in most inspected facades (see Figure 12);
- (II) bond failures in joint sealant to the edges of tiles, associated to the inadequate positioning of the back rod and sealant section;
- (III) tile cracks due to saw cut used to install wire anchorages at back of the tiles (Figure 13);
- (IV) imperfections between window frames and porcelain tiles due poor detailing and workmanship.

*Figure 12. Small cracks between grouted joint and porcelain tiles edges that happened in many facades that have been inspected during the field survey.*

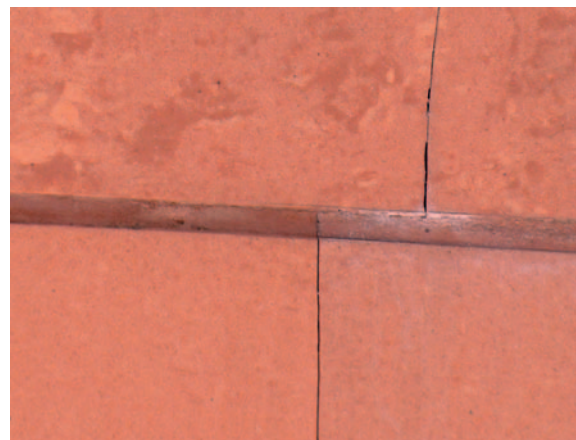
*Figure 13. Example of crack observed where wire anchorages were attached to the back of tiles in order to improve bond stability.*

All data and information collected allowed concluding that most part of the problems is related to inadequacy of materials used to fix tiles and grout joints. Therefore one of the aspects that should be investigated more thoroughly in order to minimize such defects is the correct specification of adhesive mortars and grouts. In most cases where cracks occurred other related defects also were identified, although the cracks in porcelain tiles shown in Figure 13 are related to the cuts made to fix the anchorage wires.

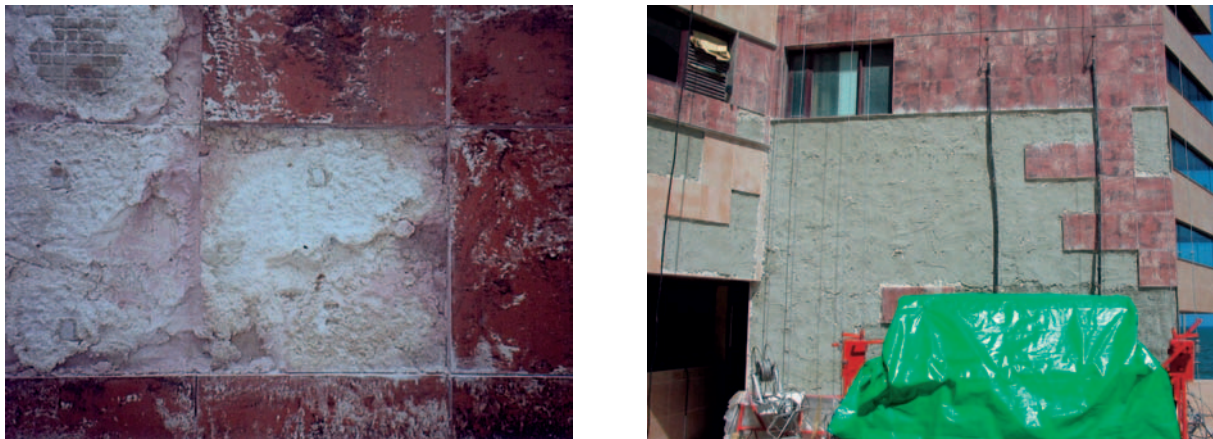
Concerning bond problems, few cases were found and only in two cases severe detachment were found as seen in Figure 14. In Figure 14 regular cement and lime render was used and detachment happened all over facade due to insufficient bond and strength.

*Figure 14. Severe bond defects occurred in two cases. After six years tile facade was entirely repaired.*
