# RESTORATION OF THE CERAMIC TILE MURAL OF THE FINCA DIAGO, IN CASTELLÓN.

**Pepe Castellano**

Cerámica Decorativa

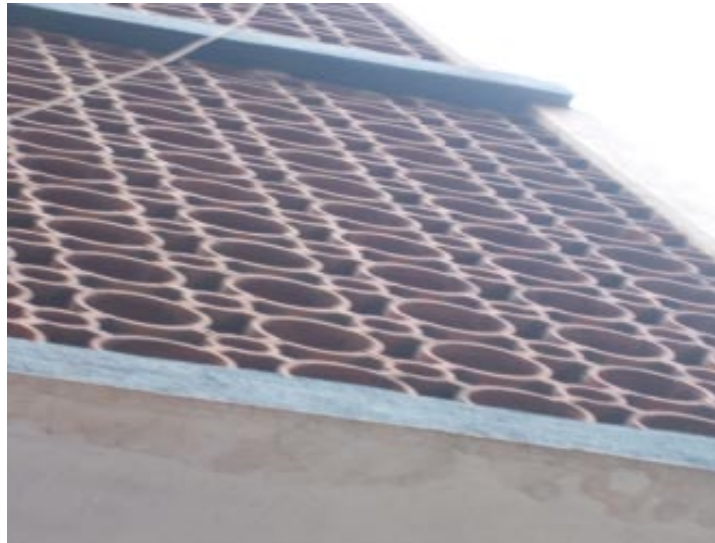
*Figure 3. External ceramic lattice by "La Fábrica de Agustinet".*

A lattice was designed for the outside, covering the entire gallery. It was produced in Castellón by "La Fábrica de Agustinet".

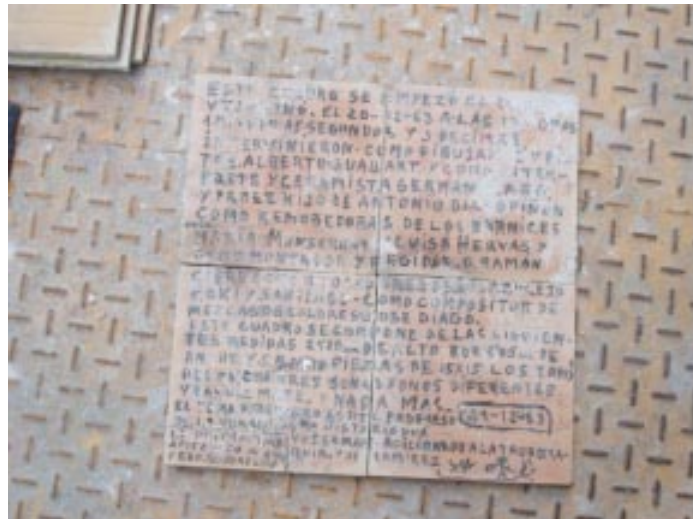
Figure 12. Handwritten detail that appeared on the back of the mural during the restoration work.

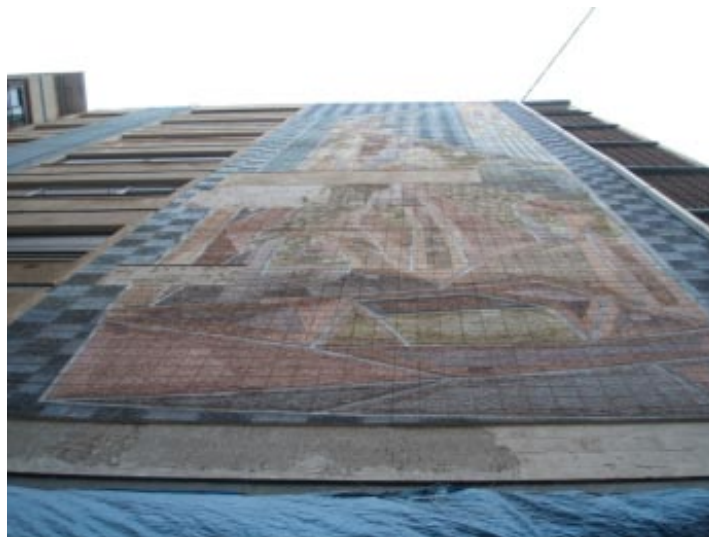
Figure 13. Beginning of the restoration work, from the bottom up, to avoid detachments.

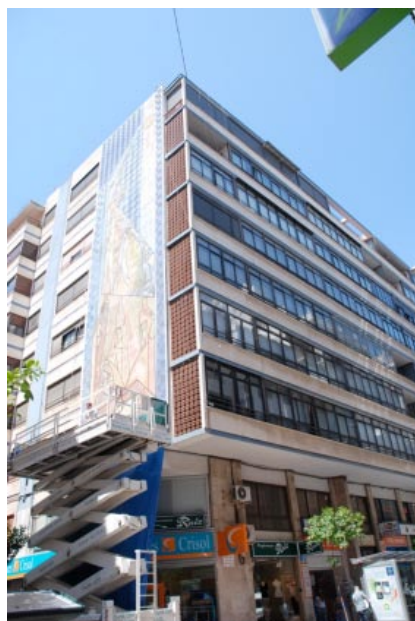
Figura 14. Final restoration process.

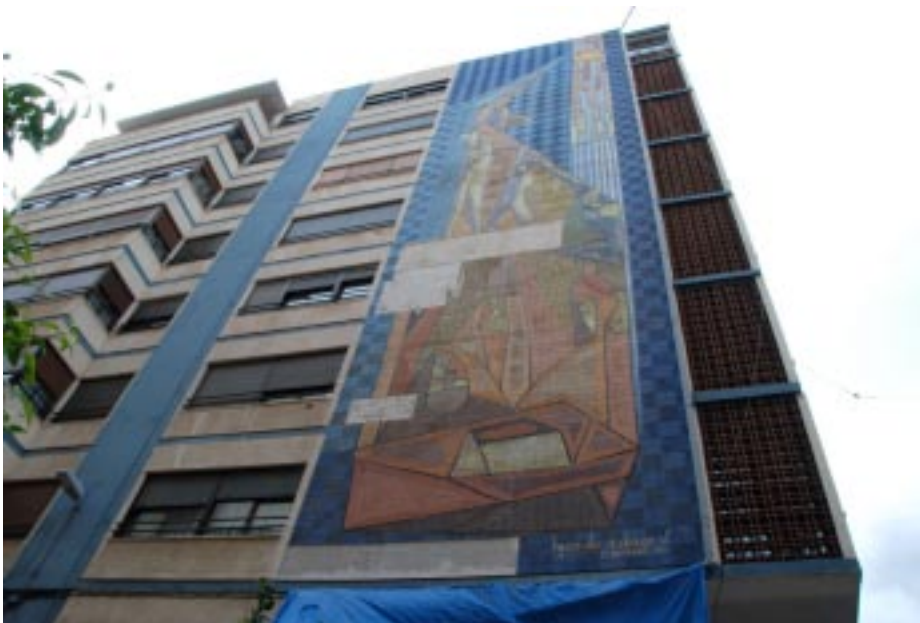
*Figure 15. Beginning of the restoration work. Removal of pieces, from the bottom up.*

The pieces were removed from the bottom up, to avoid breakages.

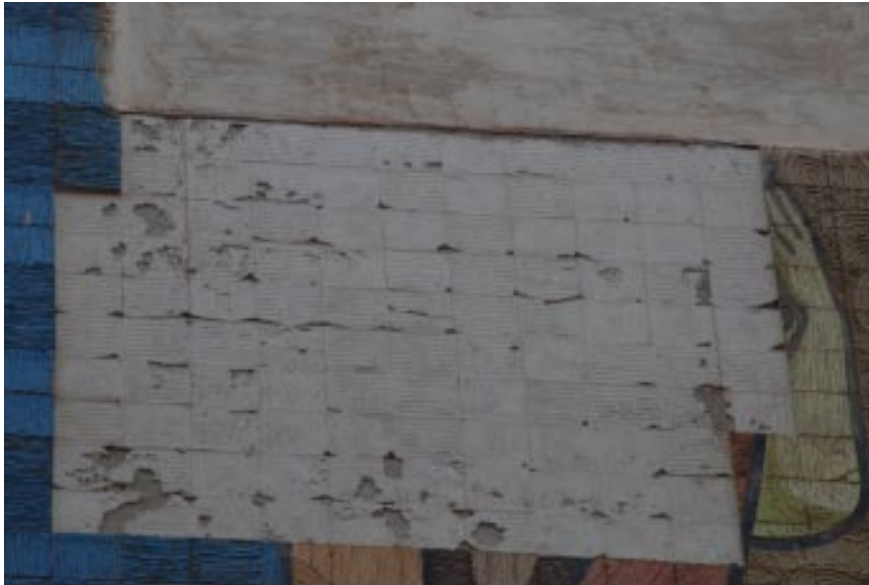
Approximately 10% of the total number of pieces of the mural are detached and/or broken, and the rest is under serious risk of detachment.

No movement joints were made in the surface of the mural. The structural displacement caused pieces to break and has impaired the consistency of the bonding material used in that period, making it lose some of its properties. The result is that the ceramics were under compression and under imminent risk of detachment (in fact, some areas of the mural had already become detached).

When tapped, the tiling sounded hollow, indicating that the ceramic tiles had detached from the background.

*Figure 16. Surface state of the mural before the restoration work.*

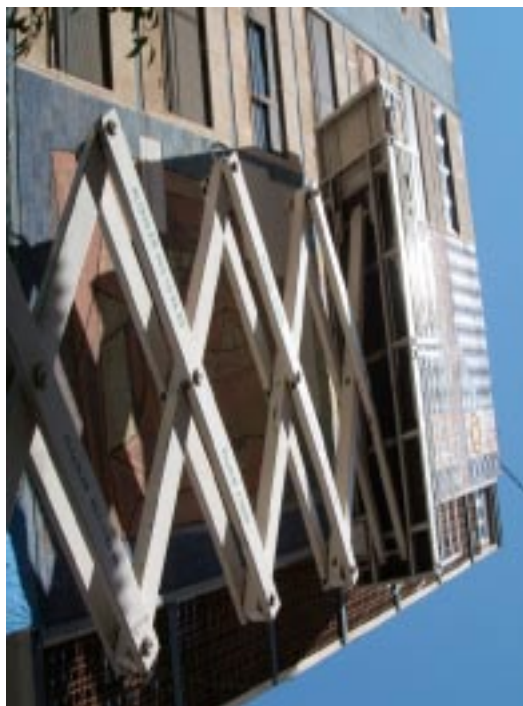
*Figura 17. Lifting platform.*

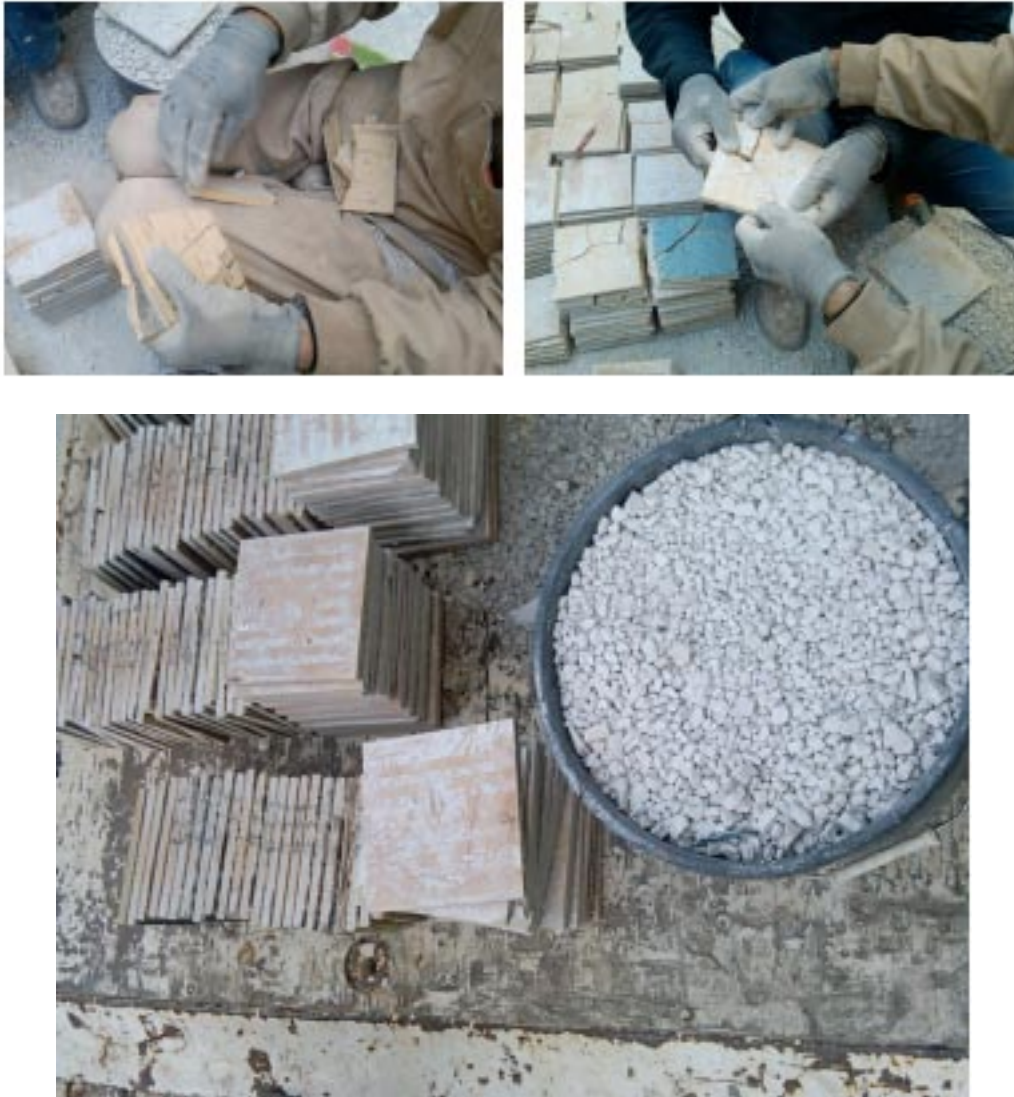
Nearly 10% of the pieces, from an approximate total of 5400, displayed cracks and/or broken parts, and had to be recomposed. Each fragment was numbered to facilitate its subsequent installation.

*Figure 18. Cleaning and numbering of the original pieces.*

Once the pieces had been removed, they were cleaned, since they contained significant rests of the old bonding materials, and numbered.

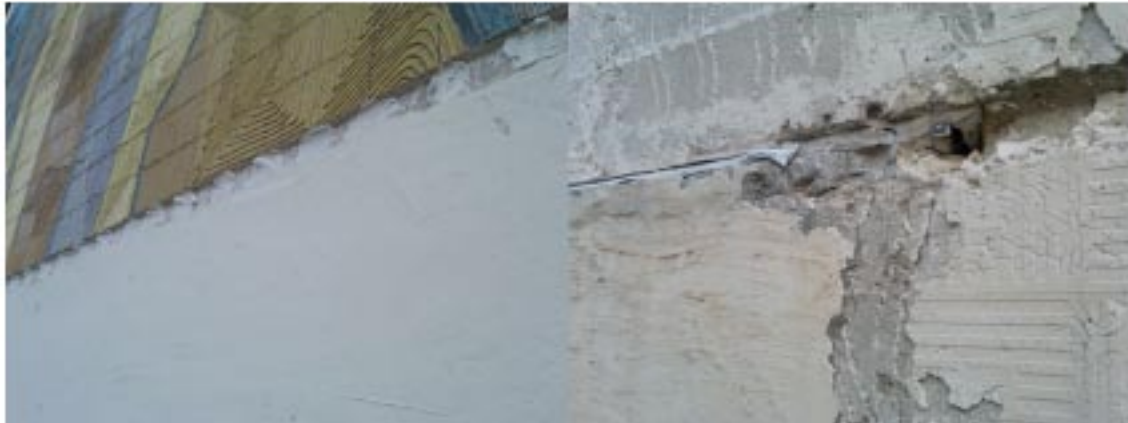
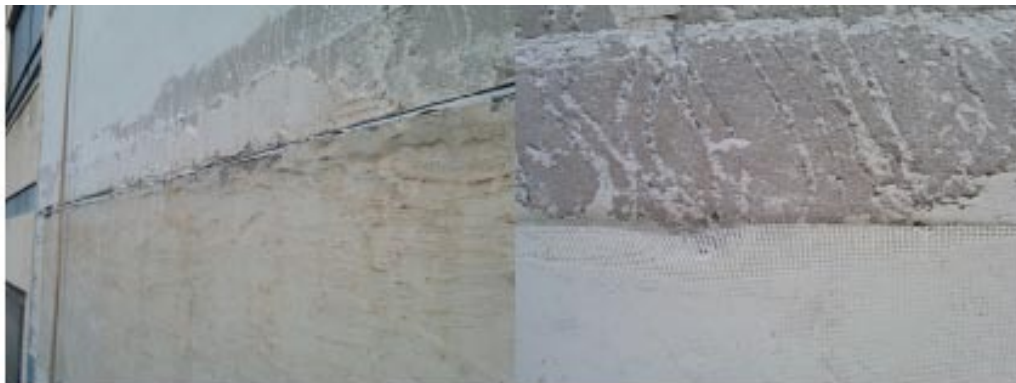
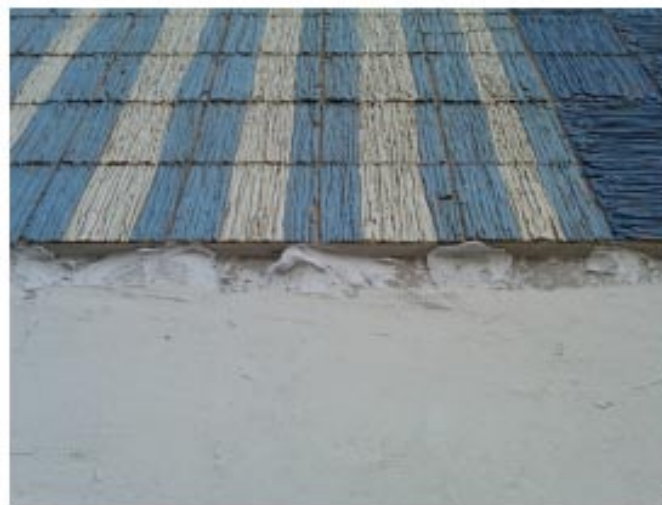
*Figure 19. Previous state of the substrate and restoration process.*

The next step consisted of rehabilitating the substrate. The rests of the old bonding materials were removed and the empty areas of the substrate were chipped to ensure the homogeneity and consistency of the entire surface.

A bonding primer was applied to increase the surface resistance to tensile stress.

A repair mortar was applied to regularize the substrate.

A C2TE cementitious adhesive was applied, together with a fibreglass mesh to unify the installation surface.

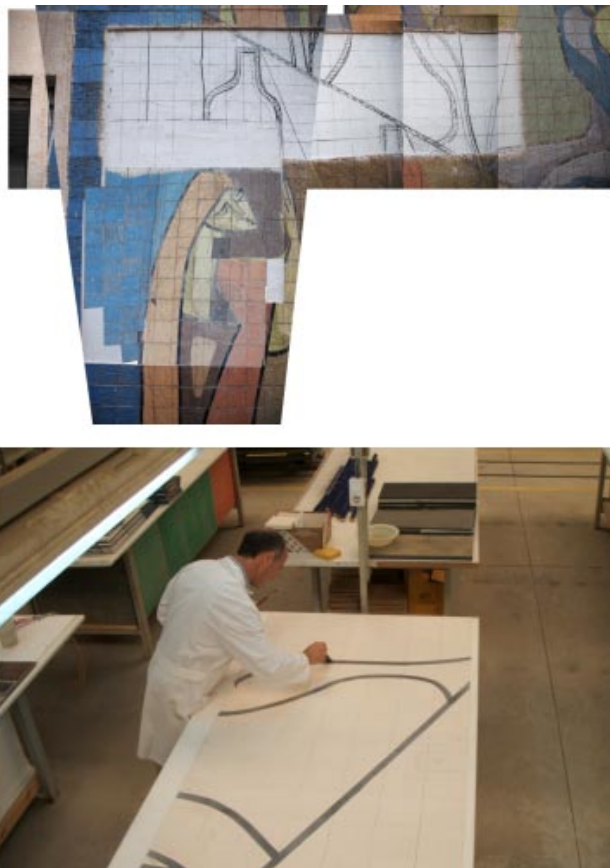
Figure 24.

Once the colours had been selected, an original-scale drawing was made on the mural, and after this had been photographed it was reproduced on the ceramic pieces, drawing directly on the biscuit and painting the embossings with water and manganese dioxide with iron.

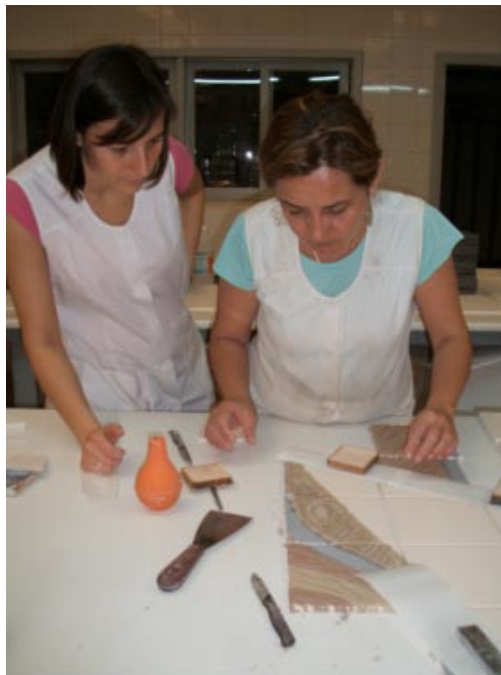
*Figure 25.*

After these profiles had been painted with a brush, the different areas of the drawing were filled, using a “bulb”. These sometimes depicted:

- The sky.
- The sun.
- People.
- Pottery.

This matt glaze, which was subsequently coloured, yielded more than different 60 colours.
