CONSERVATION AND RESTORATION OF EARTHENWARE TILES IN OVAR – METHODOLOGY FOR A SUSTAINABLE INTERVENTION

6. THE MUSEUM OF SACRED ART (THIRD ORDER OF SAINT FRANCIS OF ASSISI) – A CASE STUDY

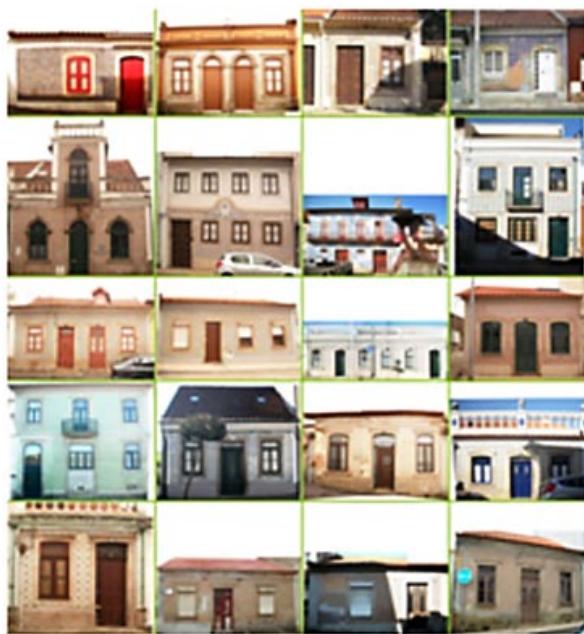
Fig. 1 – Examples of buildings with earthenware tile façades, Ovar.

The buildings with tiled façades in Ovar may be simple, consisting of a single floor, or they may have up to three floors with wrought-iron balconies and sometimes an attic. As a rule, these residential buildings have granite stonework around any openings in their frontage. Most of the buildings were originally homes, while others housed small shops. Currently, most of the buildings conserve their initial use, while others have been adapted for different functions, such as the accommodation of private businesses, or they have been adapted for public use (museums, for example) (Fig. 1).

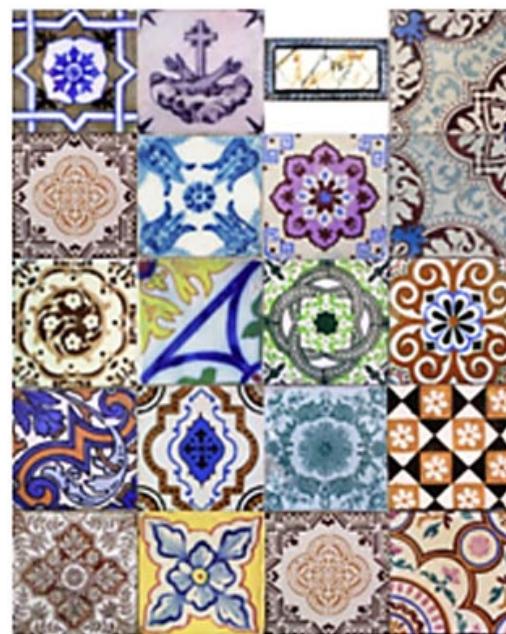
Fig. 2 – Examples of earthenware tiles from the 19th century in Ovar.

The tiles are predominantly smooth, but there are also examples of bevelled and embossed pieces. The majority were produced using the majolica technique, but some have bodies enriched with kaolin ("pó de pedra"). In the decoration of the former the stencilling technique has been used, sometimes with manual touches (applied using a fine brush), and the latter have been printed. Firing temperatures of around 1,050° C were employed and in the case of "pó de pedra" body a temperature of 1,120 °C (4). For the former, which is more common, there are alkaline and alkaline earth metal fluxes, which explains why a lower temperature was used. They have a palette of different colours (a single colour or sometimes up to five or six colours), in which vegetal and geometrical motifs predominate (Fig. 2). Many examples are of unknown origin (because they have no brand name on the back), but there are pieces labelled with factory brands, such as the José Pereira Valente Factory and the Ceramics Factory in Devesas owned by Antonio Almeida Costa & Company, which is more representative.

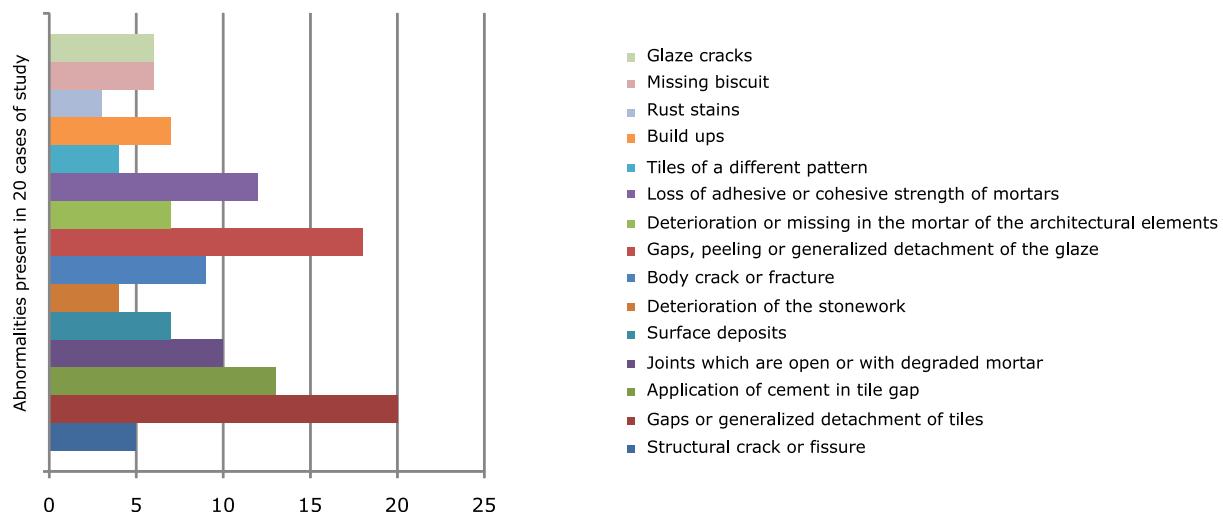
Graph 1 – Abnormalities present in 20 cases of tiled façades analysed in Ovar.

The dynamics of this system afforded by the city and the factors which impinge on it – its geographical position, the climate, urbanism, demography and industrial impact, amongst others – means that some forms of change are more pertinent than others (Table 1). Defects in the ceramic body or glaze are the main problems, not only in terms of the number of cases, but also of how extensive they are. These two problems are the most detrimental when dealing with the conserva-
