AN EXPERIMENTAL STUDY OF TILE BOND BEHAVIOUR OVER STRUCTURAL CONCRETE MASONRY WALLS

INOVATEC CONSULTORES ASSOCIADOS

ABSTRACT

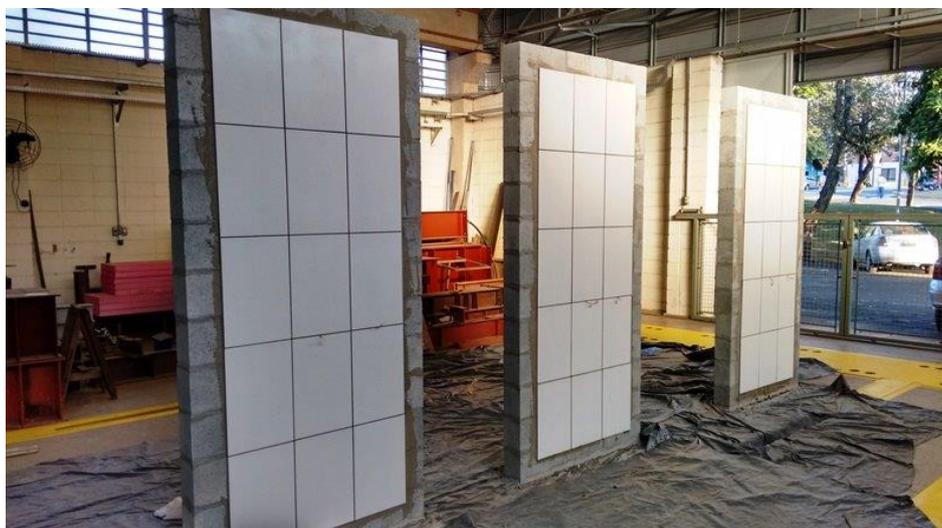
Figure 1 – Wall specimens built in the laboratory for the experimental study.

Concrete block wall masonry specimens were built and tested according to Brazilian standards NBR 13279:2005 [3], NBR 15961-2:2011 [4] and NBR 16522: 2016 [5]. All three walls were built with the same kind of block manufactured under the same factory conditions. The only difference between them were the compressive strengths. The walls were tiled on both sides with the same adhesive mortar (AC II), ceramic tile (30 x 46 cm, BIIb absorption class) and installation technique (horizontal single troweling respecting open time of less than 3 minutes). Figure 1 shows the final configuration of the walls.

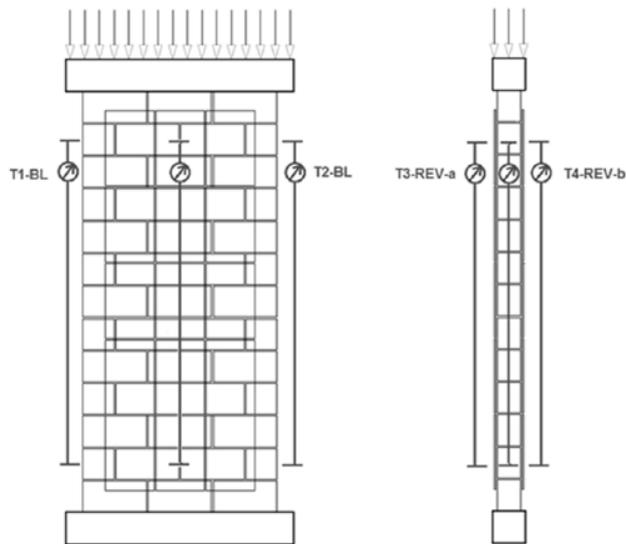
Figure 2 – Positions of vertical transducers.
Source: Report EESC/USP (not published)

During the loading application, the deformations were monitored by vertical transducers (T3 and T4) installed on each wall face and side (T1 and T2), as shown in Figure 2. A horizontal transducer was installed on the third row of ceramic tiles to monitor the horizontal displacement of the wall (T_{hor} - Figure 3).

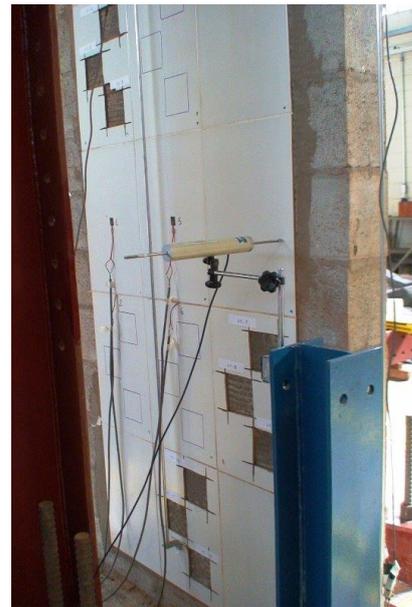
Figure 3 – Horizontal transducer as installed.

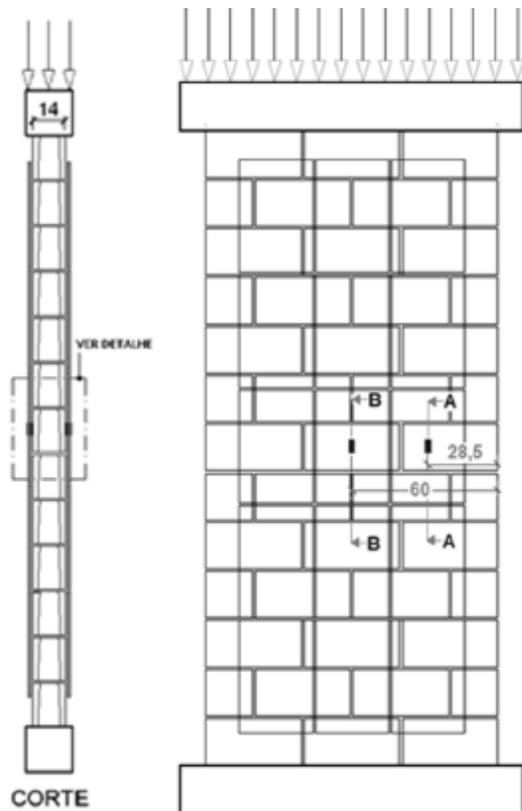
Figure 4 – Positioning of the strain gauges
Source: Report EESC/USP (not published)

Eight electric strain gauges (E1, E2, E3, E4, E5, E6, E7 and E8) were also installed, divided into two points (A and B) of each wall in the central row as shown in Figure 4, Figure 5 and Figure 6, to monitor masonry and tiling deformation.

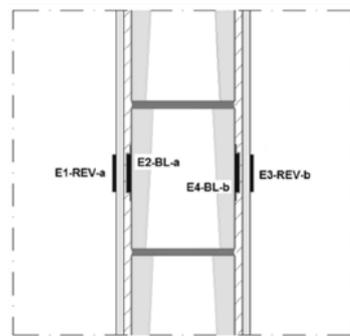
Figure 5 – Section A-A
Source: Report EESC/USP

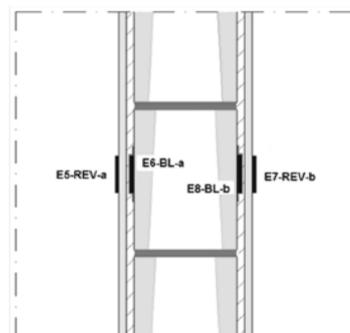
Figure 6 – Section B-B
Source: Report EESC/USP

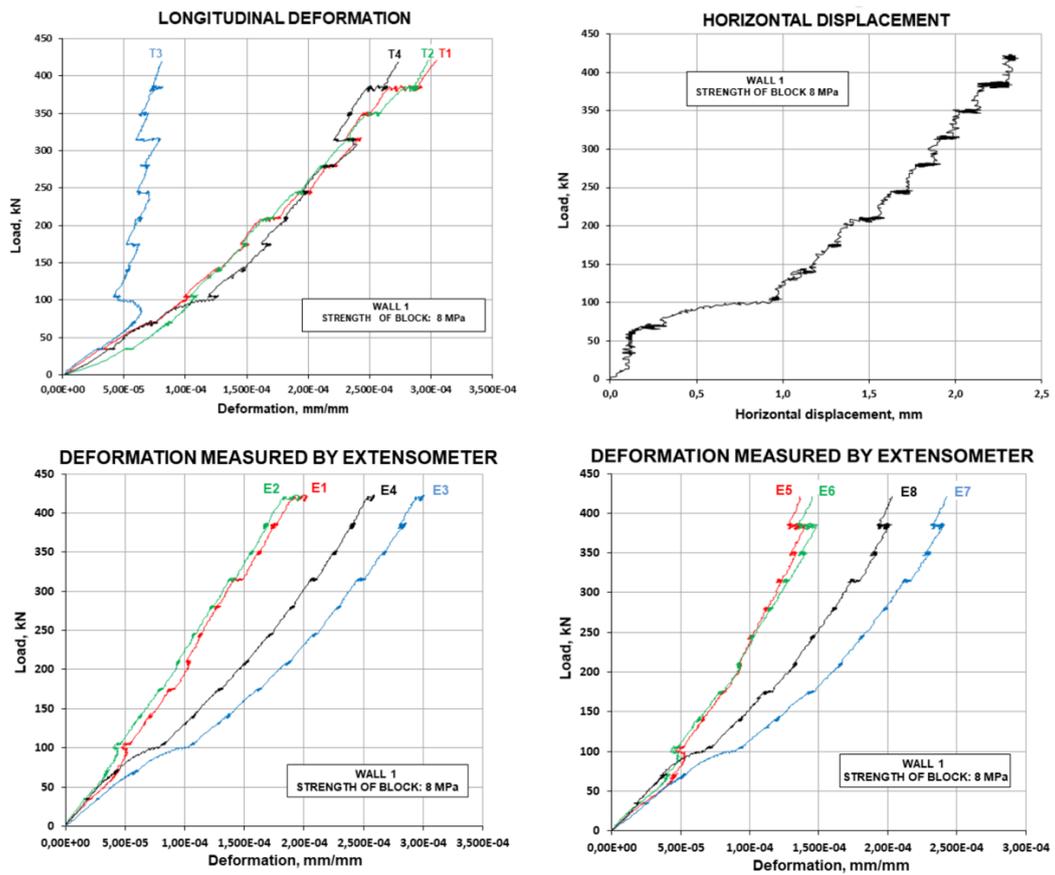
Table 3 – Wall 1 load–deformation behavior under compression.

Wall 1 presented a slight flexion during compression, which was detected by the horizontal displacement determined by T_{hor} (2.42 mm) and by the variation of the deformation of the transducers and strain gauges positioned on the faces of the wall. This explains why T3 on Side B deformed much less than T4 on Side A, indicating that the wall flexed toward side B. This behavior undermines the deformation analysis, since the wall flexion results have different deformations for each side. Because of this, the results obtained for Wall 1 are shown separately in Table 3.

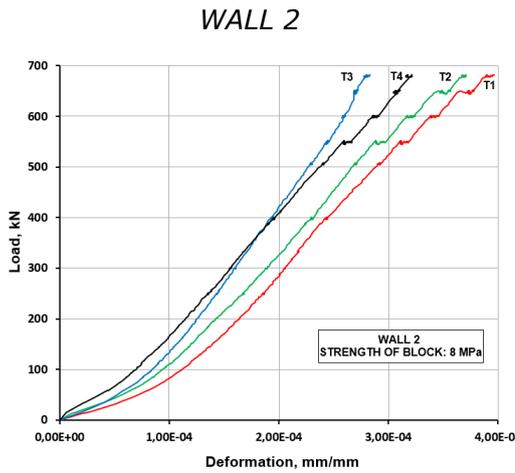
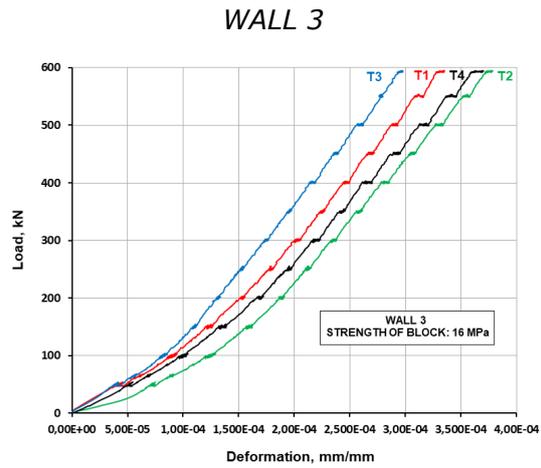
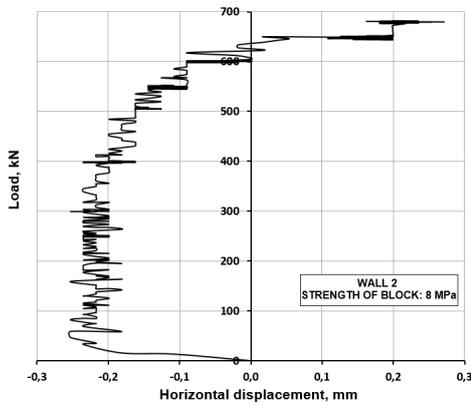
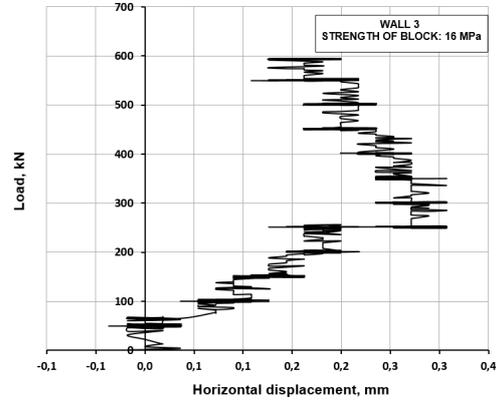
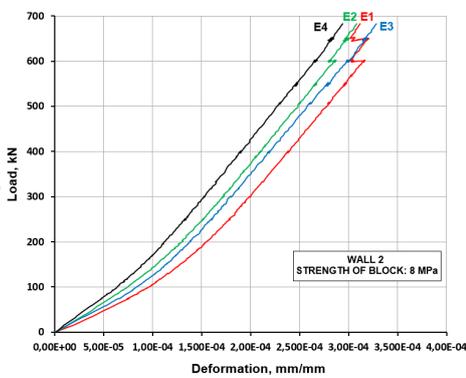
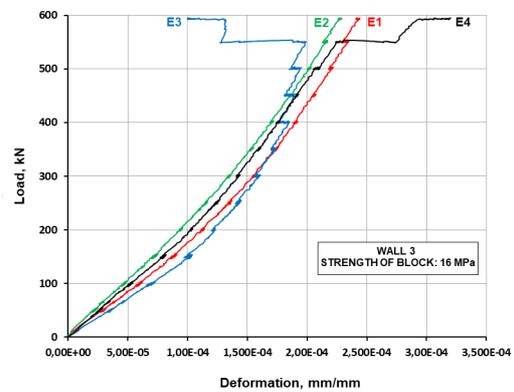
HORIZONTAL DISPLACEMENT LONGITUDINAL DEFORMATION

DEFORMATION (E1-E4)

DEFORMATION (E5-E8)

Table 4 – Wall 2 and Wall 3 load–deformation behavior under axial compression

Table 4 shows that the load–deformation curves of the strain gauges are much closer to each other on these two walls and it allows good comparison of the results. This also indicates that most of the deformation that occurred on the concrete block surface was transmitted to the tile surface. This also means that the adhesive mortar used on the specimen construction was not able to accommodate the deformation originated on the surface of wall, transferring the related stresses straight to the tiles.

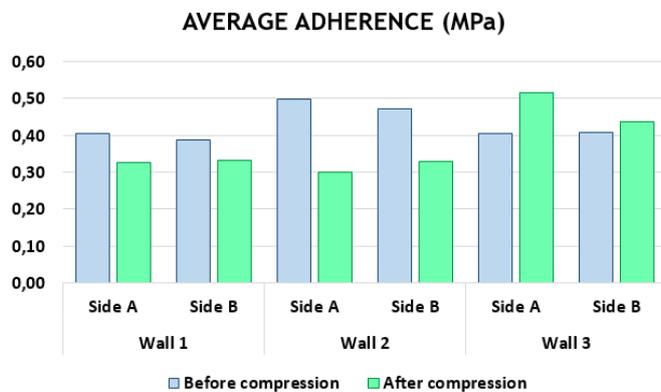
Figure 7 – Average tile bond strength before and after wall compression tests.

Figure 7 shows the average adherence obtained in the tests performed before and after wall compression.

The results for Wall 1 show a slight reduction in bond strength after compression. However, as these reduction values in bond results are higher than the coefficient of variation obtained in tests, it is not possible to draw any conclusions regarding the tile bonding tendency.

Wall 2 was loaded close to the ultimate compressive strength (200 % Nd) and showed a clearer tile debonding tendency – this time with much lower results than the statistical variation of results - indicating that tile bonding may have been affected, but just when the load cycle was close to the ultimate load.

Wall 3, which was loaded to 120 % of the design load (Nd), did not show any tendency in tile bonding loss. The pull-out test results were slightly higher after the compression cycle probably due to the high coefficient of variation of the tests.

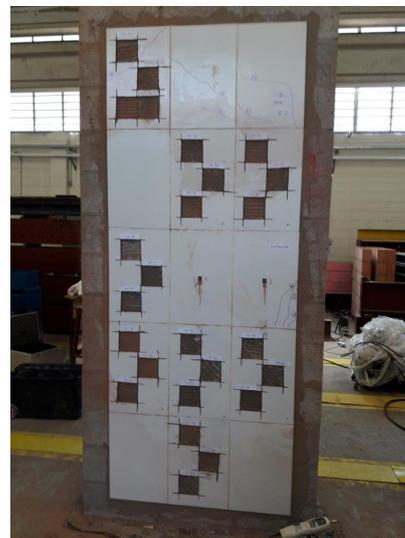
Figure 8 – Wall specimen after the compression test procedure.

Figure 8 shows the positioning of each specimen of the compression adhesion tests.
