## PROCEDURES FOR REPAIR OF PATHOLOGIES IN CERAMIC FACADE CLADDINGS

*Through a discussion of the factors involved in the occurrence of detachments in ceramic facade claddings, this work seeks to establish parameters for restoring this building subsystem. Through this investigation, subsidies are sought for applying a methodology developed for the repair of this type of pathological manifestation.*

*The work presents and analyses a case study in a residential building located in the city of São Paulo - Brazil. In this case study it is attempted to apply parameters based on actions of a preventive and corrective character, in defining an approach for repairing facades affected by detachments.*

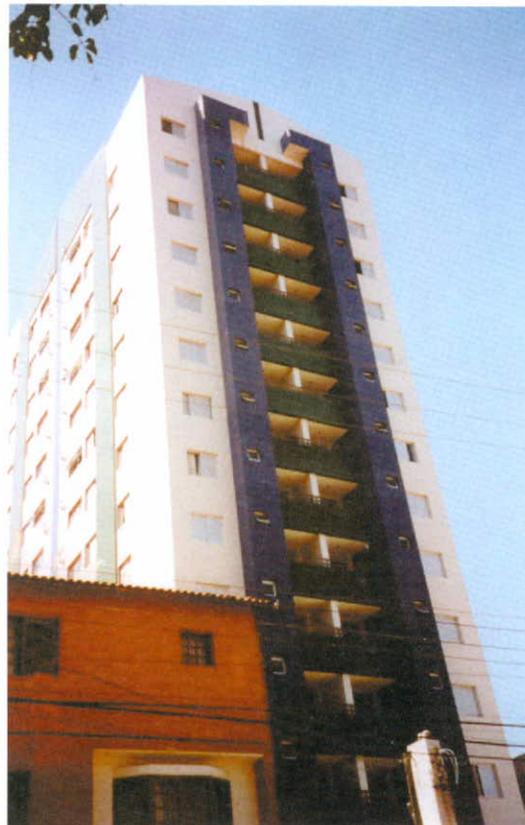
Figure 1: View of the building.

This case originated in user claims that there were physical risks because of a problem of falling ceramic tiles in a pedestrian passage alongside the building. The builder was then called and after visiting the site concluded that specified repair work being carried out was not solving the problem.
