NEW CHALLENGES FOR CERAMIC FLOORING WITH RESPECT TO THE USE OF ANTI-IMPACT SHEETS (TBC DB HR) AND THE CURRENT USE OF DECK SCREEDS WITH SELF-LEVELLING MORTARS

⁽¹⁾ J. Pérez Navarro, ⁽²⁾ G. Martínez Sánchez, ⁽³⁾ Flor de Liz Ramos Gomariz

ABSTRACT

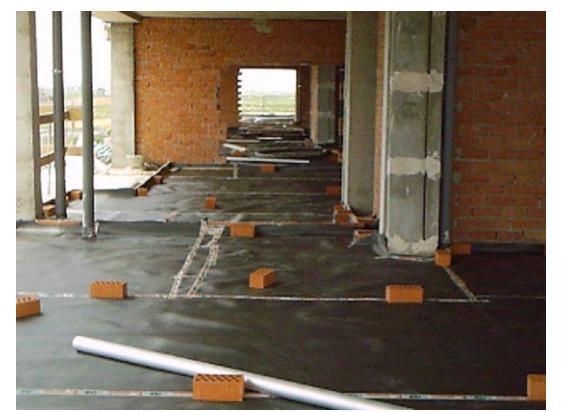
Figure 1. Installation of the soundpoofing sheet.

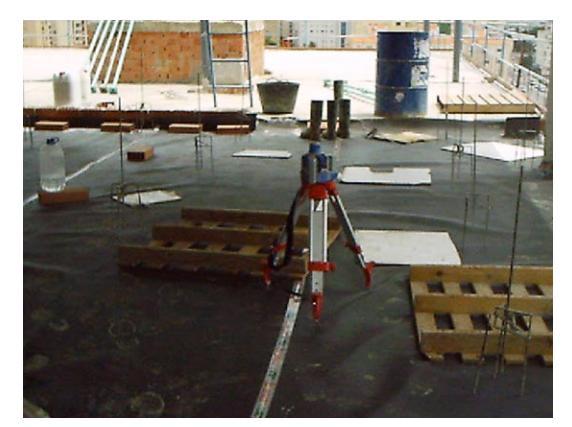
Figure 2. Level gauges.

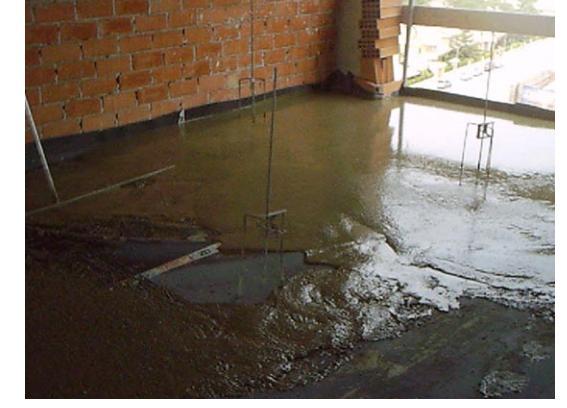
Figure 3. Pouring of the self-levelling mortar.

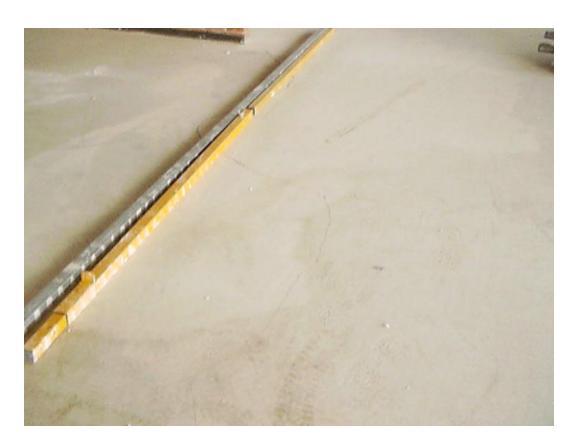
There was no cracking caused by any notable shrinkage in the mortar base installed directly on the deck. The cracks that appeared were of little significance and when they developed, they were very different from one another. Therefore, there

Figure 4. Finished and set mortar base.

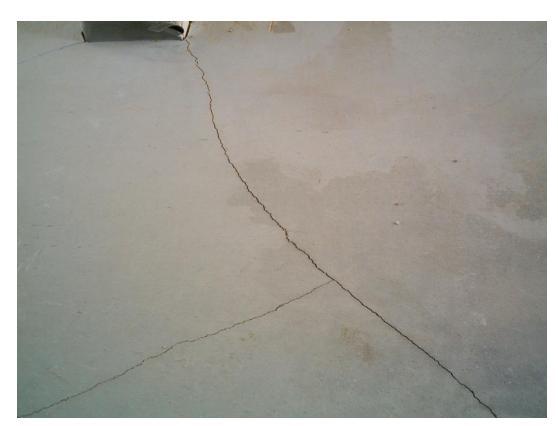
When the self-levelling mortar base was installed on the noise reduction sheet, the cracking due to shrinkage came to reach unacceptable levels, with the mortar slabs breaking and the phenomenon getting worse when the mechanical actions typical of the movement of site materials occurred at the cracks, especially when the thickness of the mortar layer in the area did not exceed 3 cm, and so-called "spider web" cracks appeared that evidenced complete fracture of the affected area.

Figure 5. Cracking. Crack width >3mm.

- The cracks reached and easily exceeded widths of 3 mm. This caused lipping between both sides of the crack, which also exceeded this magnitude.
- Shrinkage is intrinsic to the setting of mortars made with cement. This was more pronounced in this case due to the high water-cement ratio required to make the mortar fluid, to facilitate pumping and help mortar levelling. Also, when it was poured onto the closed cell noise reduction sheet, which insulated the mortar substrate from the deck and completely prevented the mortar base from adhering to it, all the rapid water loss of the mortar during setting occurred at the surface, and this effect was not controlled sufficiently by the plasticiser addition that was incorporated into the mortar.

- 3. With respect to the cracks with 3-mm lipping between their top sides, a minimum width of 36 cm of the flooring shall be demolished along the whole length of the crack, and the resulting strip filled with TOPCEM PRONTO. Sealing shall then follow.
- 4. Sealing of the cracks by pouring EPORIT.

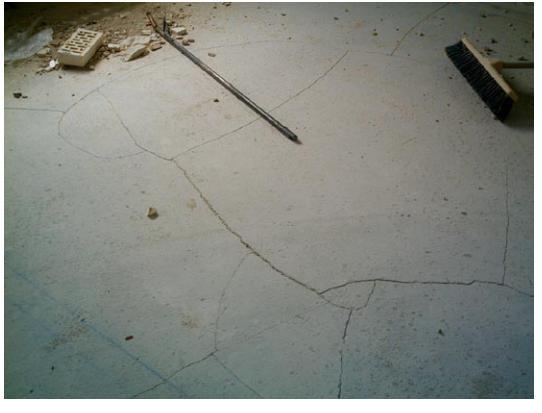
Figure 6. "Spider web" cracks.

- With the small thicknesses of the self-levelling mortars and the mechanical movement of site materials, in some houses, the cracking worsened and "spider webs" formed that caused the slab to break.

- 1. The cracks must be opened with radial cuts, cleaned and vacuumed before being sealed.
- 2. The areas affected by "spider web" cracking shall be demolished and the resulting area filled with TOPCEM PRONTO. Sealing shall then follow.

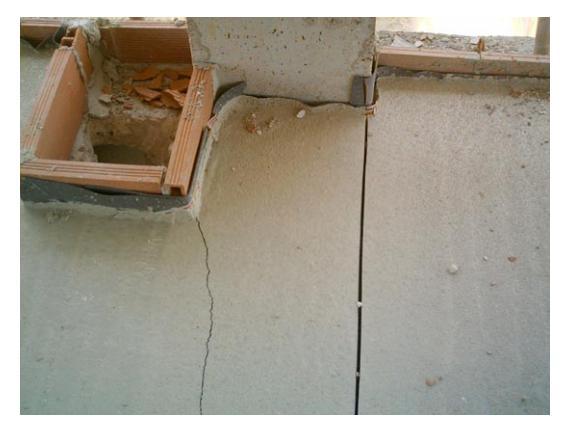
Figure 7.

As a first preventive measure, shrinkage joints were ordered to be made by radial cuts of the mortar layer in order to control the shrinkage.

As the above photograph shows, the result was not satisfactory.

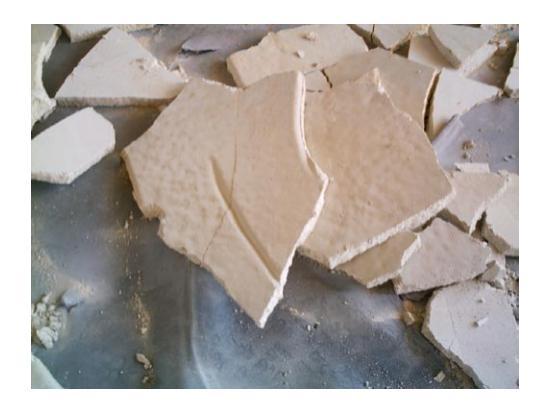
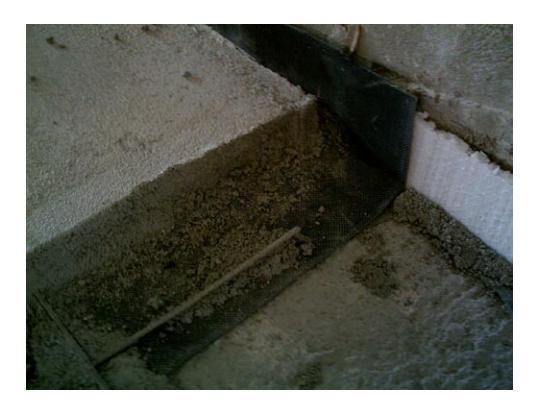
- In order to resolve the pathology, and with a view to repairing the selflevelling mortar without completely breaking it up, in contact with the company MAPEI, the following tests were carried out:
 - Demolition of the mortar layer in two houses for a TOPCEM PRONTO floating cement screed to be applied, according to the procedure by this commercial company. In one of the houses, the screed was reinforced with lath and in the other it was not.

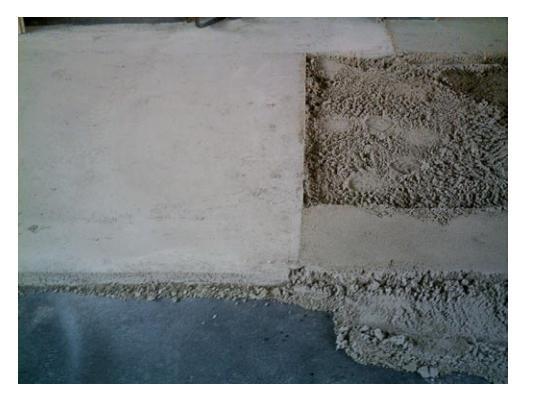
Figure 9.

• Repair of the mortar layer in one house according to this commercial company's procedure, sealing cracks with EPORIT and then preparing the flooring substrate and way of installing it. This testing of this procedure was carried out in its entirety.

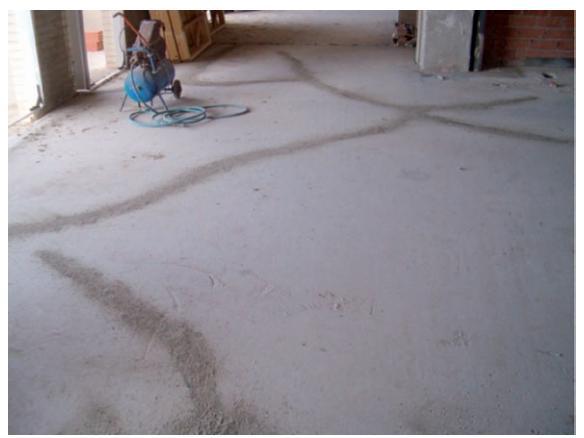
5. Sprinkling the surface of the fresh resin with sand and then vacuuming it once it has hardened.

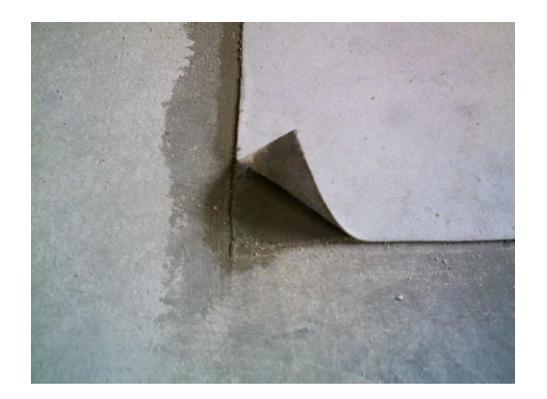
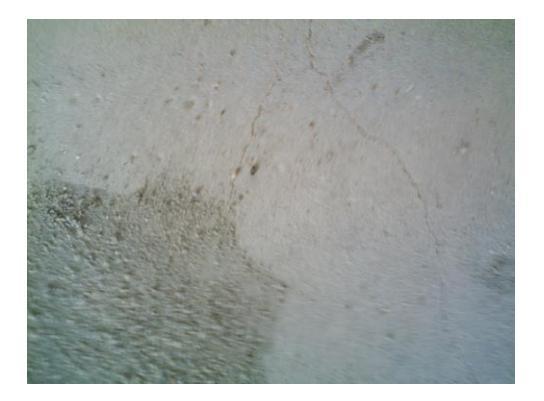
1. Gluing the MAPETEX felt with KERABOND adhesive with 100% ISOLASTIC added.

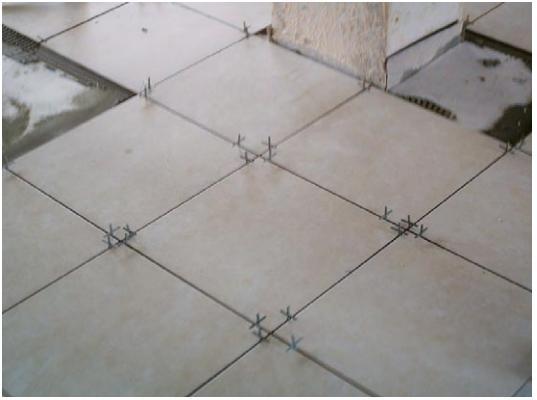
Figure 13.

2. Installation of the ceramic flooring on the MAPETEX felt with the KERABOND adhesive with 100% ISOLASTIC added, using the buttering and floating technique (substrate and back of the tiles). The tile-to-tile joints shall be 3 mm wide.

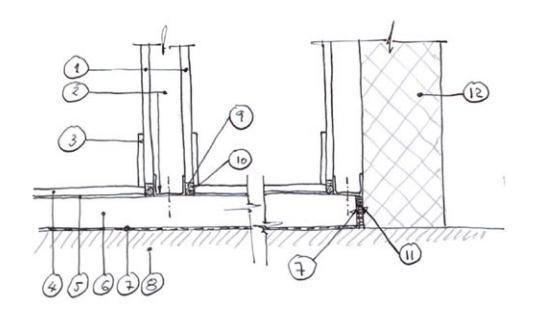
Figure 14. 1. Gypsum wallboard e=15 mm. 2. Gypsum wallboard structure. 3. Ceramic skirting. 4. Ceramic flooring. 5. MAPETEX felt and KERABOND adhesive. 6. Repaired self-levelling mortar. 7. Noise reduction sheet. 8. Deck. 9. Joint sealing with MAPESIL AC. 10. MAPEFOAM for joint bottom. 11. Porexpan e=5mm. 12. Structural element or building envelope.

Given the size of the rooms in the houses, the configuration of the flooring stretches is considered adequate for the room dimensions, while the perimeters of the rooms are left as movement joints. In the event of the flooring model changing between rooms, a movement joint shall be made between both.

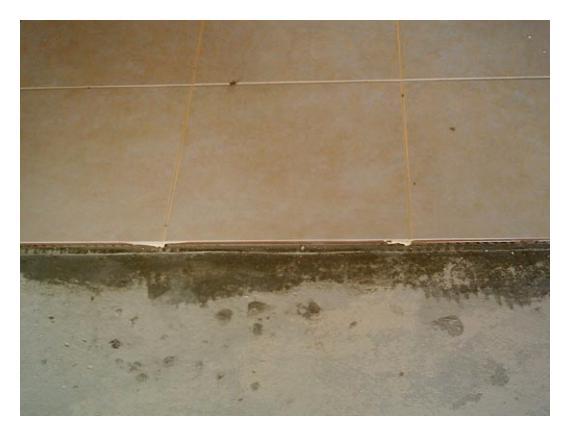
Figura 15.

3. ULTRACOLOR filling of the tile-to-tile joints.

4. Sealing of movement joints with MAPESIL AC before installing MAPEFOAM for the bottom of the joint.

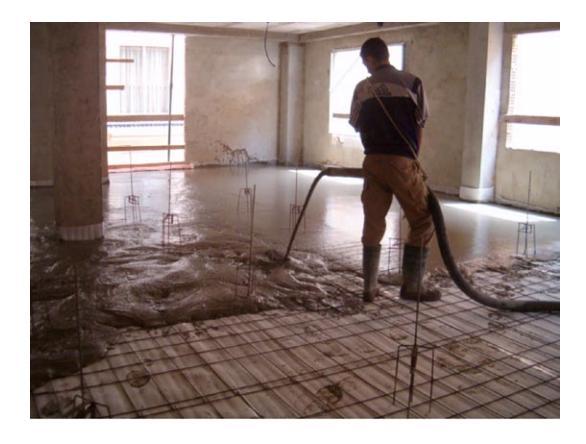
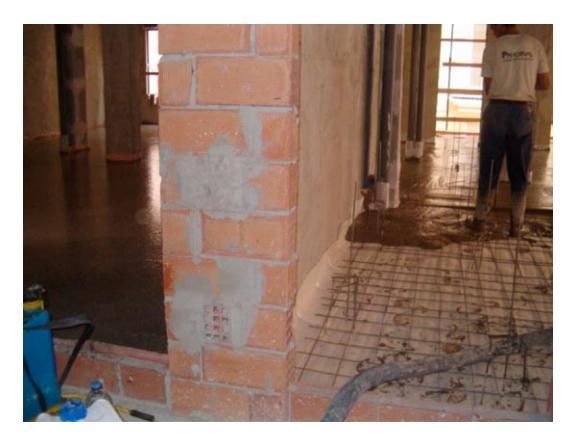
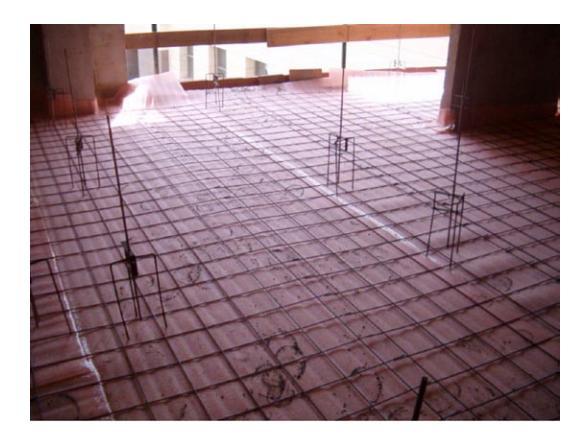
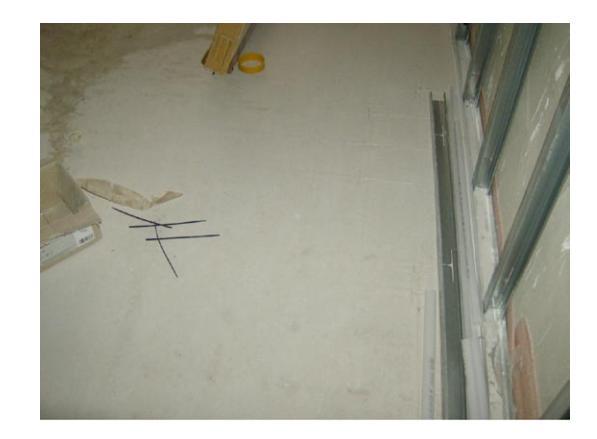
Figure 16.

- Not very significant cracking was noticed approximately one week after the pouring. No intervention was required for crack sealing.
- Areas where the lath showed through by default in the installation were observed, which remained in the upper part of the floor.
- The ceramic flooring was installed using adhesive without any previous preparation.

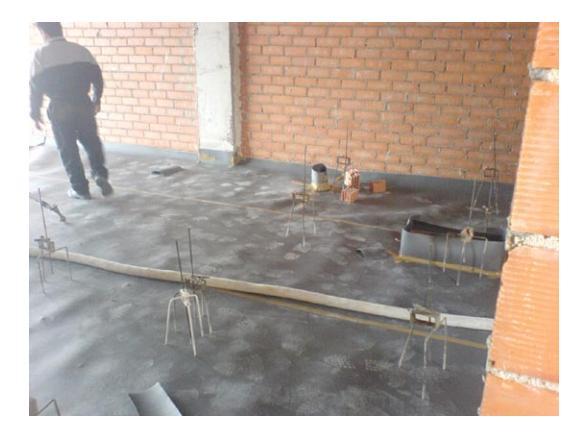
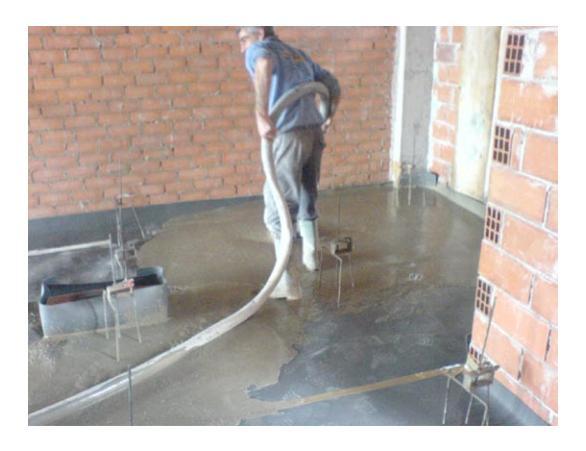
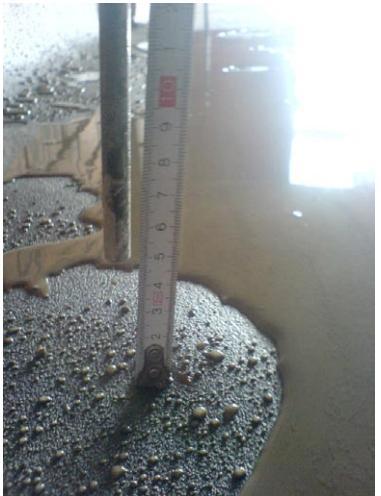
Figure 17.

The building location and orientation favoured cracking of the floor due to the uncontrolled shrinkage of the mortar as a result of excessive airing.

Cracking, in some cases +up to 2 mm, was noticed two or three days after pouring. These were 45° tracks in spider form that ran through the rooms and that began at particular points, such as false openings and pillar linings. In other cases, cracks were involved that coincided with areas where the mortar thickness was less than 5 cm.

In these cases, the intervention was demolition of the floor.

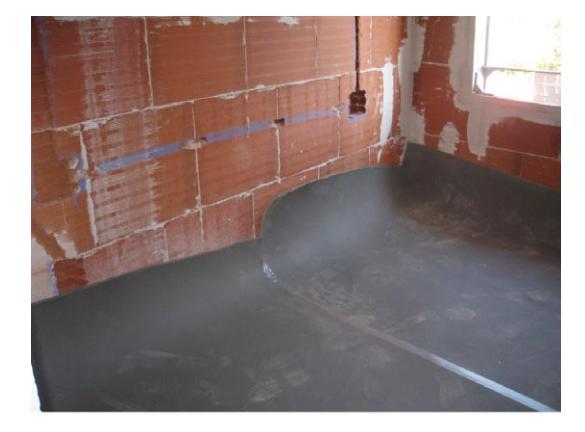
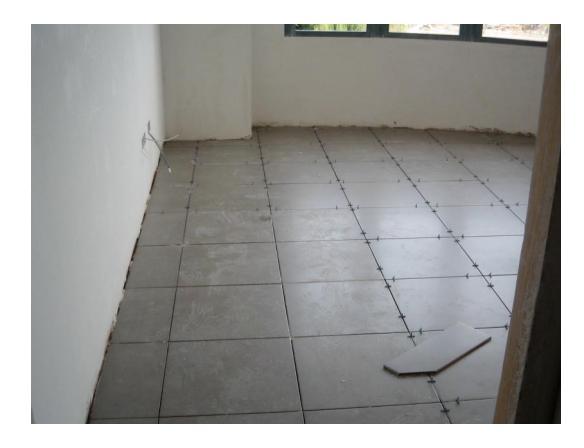
Figure 20.

- Installation of the self-levelling mortar with a minimum thickness of 8 cm (10 cm being recommendable) reinforced with MALLATEX. (Reinforcement with lath creates problems when pouring the self-levelling mortar through the undulations that are typical of the lath, which end up appearing at the surface). The minimum thickness is to provide the base mortar on the thermal insulation with rigidity and weight. Otherwise, the floating effect of the flooring appears once it has been installed and it is easy for a thinner mortar layer to fail, leading to fractures in the flooring once it has been installed.

- Installation of ceramic flooring with adhesive, always using the buttering and floating technique (substrate and tile).
