# **SUSTAINABLE SLIP RESISTANCE: AN OPPORTUNITY FOR INNOVATION**

**Carl J Strautins**

Slip Check Pty Ltd, Sydney Australia  
carl.strautins@gmail.com

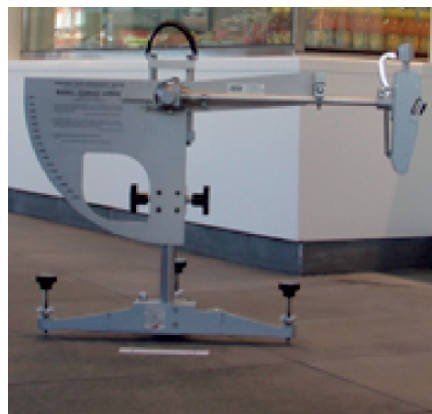
(b) Pendulum slip resistance friction tester

Figure 1. Initial investigation of test methodology using: (a) Gardco linear motion washability and wear tester; and (b) Pendulum slip resistance friction tester

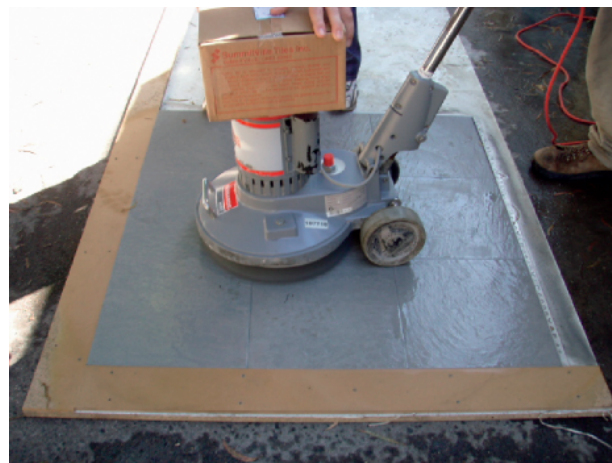
(a) Polishing/buffing machine used to wear tiles

Figure 3. Apparatus used for preparation and testing of samples for the inclining ramp test method.

Samples were first exposed to 5000 cycles of the accelerated Gardco wear procedure. The slip resistance was measured using the wet pendulum test method using both potable water and (the DIN 51 030 specified) oil. 0.5m<sup>2</sup> samples of each tile were then mounted separately on a board and subjected to wear using a floor polishing/buffing machine using a variety of abrasive cleaning pads. The position of the tiles on the board was changed during the procedure in an attempt to wear each of the tiles uniformly. The tiles were tested periodically using the pendulum friction tester (Slider 96) until the slip resistance had reduced equivalent to that of 5000 cycles of the accelerated wear procedure. Multiple measurements were conducted on each sample of worn tiles. Some minor variation may have occurred throughout the panels. One sample board was rejected as there was a difference in CoF between the Gardco accelerated wear samples and the polishing/buffing machine was greater than 0.02. The process was then repeated until the sample board conformed within  $\pm 0.02$  CoF of the mean.
