# **SUSTAINABLE SLIP RESISTANCE: AN OPPORTUNITY FOR INNOVATION**

**Carl J Strautins**

Slip Check Pty Ltd, Sydney Australia  
carl.strautins@gmail.com

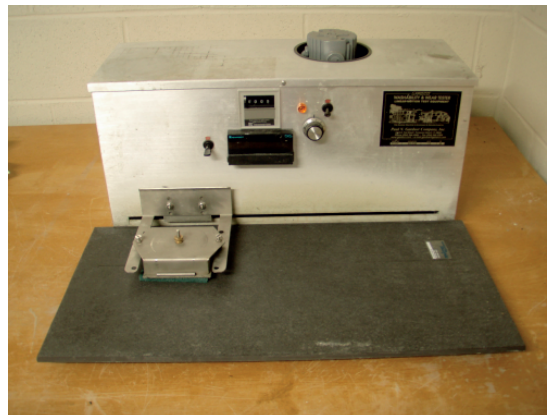
(a) Gardco linear motion washability and wear tester

Figure 1. Initial investigation of test methodology using: (a) Gardco linear motion washability and wear tester; and (b) Pendulum slip resistance friction tester

A Gardco 12VFI linear motion washability and wear tester was used to develop an accelerated wear test. This apparatus has traditionally been used to assess the wear resistance of paint systems using nylon bristle brushes. The machine has a 100mm x 100mm friction boat, which is cradled within a fork drive. Different abrasive materials were fixed to the bottom of the friction boat, which was set to operate at a rate of 50 cycles per minute, traversing backwards and forwards over a 300 mm path length. The pressure on the (water) wetted test specimen was controlled by adjusting the friction boat weight.

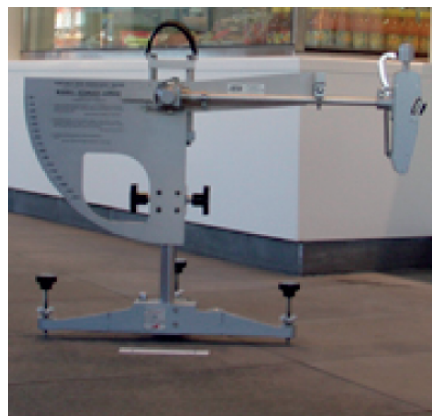
(b) Pendulum slip resistance friction tester

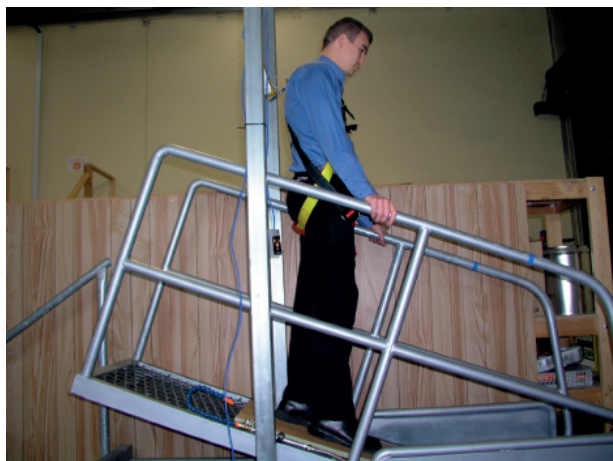
(b) Inclining ramp testing apparatus

Figure 3. Apparatus used for preparation and testing of samples for the inclining ramp test method.

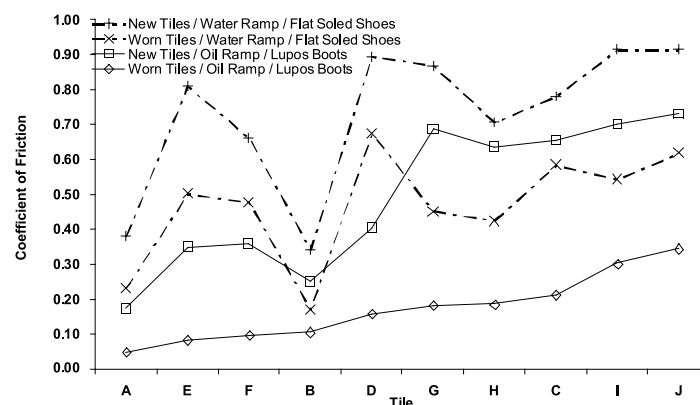
(a) Comparison of new and worn tiles

Figure 4. Investigation of inclining ramp test methodology (a) difference between new and worn tiles using water and oil for the ramp test; and (b) comparison of shoes used and contamination.

Figure 4(a) shows the results graphically of the coefficient of friction for both new and worn tiles using inclining ramp with water and flat soled shoes shod with slider 96 rubber prepared with P400grade paper. The standardised safety boots were not prepared with abrasive paper when ramp testing with oil as a contaminant. The results were ranked in an ascending order of worn tiles when tested to DIN 51 030. After the equivalent of 5000 cycles of wear the reduction in slip resistance was noteworthy. There was a reduction of between 25-50% when measured with the water ramp test and 53-75% with the oil wet ramp test.
